WEST ELEVATION.

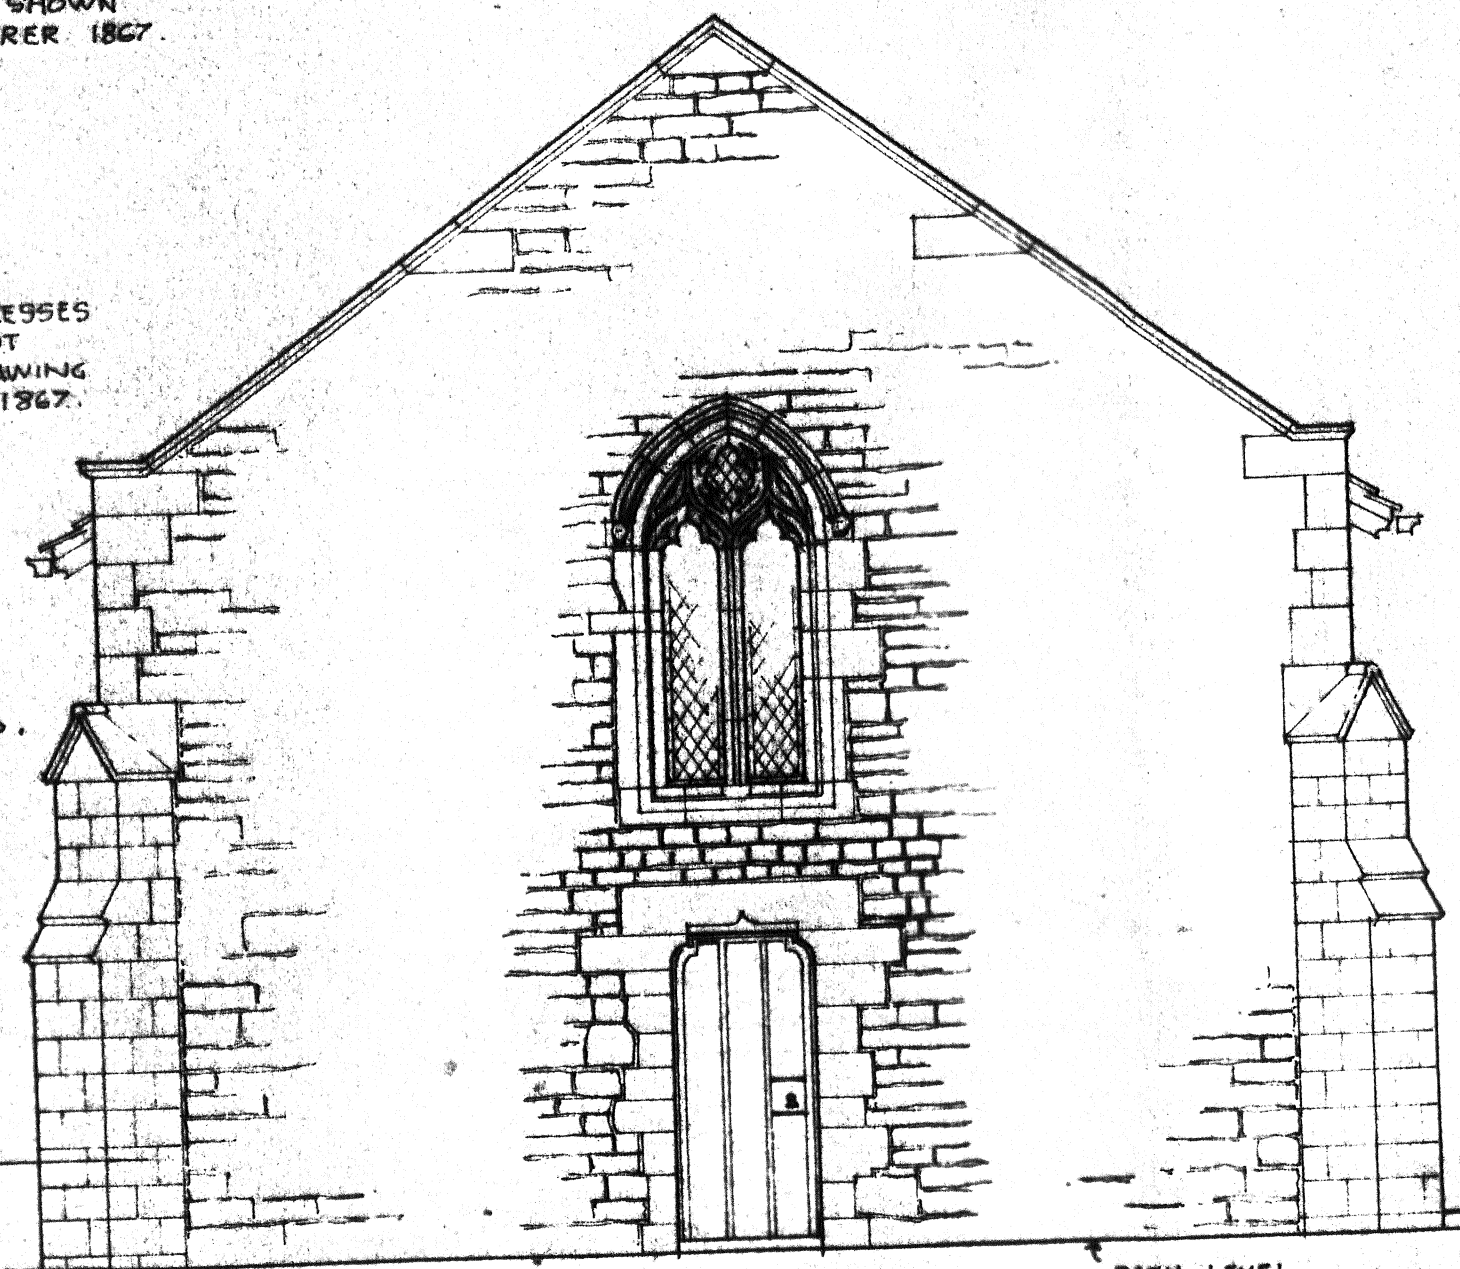
GABLE CORNING NOT SHOWN
ON DRAWING BY TYRER 1867.

THE ANGLE BLITRESSES
OF THE NAIVE DO NOT
APPEAR ON THE DRAWING
BY TYRER DATED 1867.

NORTH SIDE OF
CHURCH REMAINS
LARGELY AS BUILT
IN NORMAN PERIOD.
THERE ARE SOME
SMALL AREAS OF
REFACING.

CONCRETE TILES TO ROOF
ARE A RECENT REPLACEMENT.

LINE OF W. FRONT
PRIOR TO DEMOLITION
EARLY IN 19. C.

STONEMWORK TO S. WALL OF NAIVE
ABOVE 1 M LEVEL APPEARS TO BE
A 19 CENT REFACING.

EXISTING FOUNDATIONS
AS EXPOSED DURING ARCH.
EXCAVATIONS 1979/80

W. FRONT RESULT IN
PRESENT POSITION
C. 1800.
L.C. WINDOW
REINSTATED.
