EXISTING EXTERNAL WINDOW SCHEDULE

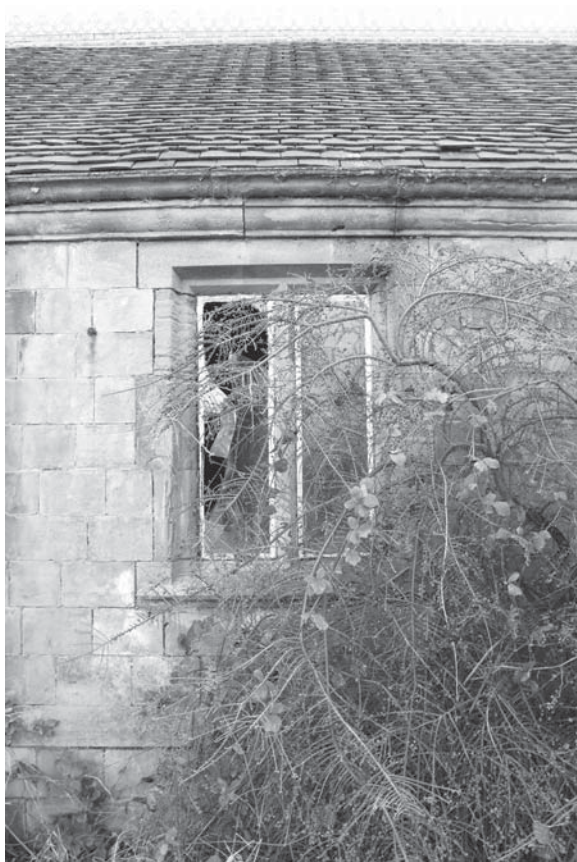
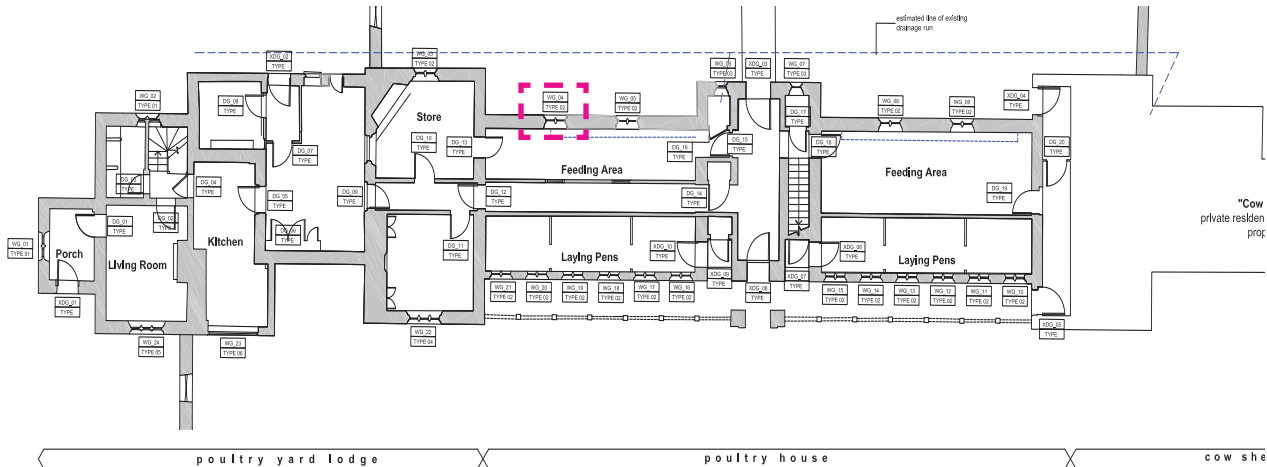
WG-04

Two panel window with central stone pier and metal framed window to both LHS and RHS with no opening light

YES. SECONDARY
GLAZING TO BE
PROVIDED

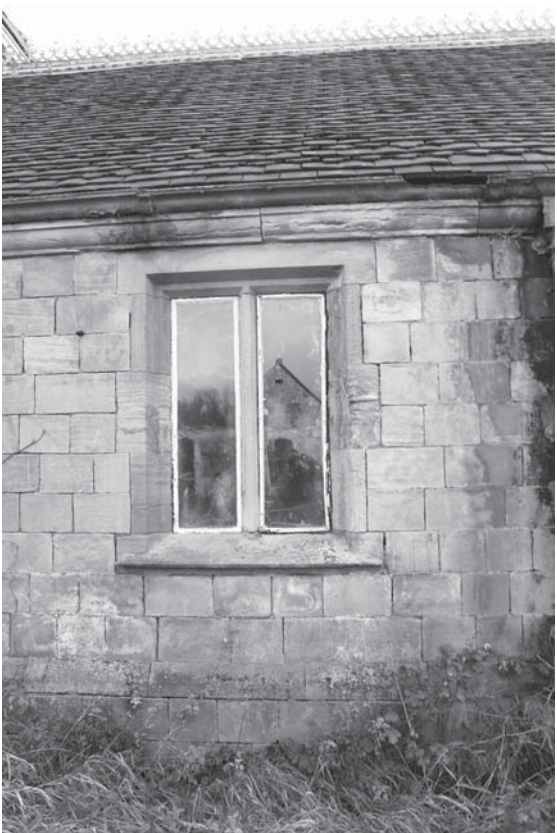
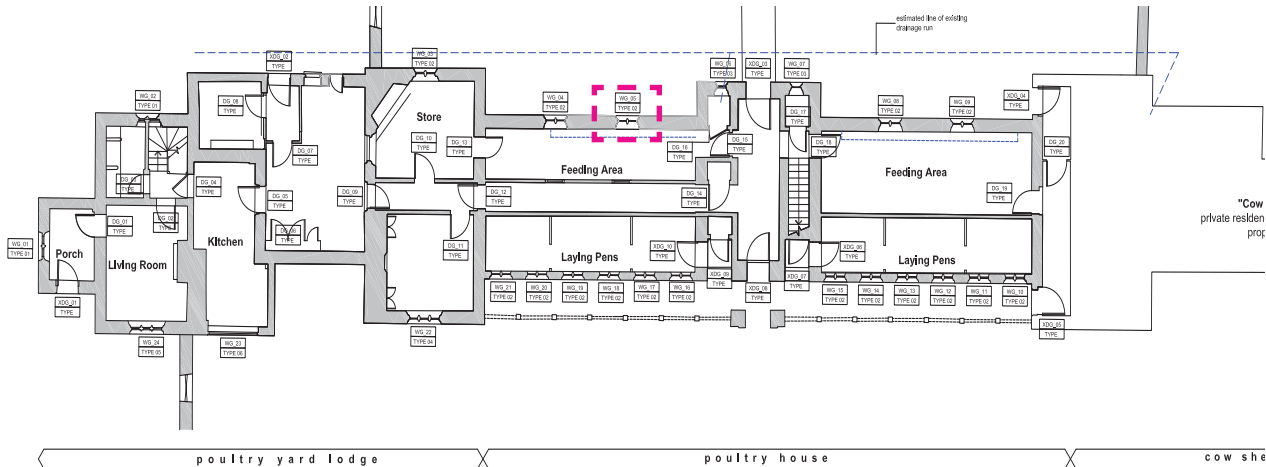
WG-05

Two panel window with central stone pier and metal framed window to both LHS and RHS with no opening light.

YES. SECONDARY
GLAZING TO BE
PROVIDED

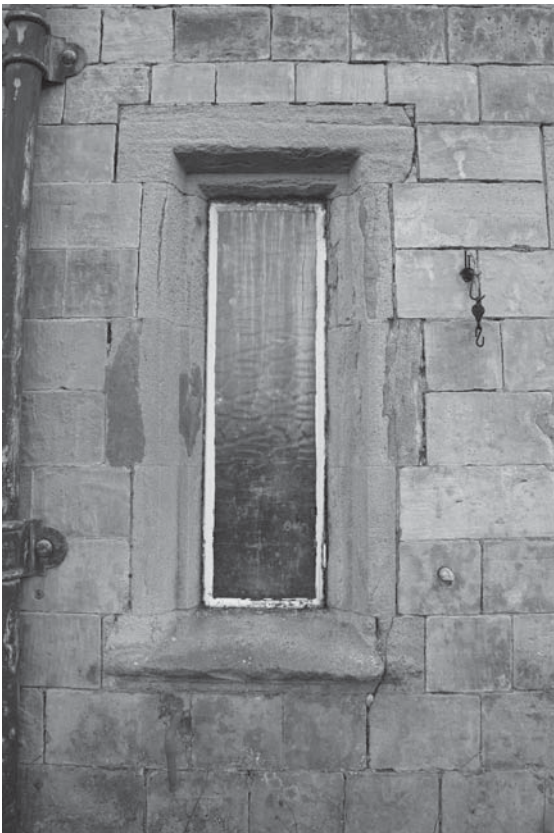
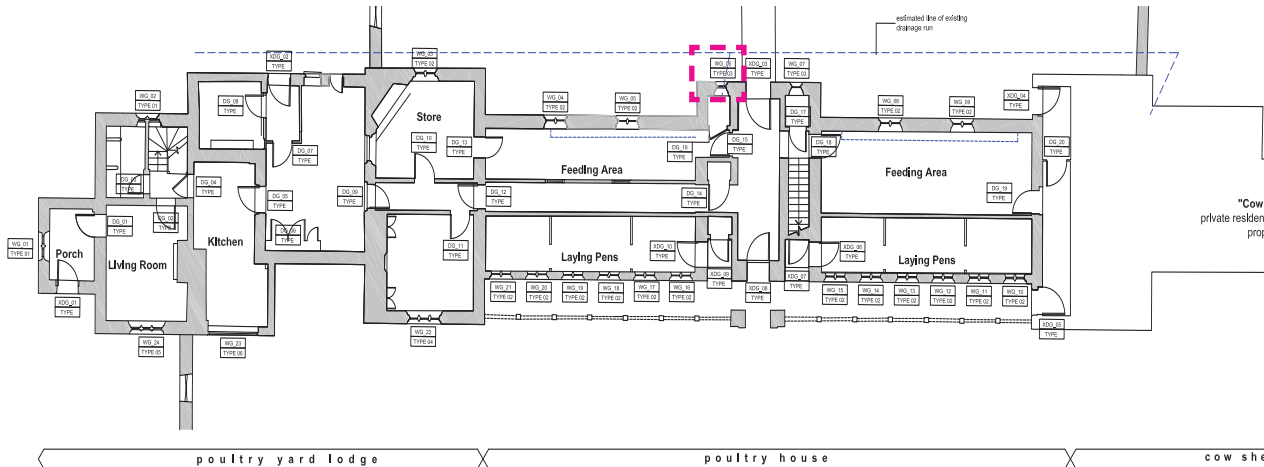
EXISTING EXTERNAL WINDOW SCHEDULE									
Window reference No :							WG-06		
Floor level :	Ground		External window type :		Type 03				
HISTORICAL SIGNIFICANCE			Level of significance	1=low, 5=high	1	2	3	4	5
Approximate date :	C 1860							4	
Description :			WORKS PROPOSED						
Single panel metal framed window with opening light			Retained and repaired :		Removed and replaced :				
			YES. SECONDARY GLAZING TO BE PROVIDED

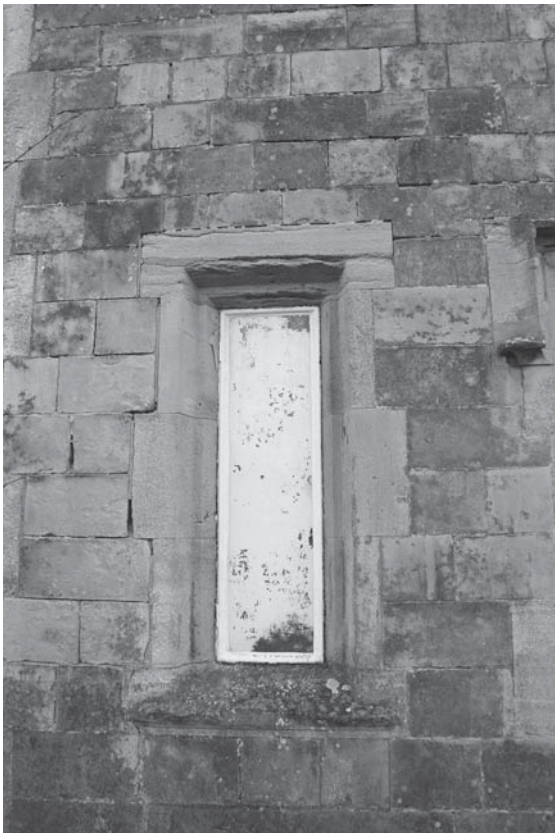
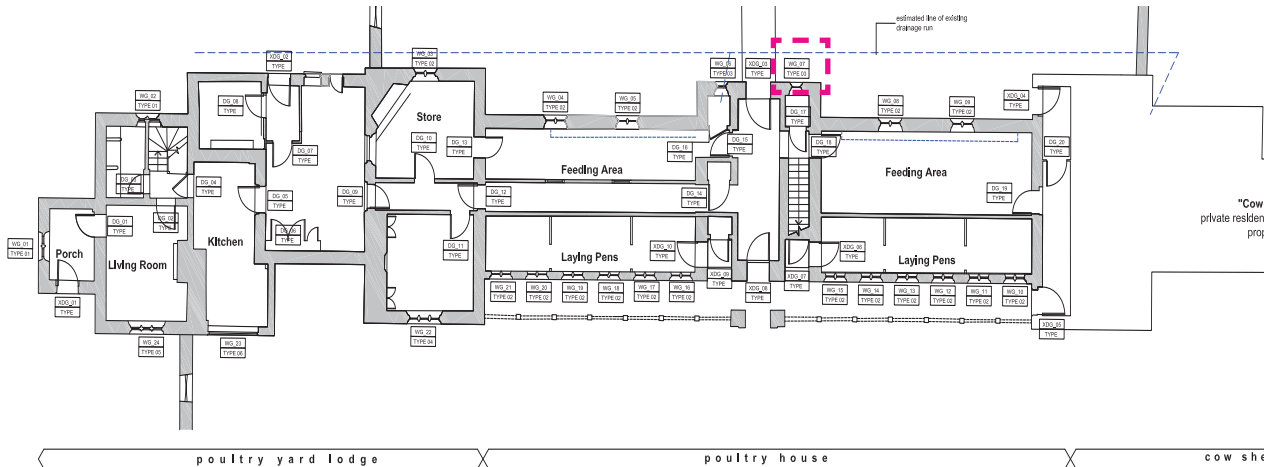
EXISTING EXTERNAL WINDOW SCHEDULE									
Window reference No :					WG-07				
Floor level :	Ground		External window type :		Type 03				
HISTORICAL SIGNIFICANCE			Level of significance	1=low, 5=high	1	2	3	4	5
Approximate date :	C 1860							4	
Description :			WORKS PROPOSED						
Single panel metal framed window with no opening light.			Retained and repaired :		Removed and replaced :				
			YES. SECONDARY GLAZING TO BE PROVIDED

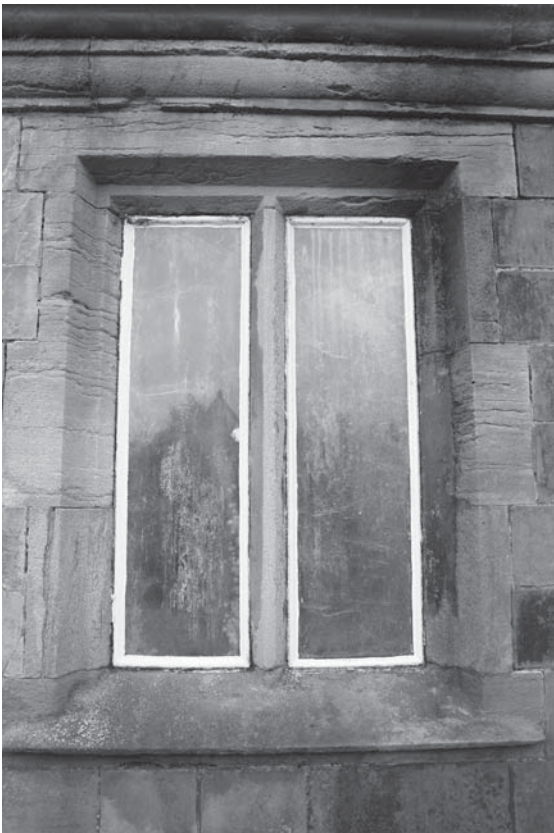
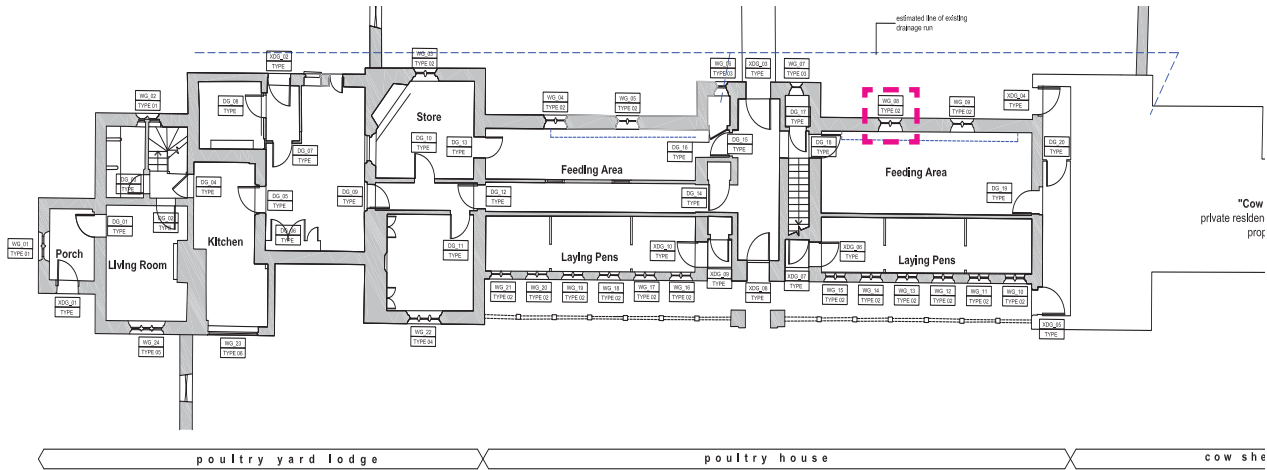
EXISTING EXTERNAL WINDOW SCHEDULE							
Window reference No :			WG-08				
Floor level :	Ground	External window type :		Type 02			
HISTORICAL SIGNIFICANCE		Level of significance	1=low, 5=high	1	2	3	4
Approximate date :	C 1860						4
Description :		WORKS PROPOSED					
Two panel window with central stone pier and metal framed window to both LHS and RHS with no opening light.		Retained and repaired :		Removed and replaced :			
		YES. SECONDARY GLAZING TO BE PROVIDED

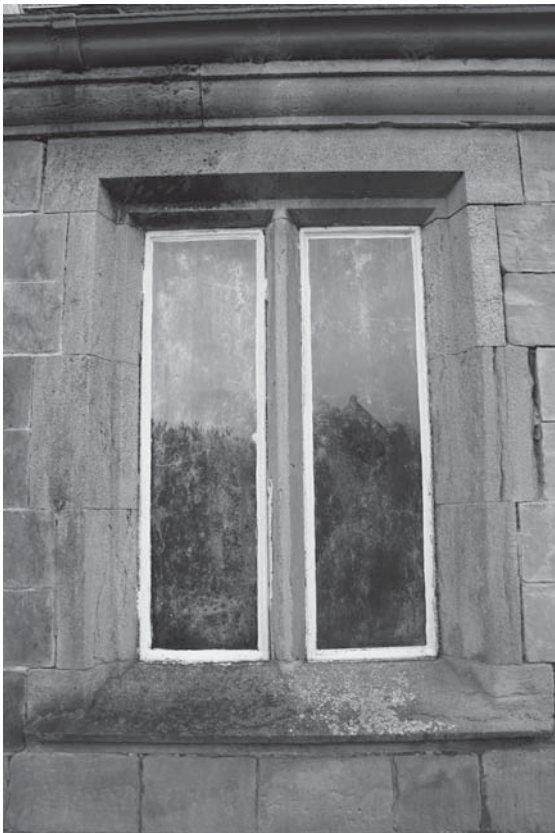
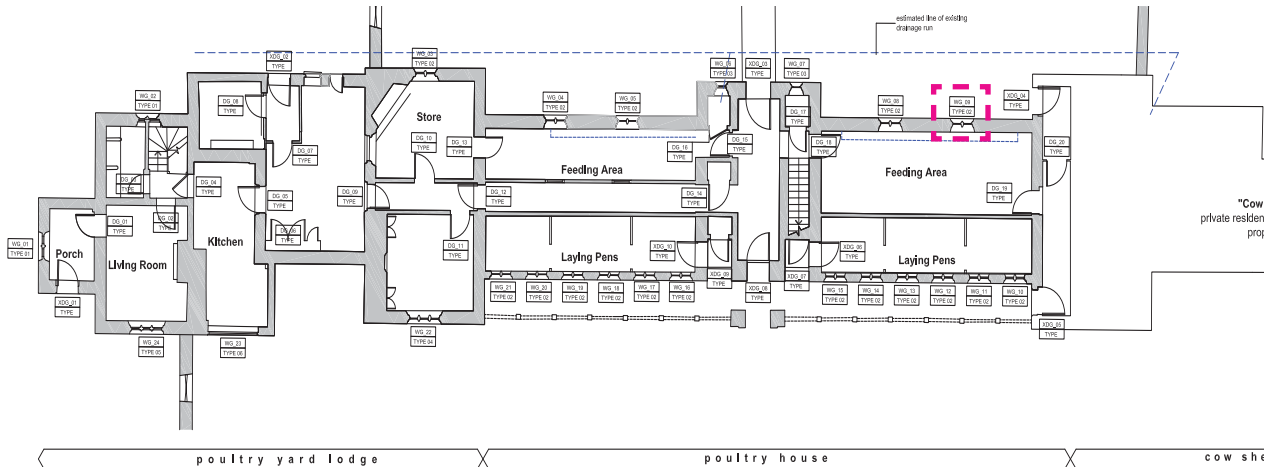
EXISTING EXTERNAL WINDOW SCHEDULE						
Window reference No :			WG-09			
Floor level :	Ground	External window type :		Type 02		
HISTORICAL SIGNIFICANCE		Level of significance	1=low, 5=high	1	2	3
Approximate date :	C 1860					4
Description :		WORKS PROPOSED				
Two panel window with central stone pier and metal framed window to both LHS and RHS with no opening light.		Retained and repaired :		Removed and replaced :		
		YES. SECONDARY GLAZING TO BE PROVIDED

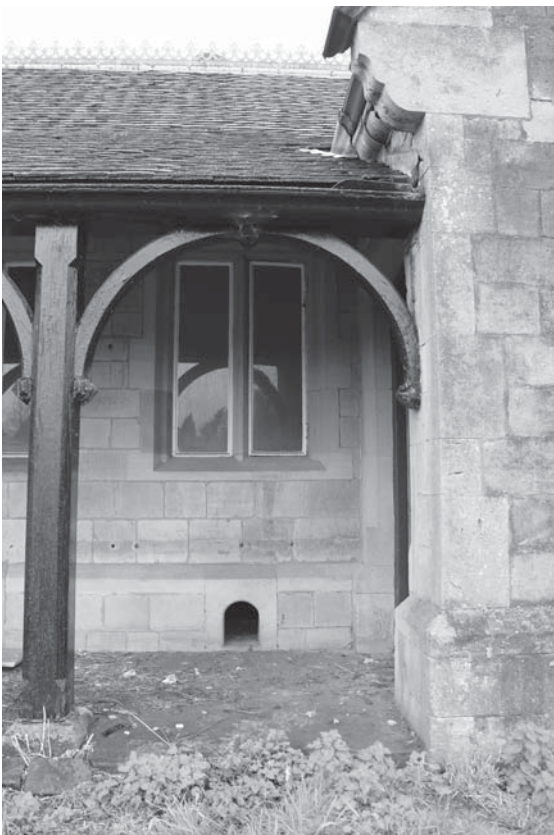
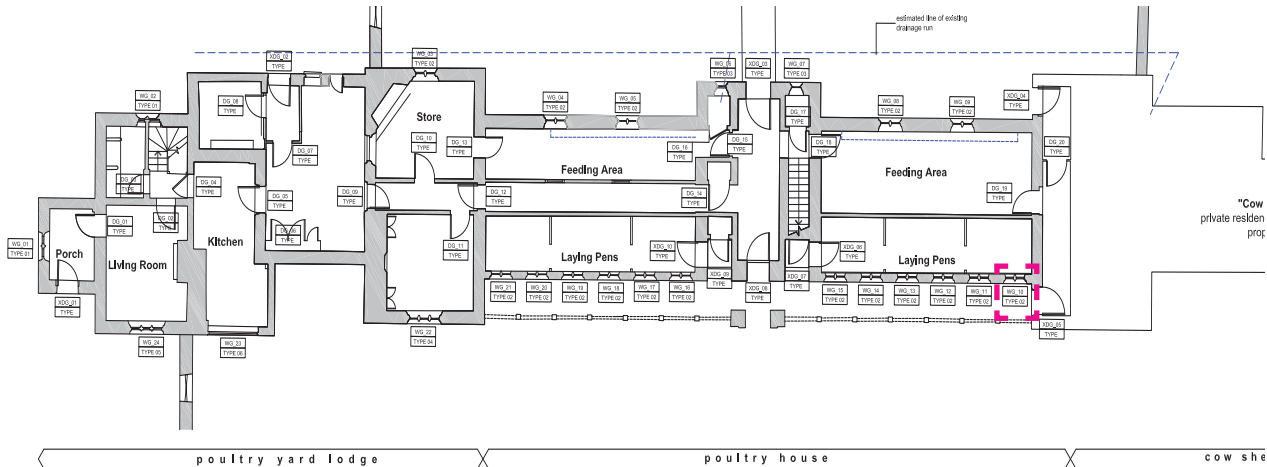
WG-10

Two panel window with central stone pier and metal framed window to both LHS and RHS with no opening light.

**YES. SECONDARY
GLAZING TO BE
PROVIDED**

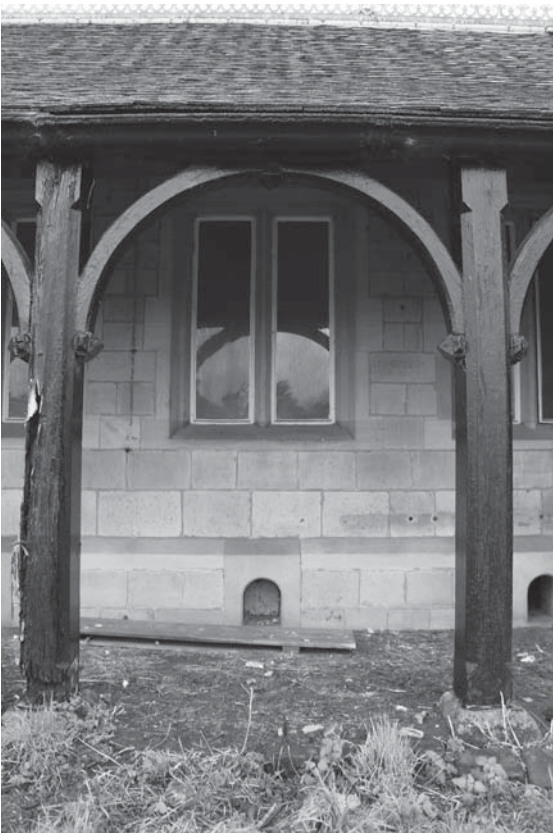
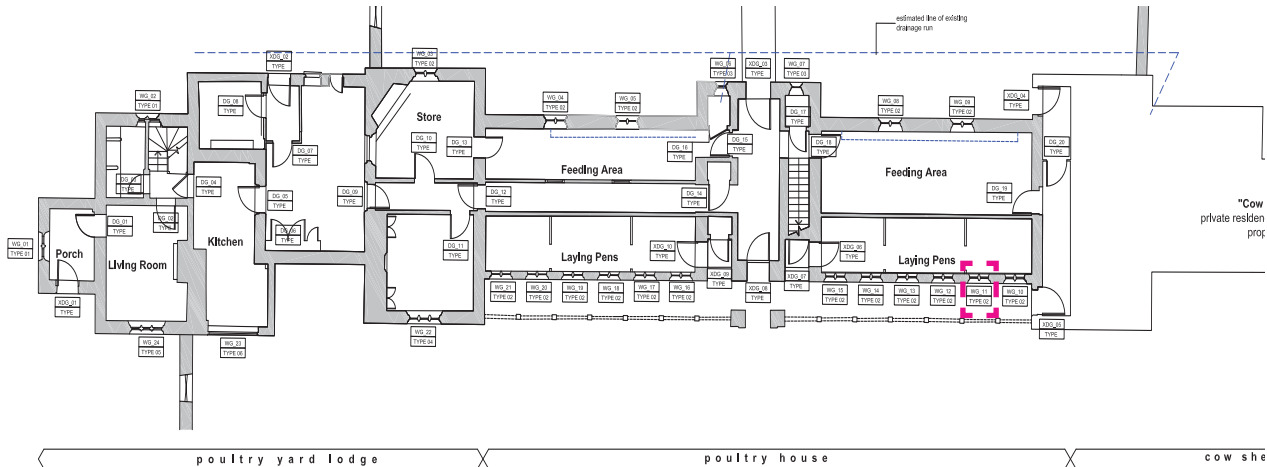
WG-11

Two panel window with central stone pier and metal framed window to both LHS and RHS with no opening light.

**YES. SECONDARY
GLAZING TO BE
PROVIDED**

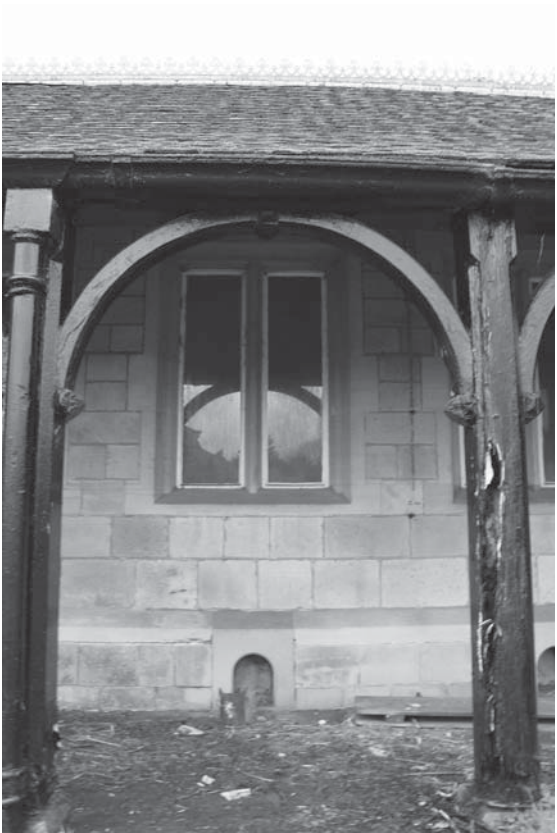
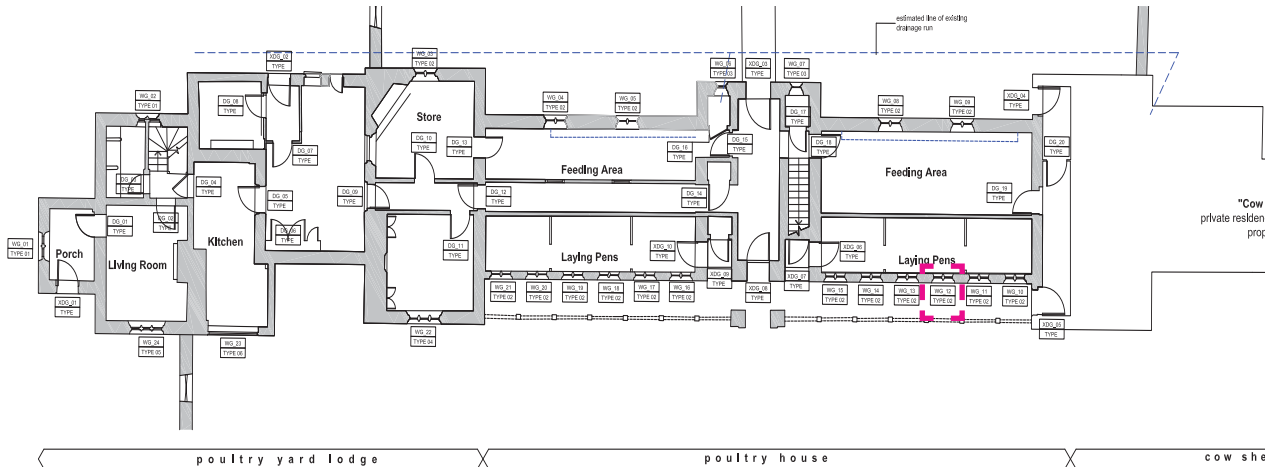
WG-12

Two panel window with central stone pier and metal framed window to both LHS and RHS with no opening light.

YES. SECONDARY
GLAZING TO BE
PROVIDED

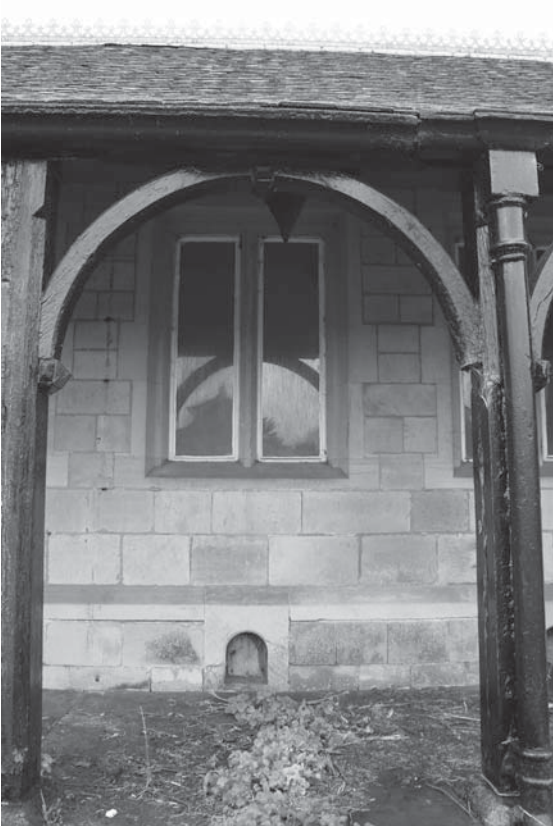
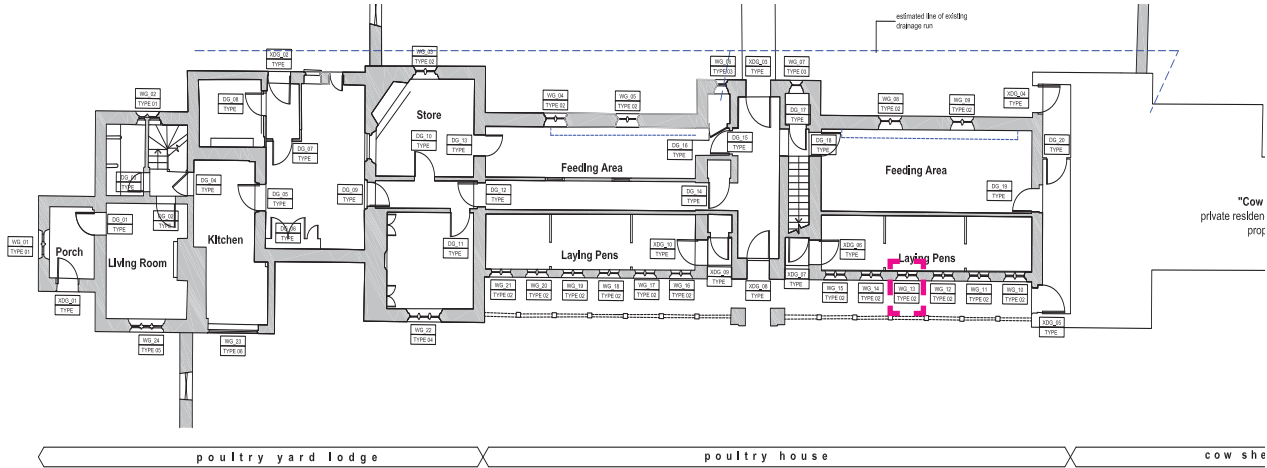
WG-13

Two panel window with central stone pier and metal framed window to both LHS and RHS with no opening light.

**YES. SECONDARY
GLAZING TO BE
PROVIDED**

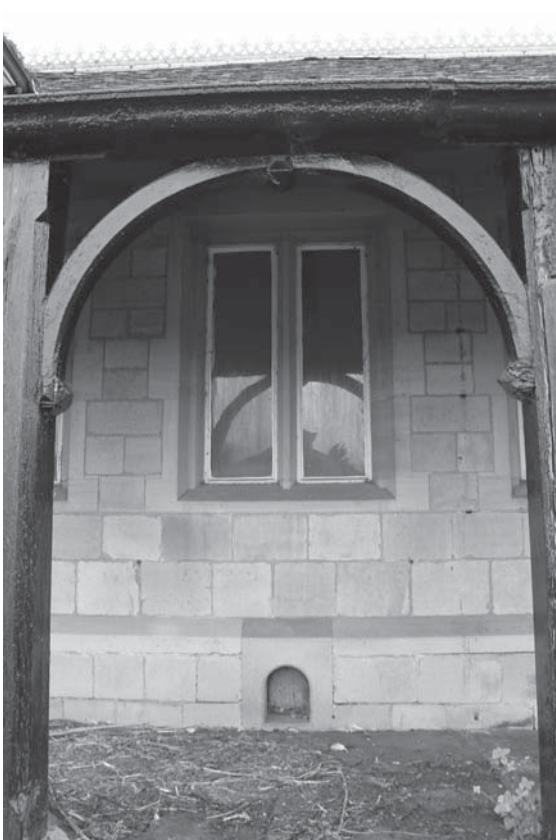
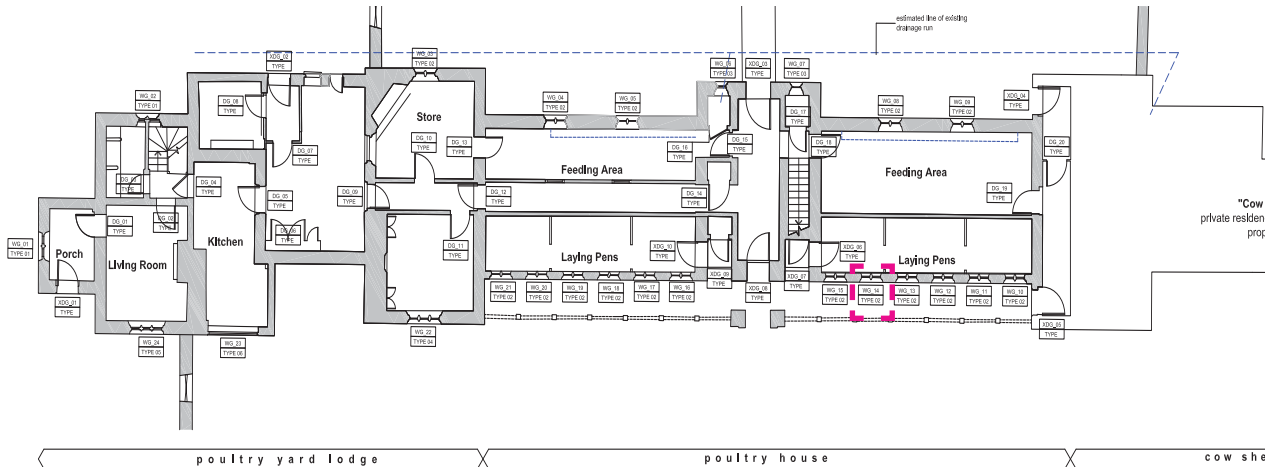
WG-14

Two panel window with central stone pier and metal framed window to both LHS and RHS with no opening light.

**YES. SECONDARY
GLAZING TO BE
PROVIDED**

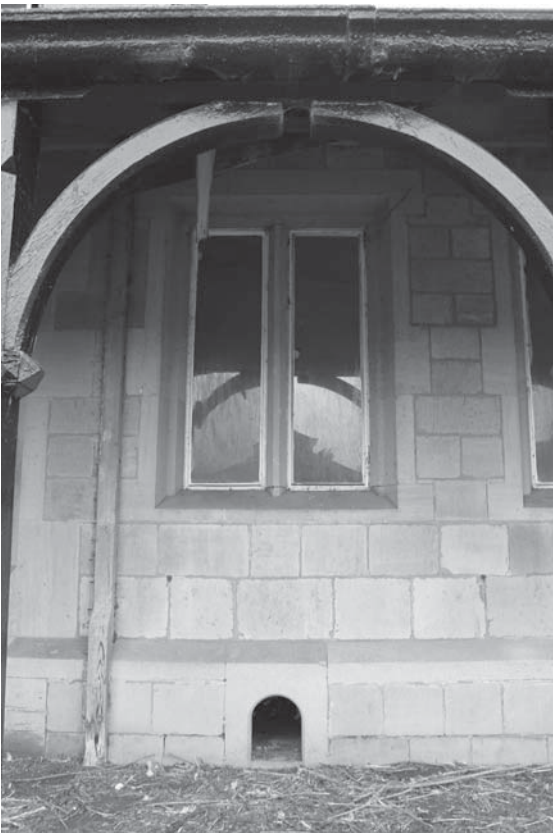
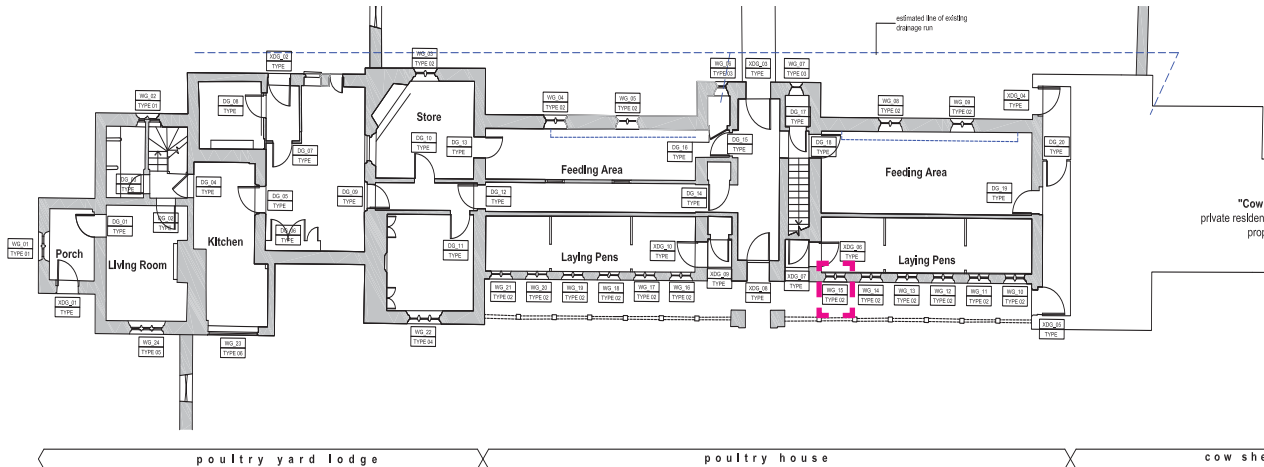
EXISTING EXTERNAL WINDOW SCHEDULE									
Window reference No :					WG-15				
Floor level :	Ground		External window type :		Type 02				
HISTORICAL SIGNIFICANCE			Level of significance	1=low, 5=high	1	2	3	4	5
Approximate date :	C 1860								5
Description :			WORKS PROPOSED						
Two panel window with central stone pier and metal framed window to both LHS and RHS with no opening light.			Retained and repaired :		Removed and replaced :				
			YES. SECONDARY GLAZING TO BE PROVIDED

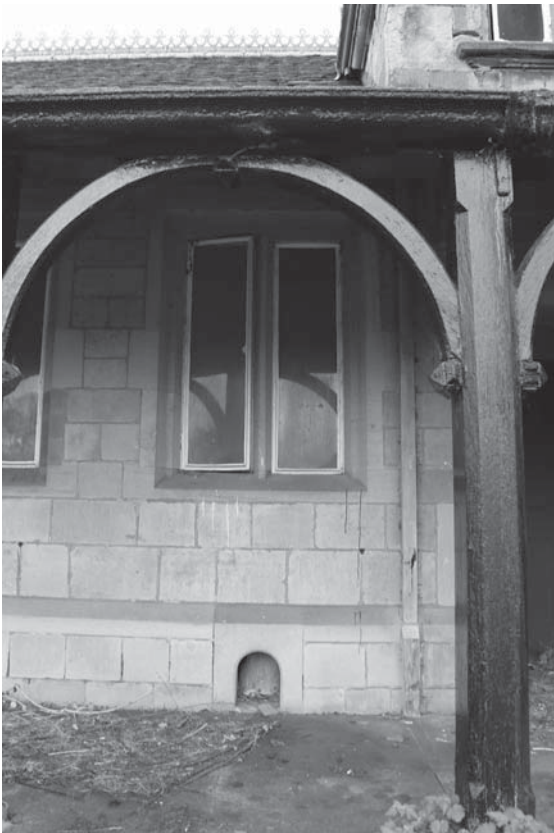
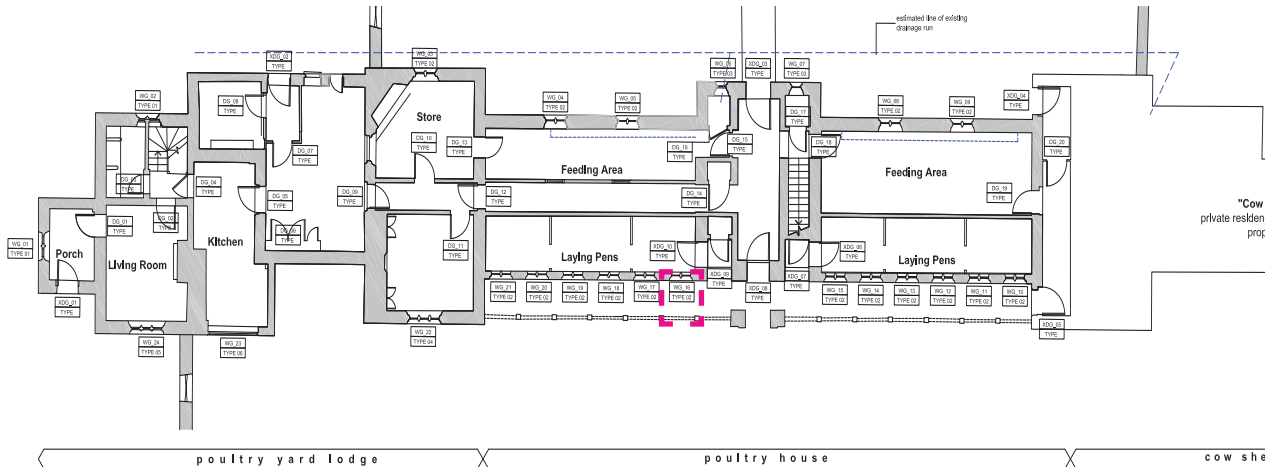
WG-16

Two panel window with central stone pier and metal framed window to both LHS and RHS with no opening light.

YES. SECONDARY
GLAZING TO BE
PROVIDED

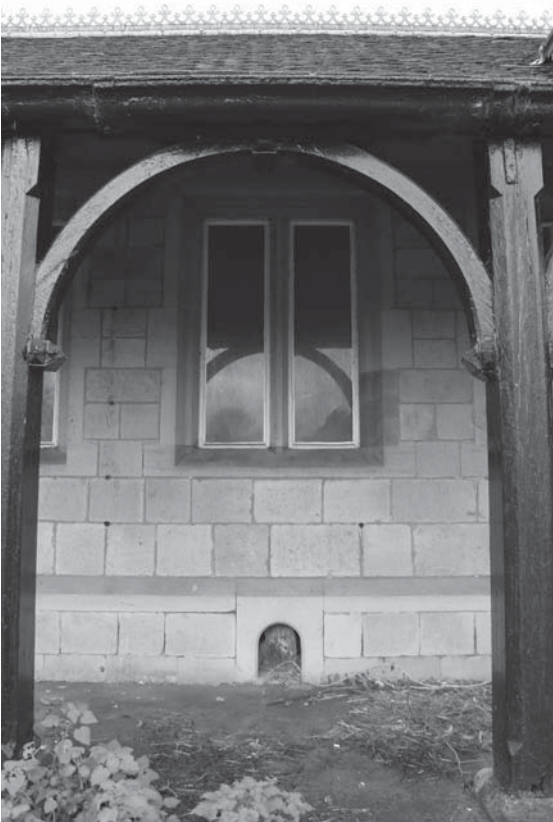
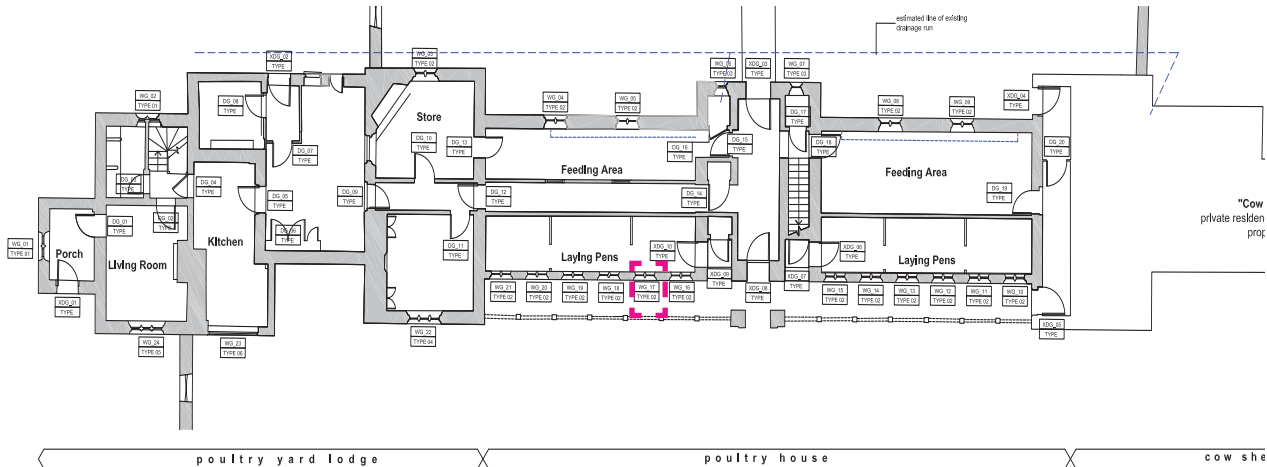
WG-17

Two panel window with central stone pier and metal framed window to both LHS and RHS with no opening light.

YES. SECONDARY
GLAZING TO BE
PROVIDED

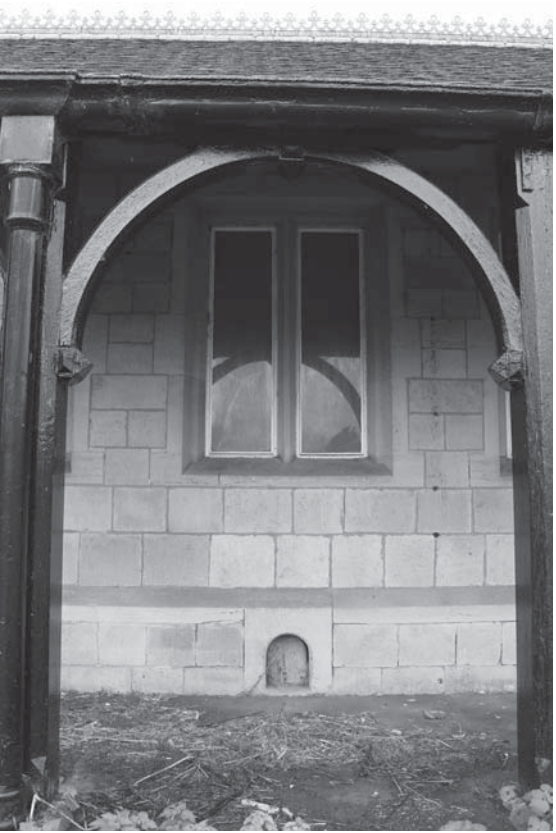
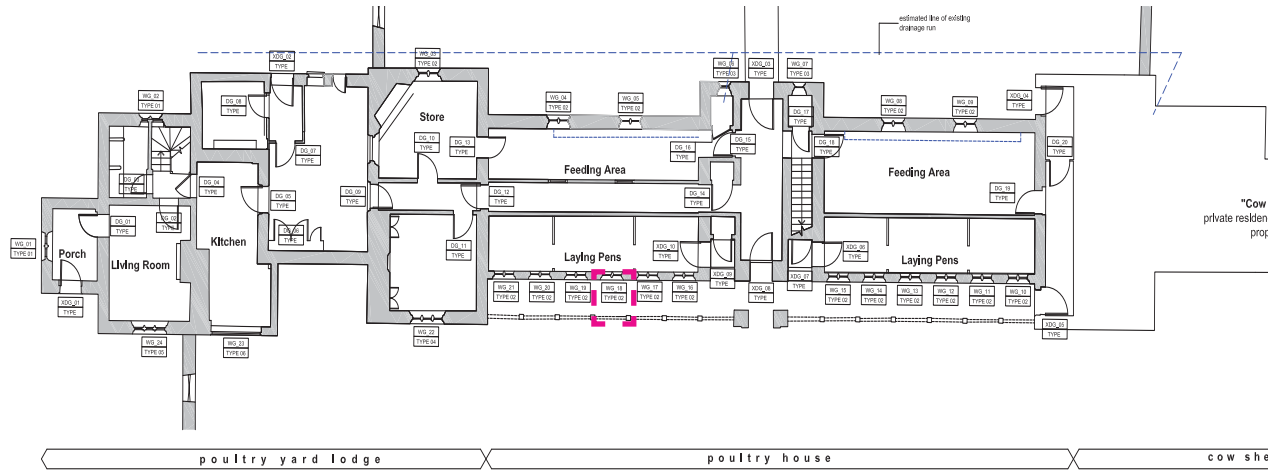
WG-18

Two panel window with central stone pier and metal framed window to both LHS and RHS with no opening light.

YES. SECONDARY
GLAZING TO BE
PROVIDED

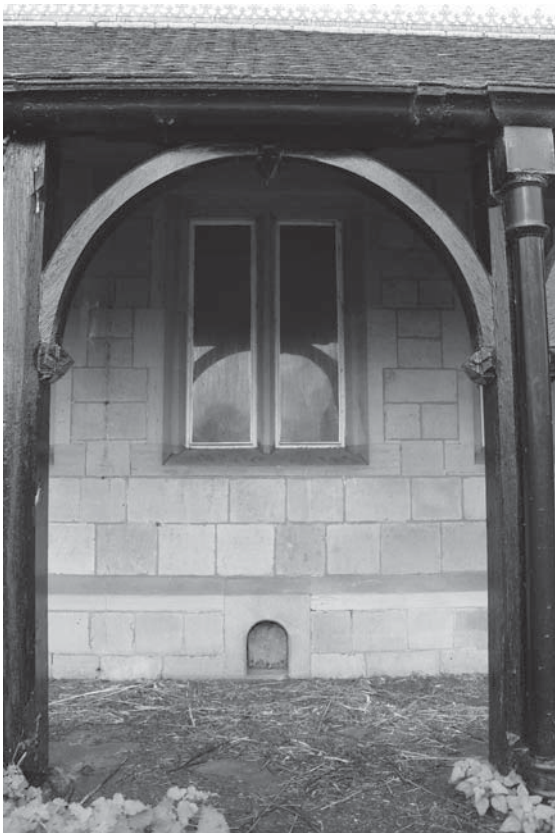
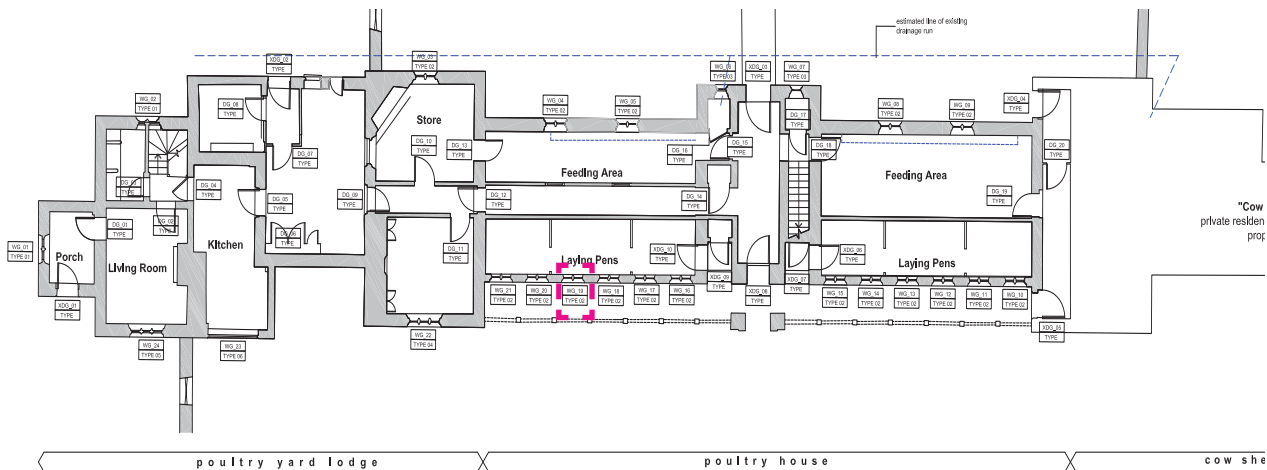
EXISTING EXTERNAL WINDOW SCHEDULE								
Window reference No :					WG-19			
Floor level :	Ground	External window type :		Type 02				
HISTORICAL SIGNIFICANCE		Level of significance	1=low, 5=high	1	2	3	4	5
Approximate date :	C 1860							5
Description :		WORKS PROPOSED						
Two panel window with central stone pier and metal framed window to both LHS and RHS with no opening light.		Retained and repaired :		Removed and replaced :				
		YES. SECONDARY GLAZING TO BE PROVIDED

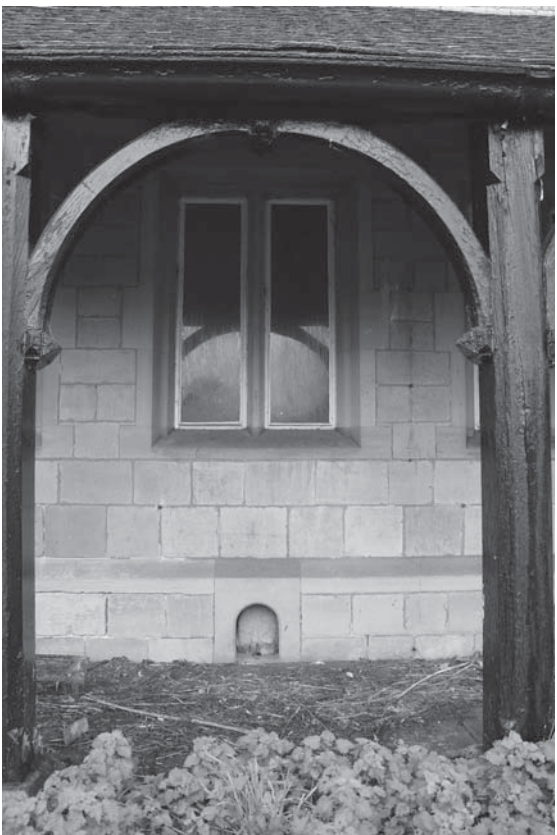
WG-20

Two panel window with central stone pier and metal framed window to both LHS and RHS with no opening light.

**YES. SECONDARY
GLAZING TO BE
PROVIDED**

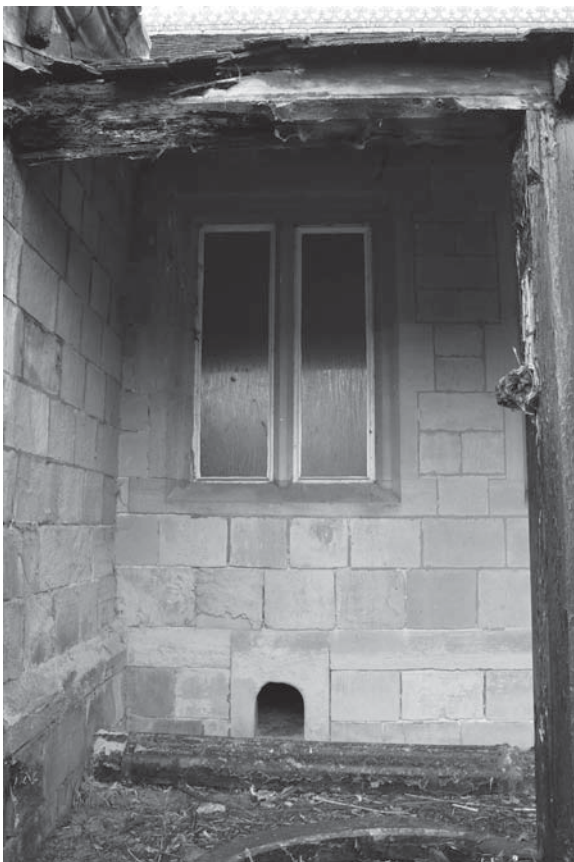
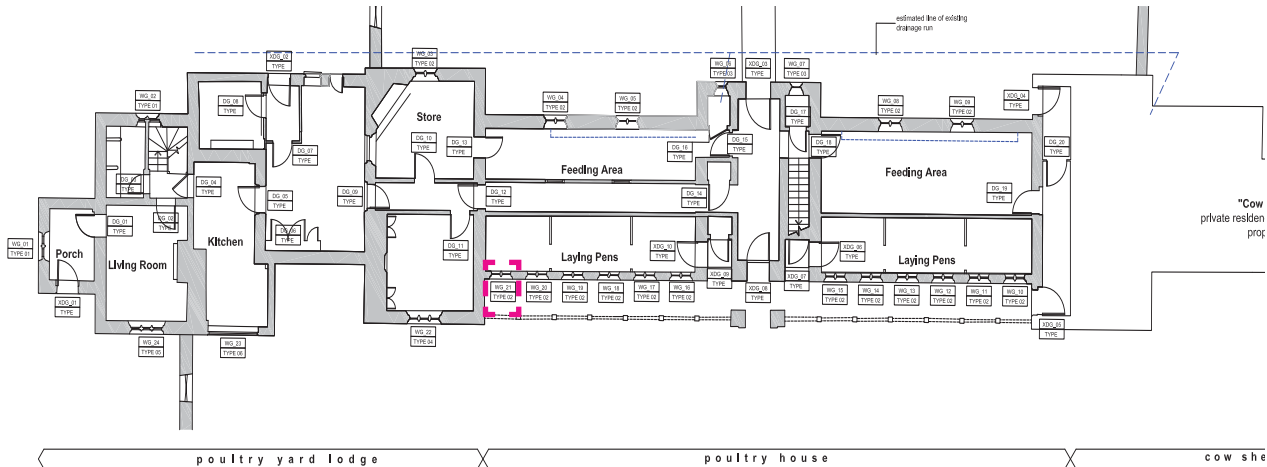
WG-21

Two panel window with central stone pier and metal framed window to both LHS and RHS with no opening light.

YES. SECONDARY
GLAZING TO BE
PROVIDED

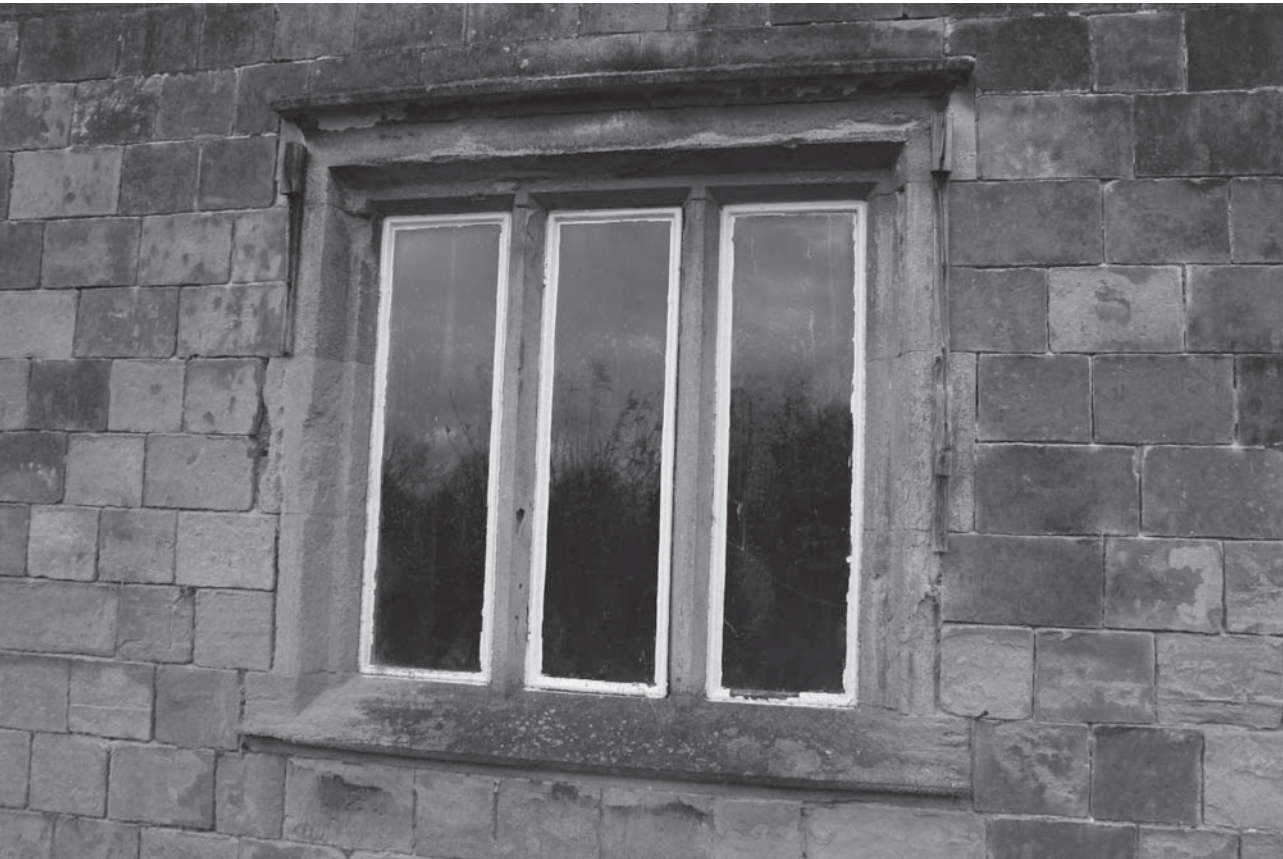
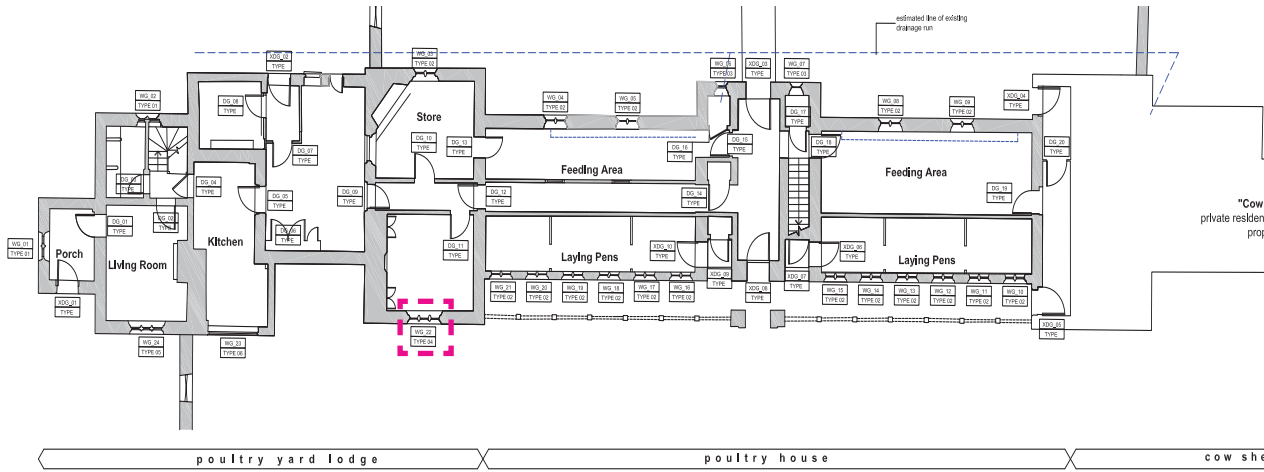
WG-22

Three panel window with two stone piers and metal framed window to all windows with no opening lights.

**YES. SECONDARY
GLAZING TO BE
PROVIDED**

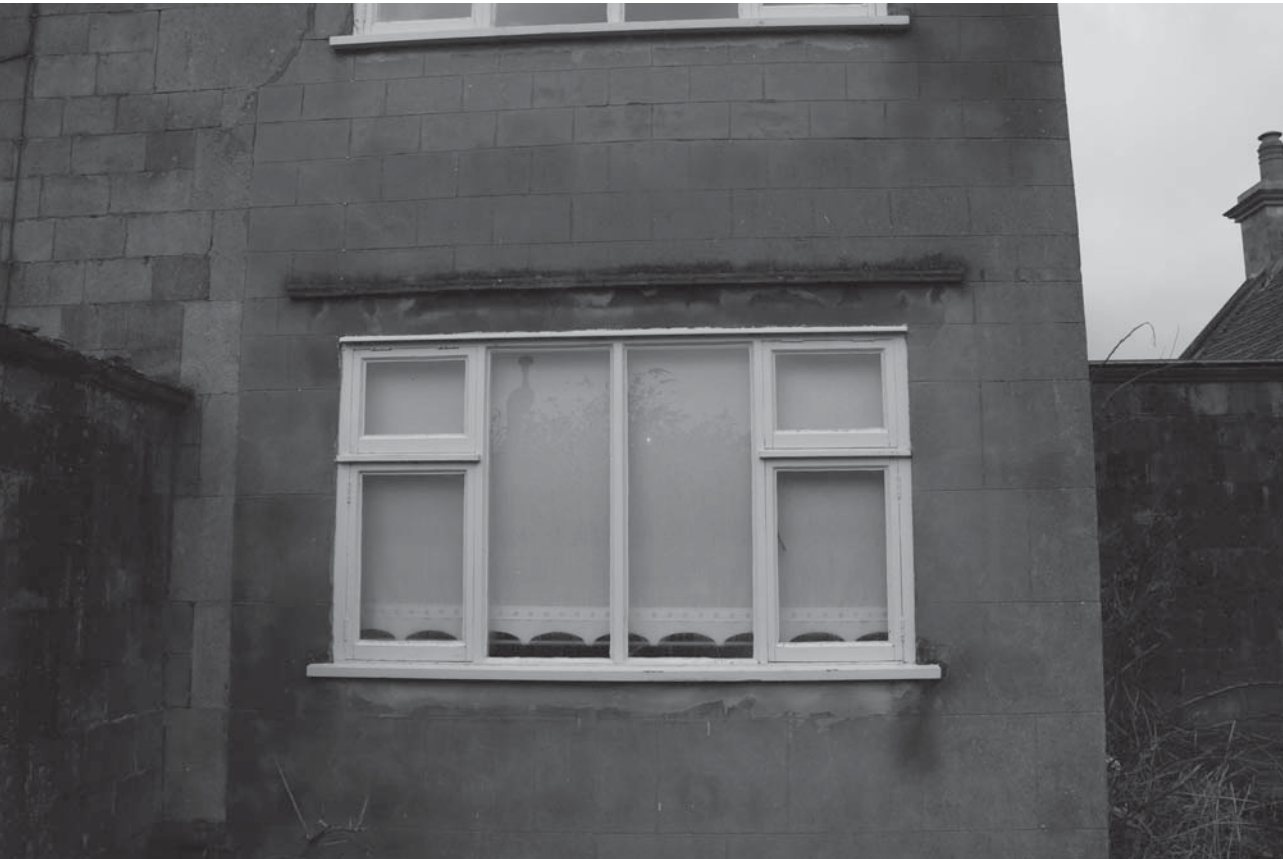
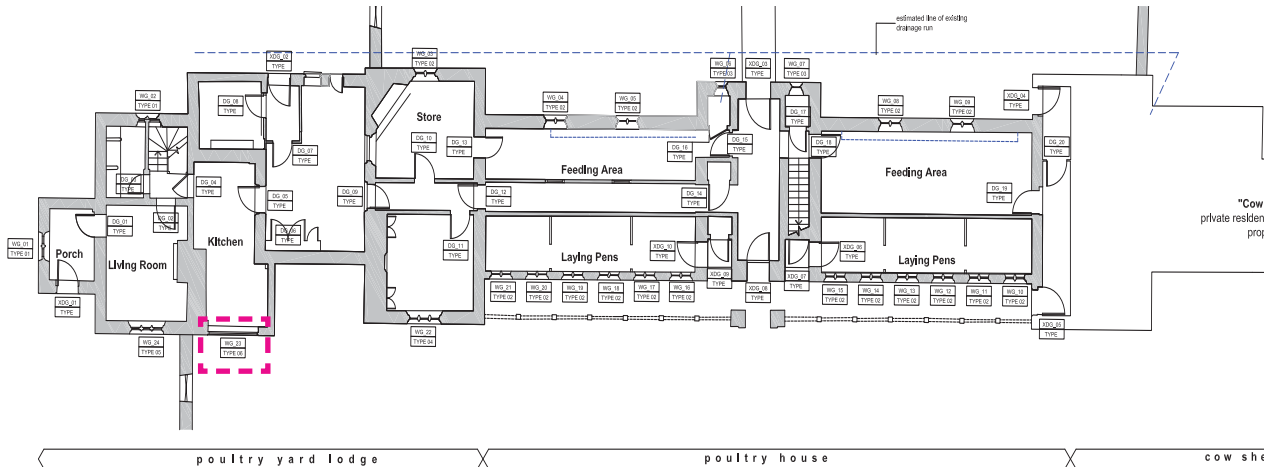
WG-23

Four panel later addition timber framed windows with high level opening lights to LHS and RHS windows

YES. SECONDARY
GLAZING TO BE
PROVIDED
