EXISTING EXTERNAL WINDOW SCHEDULE

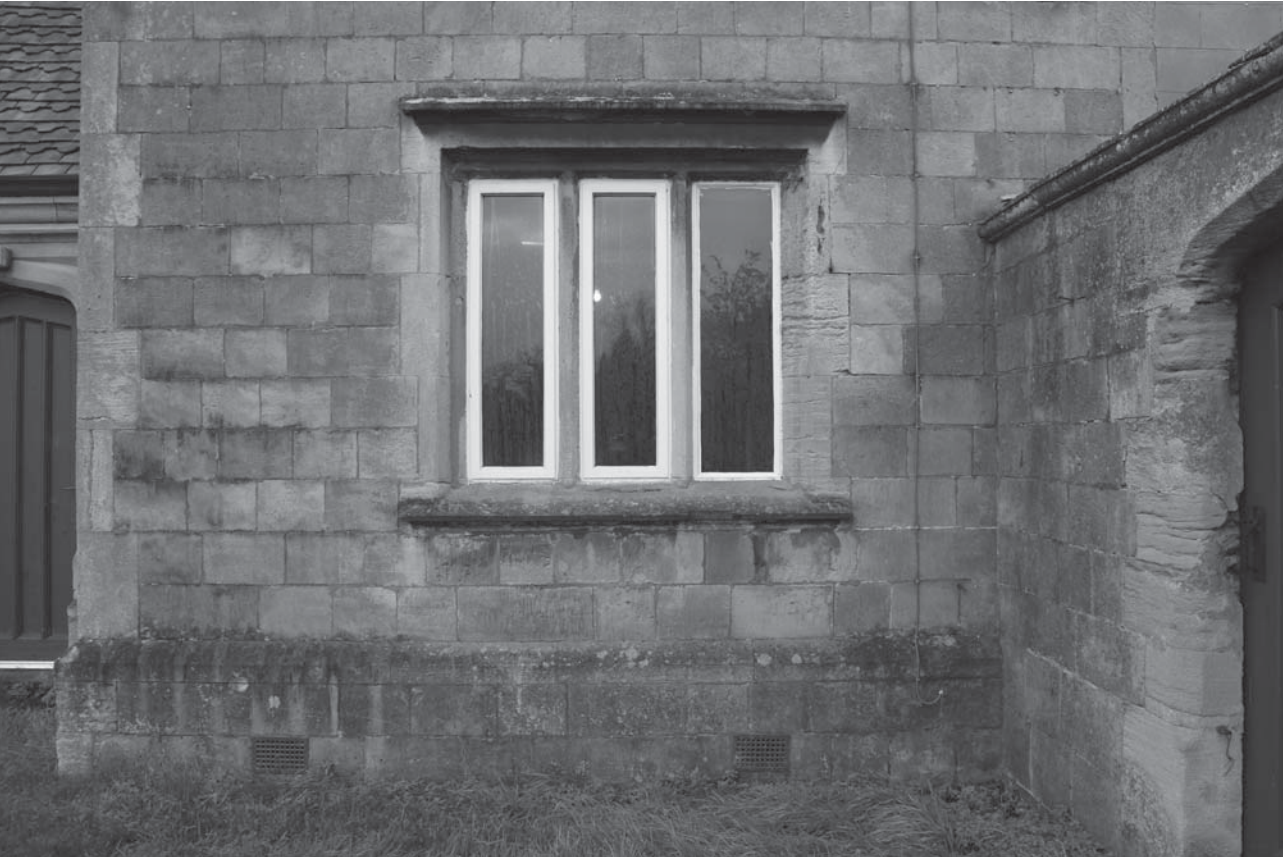
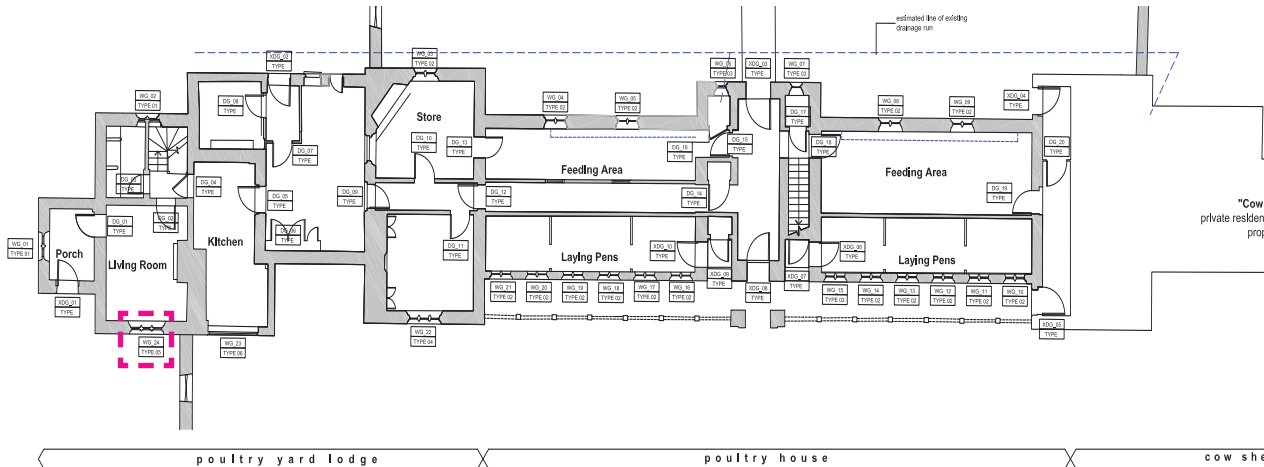
EXISTING EXTERNAL WINDOW SCHEDULE										
Window reference No :						WG-24				
Floor level :	Ground		External window type :			Type 05				
HISTORICAL SIGNIFICANCE			Level of significance		1=low, 5=high	1	2	3	4	5
Approximate date :		C 1860								
Description :			WORKS PROPOSED							
Three panel window with two stone piers and metal framed window to RHS window, later addition timber framed windows to central and LHS to provide opening lights.			Retained and repaired :		Removed and replaced :					
			YES. SECONDARY GLAZING TO BE PROVIDED

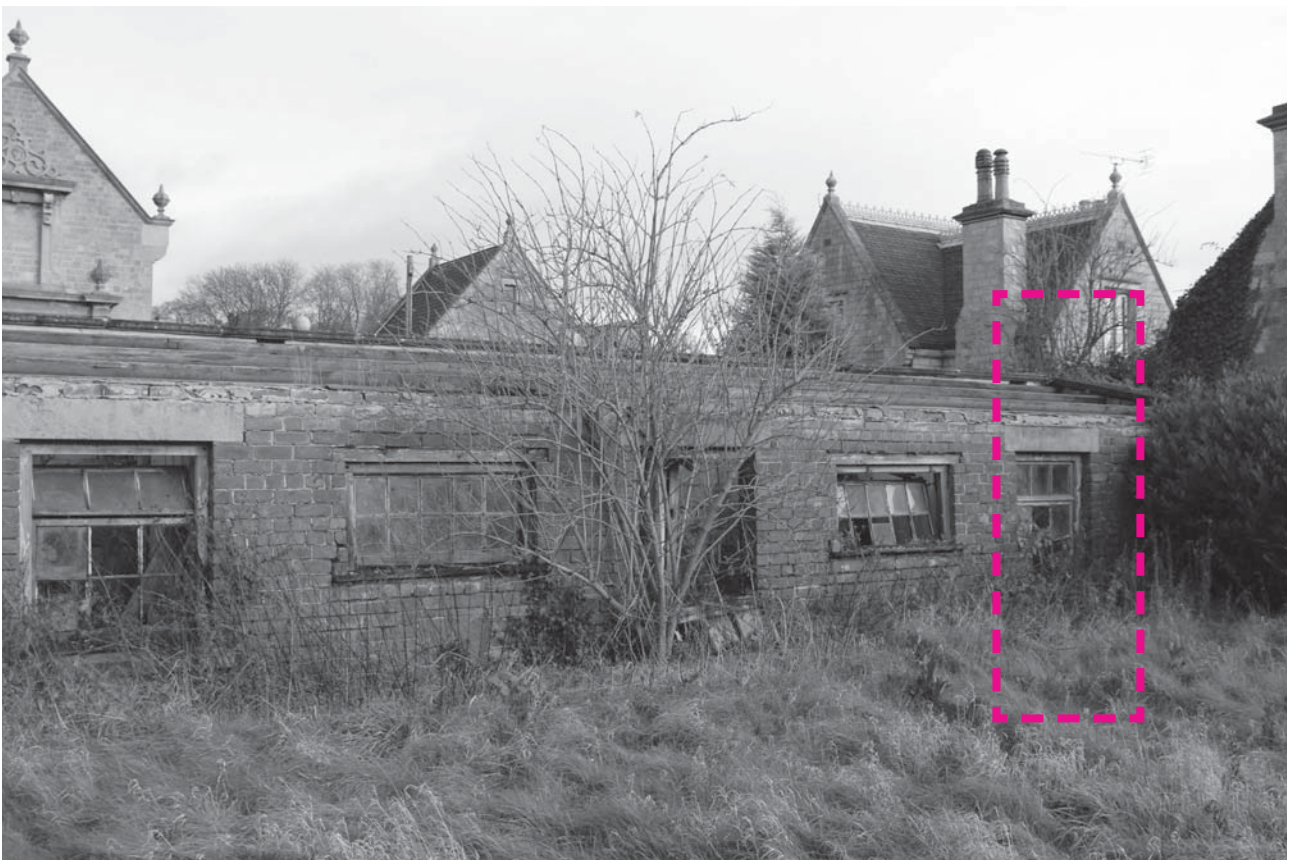
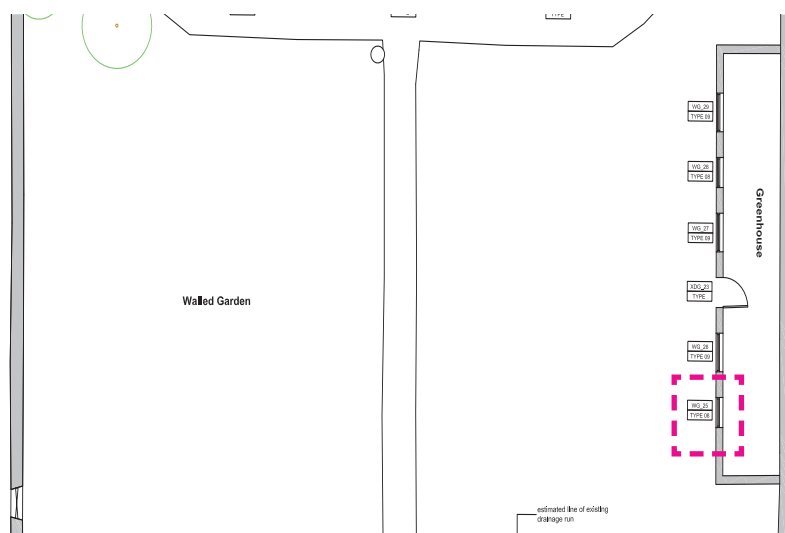
EXISTING EXTERNAL WINDOW SCHEDULE										
Window reference No :						WG-25				
Floor level :	Ground		External window type :		Type 08					
HISTORICAL SIGNIFICANCE			Level of significance		1=low, 5=high	1	2	3	4	5
Approximate date :	C 1900's						2			
Description :			WORKS PROPOSED							
9 Panel georgian style window with high level opening light. Very poor condition.			Retained and repaired :		Removed and replaced :					
					Existing windows in a very poor state of repair. Existing windows to be removed and replaced with new windows to match existing type 07.

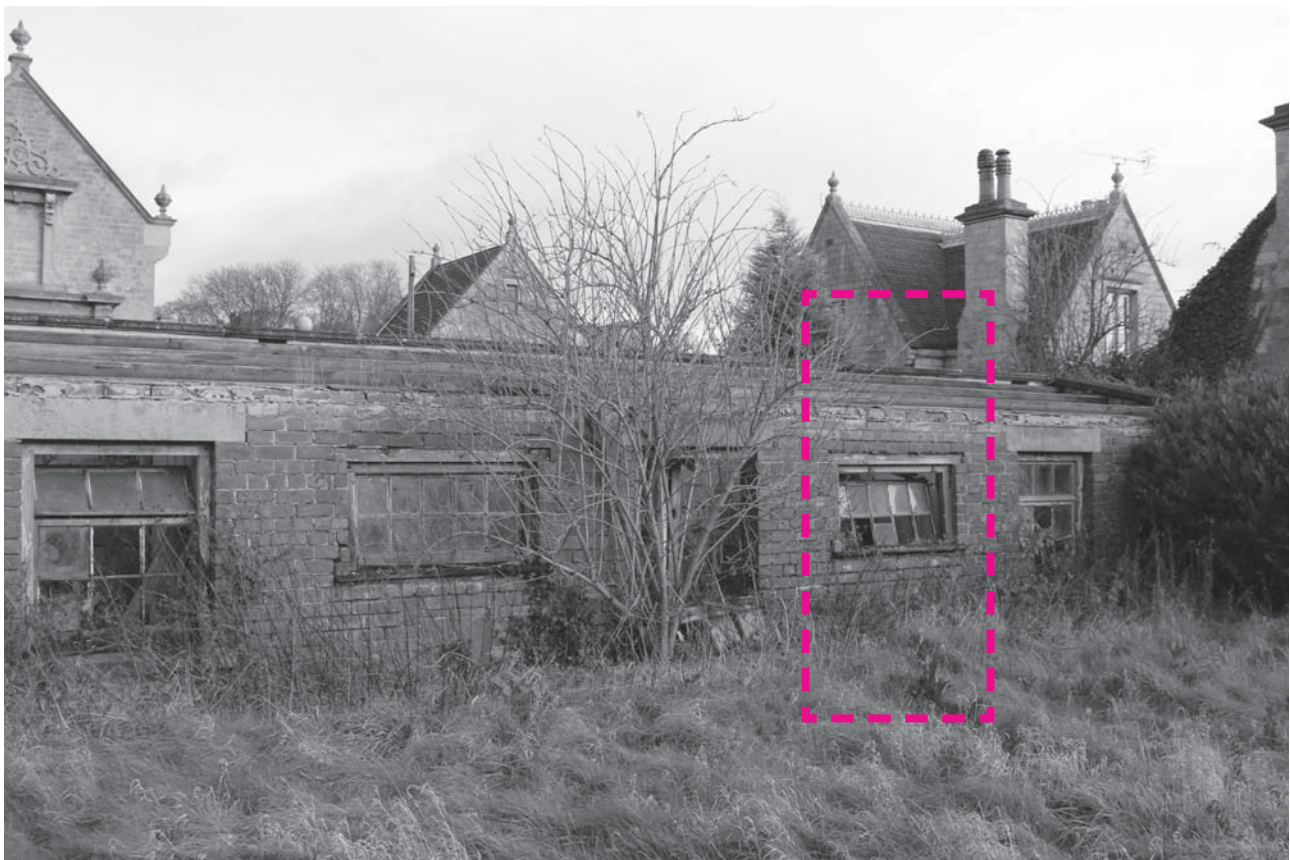
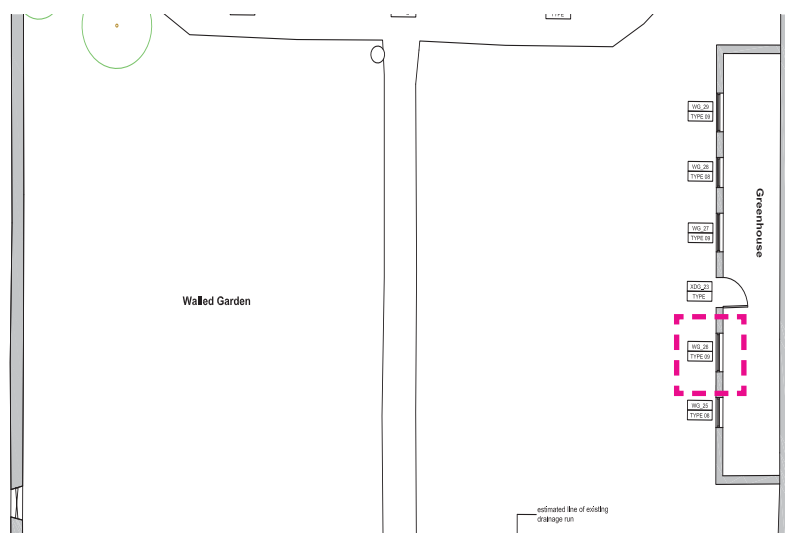
EXISTING EXTERNAL WINDOW SCHEDULE										
Window reference No :						WG-26				
Floor level :	Ground		External window type :		Type 09					
HISTORICAL SIGNIFICANCE			Level of significance		1=low, 5=high	1	2	3	4	5
Approximate date :	C 1900's						2			
Description :			WORKS PROPOSED							
10 Panel georgian style window fully opening with central rotational hinges. Very poor condition.			Retained and repaired :		Removed and replaced :					
					Existing windows in a very poor state of repair. Existing windows to be removed and replaced with new windows to match existing type 07.

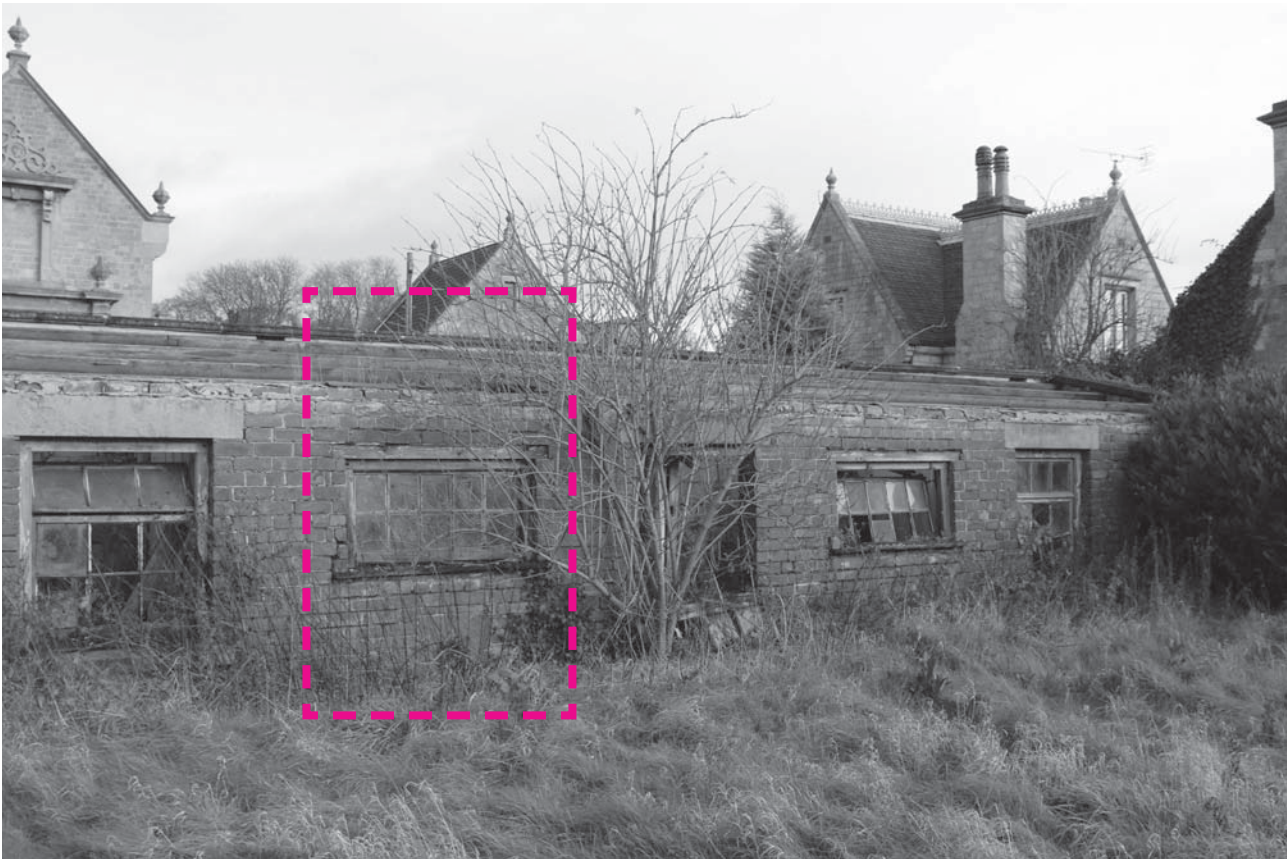
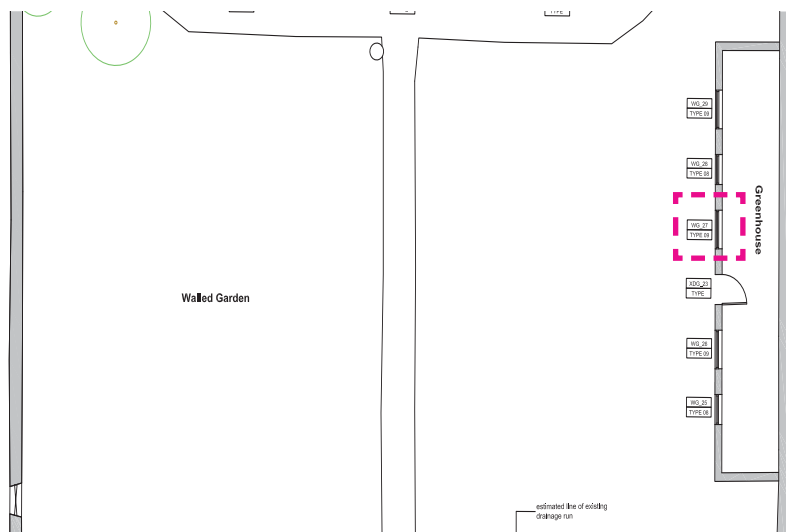
EXISTING EXTERNAL WINDOW SCHEDULE										
Window reference No :						WG-27				
Floor level :	Ground		External window type :		Type 09					
HISTORICAL SIGNIFICANCE			Level of significance		1=low, 5=high	1	2	3	4	5
Approximate date :	C 1900's						2			
Description :			WORKS PROPOSED							
10 Panel georgian style window fully opening with central rotational hinges. Very poor condition.			Retained and repaired :		Removed and replaced :					
					Existing windows in a very poor state of repair. Existing windows to be removed and replaced with new windows to match existing type 07.

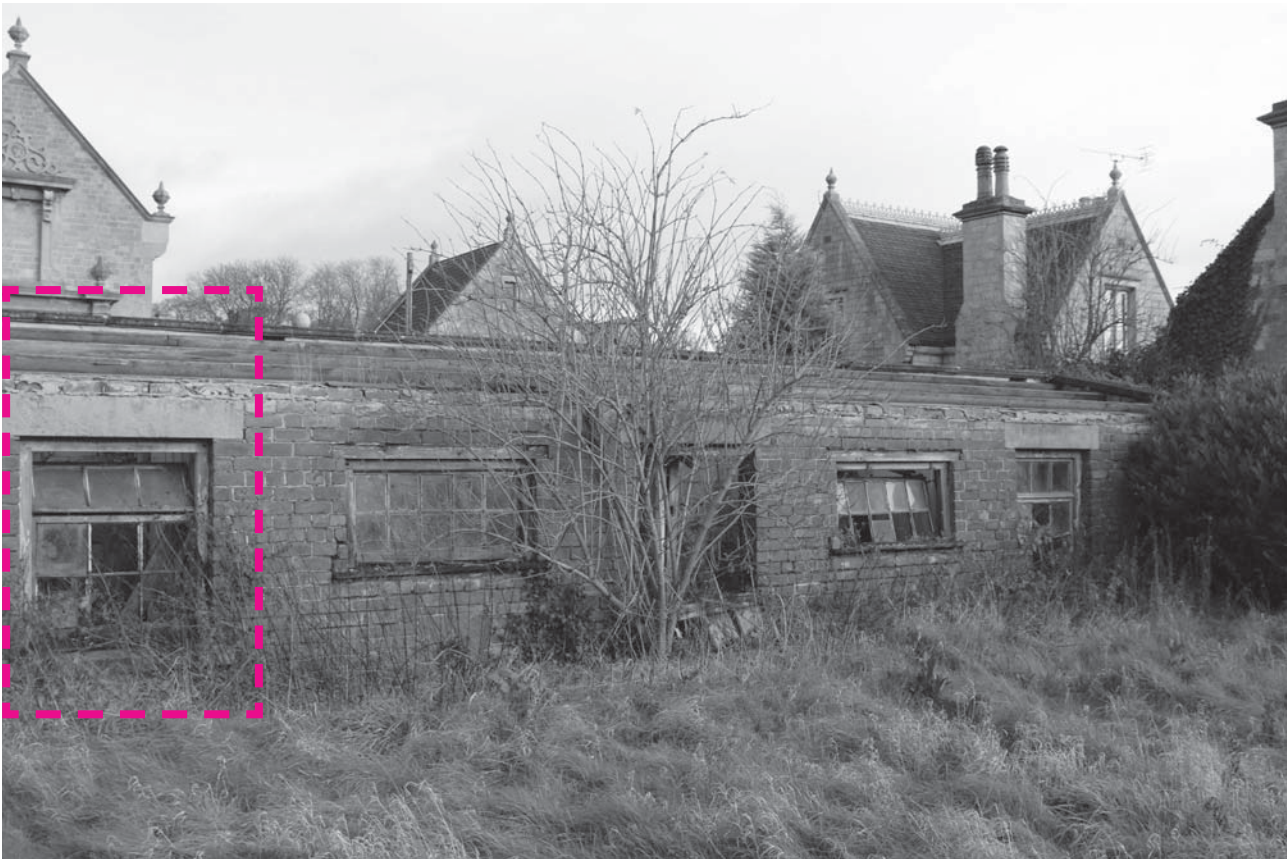
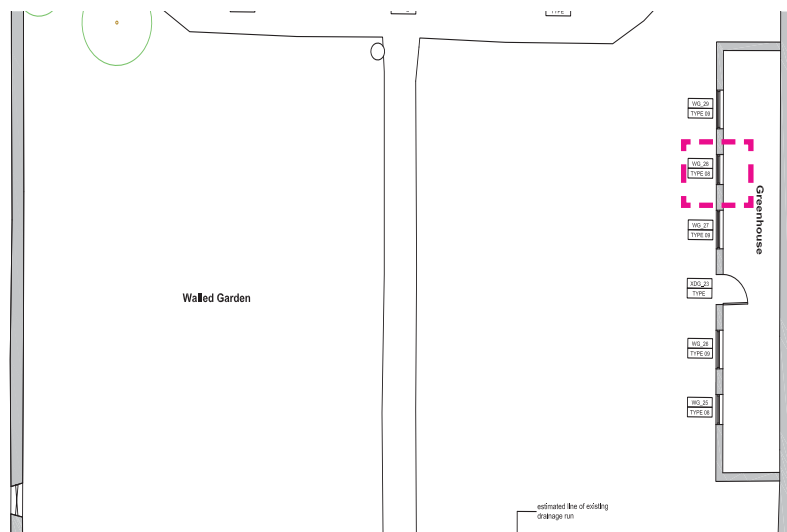
EXISTING EXTERNAL WINDOW SCHEDULE										
Window reference No :						WG-28				
Floor level :	Ground		External window type :		Type 08					
HISTORICAL SIGNIFICANCE			Level of significance		1=low, 5=high	1	2	3	4	5
Approximate date :	C 1900's						2			
Description :			WORKS PROPOSED							
9 Panel georgian style window with high level opening light. Very poor condition.			Retained and repaired :		Removed and replaced :					
					Existing windows in a very poor state of repair. Existing windows to be removed and replaced with new windows to match existing type 07.

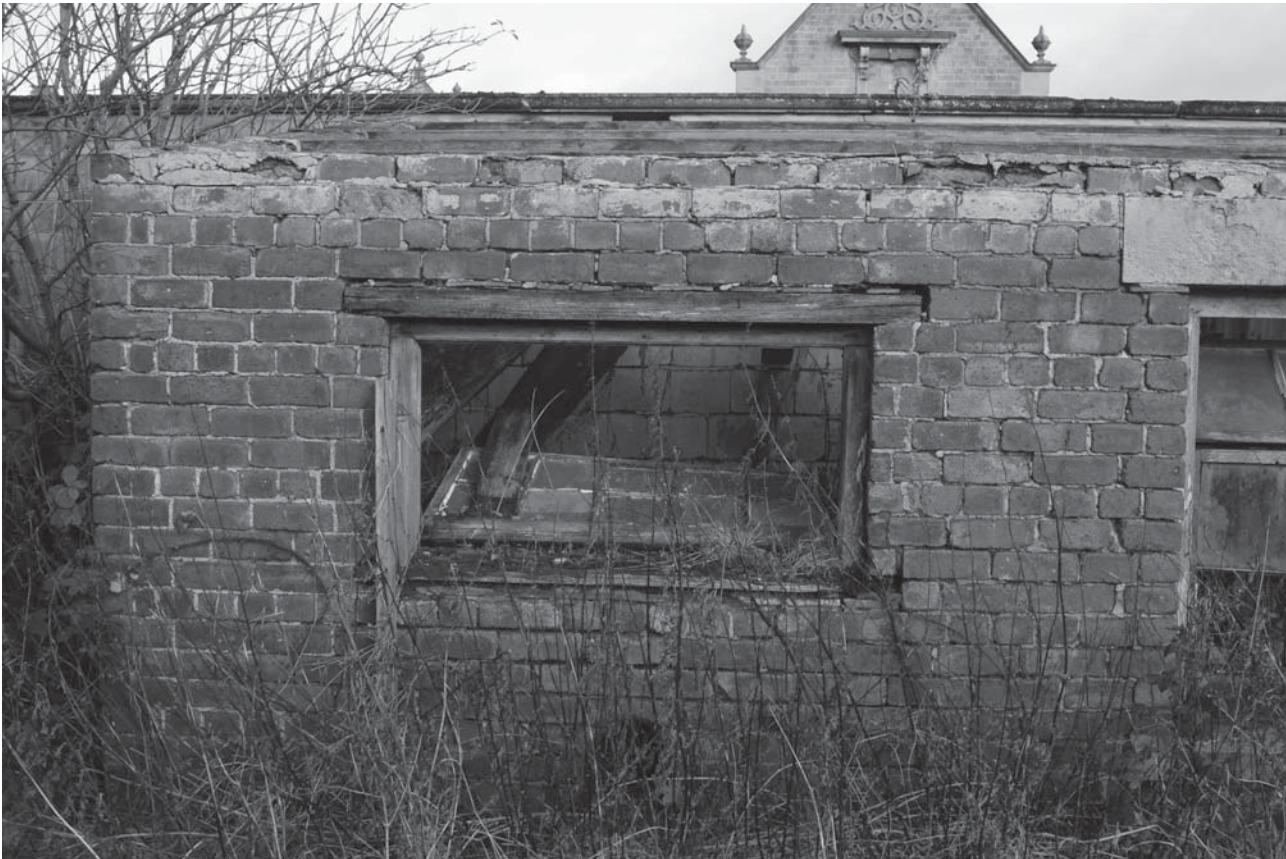
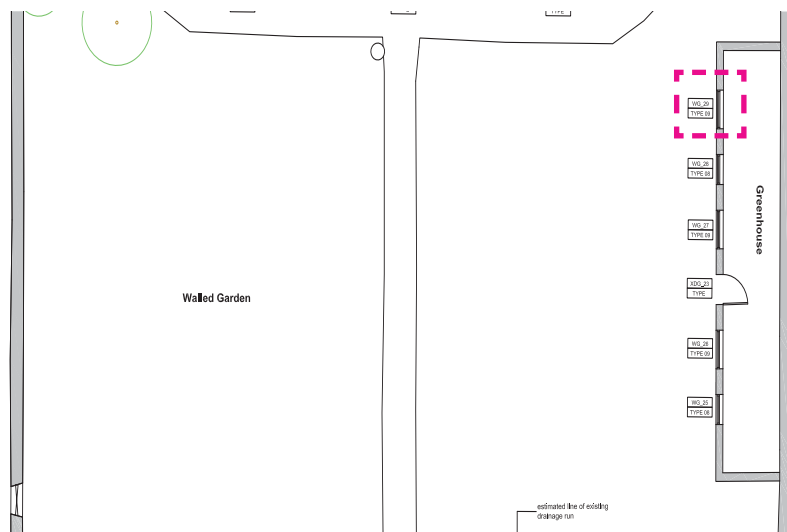
EXISTING EXTERNAL WINDOW SCHEDULE										
Window reference No :						WG-29				
Floor level :	Ground		External window type :		Type 09					
HISTORICAL SIGNIFICANCE			Level of significance		1=low, 5=high	1	2	3	4	5
Approximate date :	C 1900's						2			
Description :			WORKS PROPOSED							
10 Panel georgian style window fully opening with central rotational hinges. Very poor condition.			Retained and repaired :		Removed and replaced :					
					Existing windows in a very poor state of repair. Existing windows to be removed and replaced with new windows to match existing type 07.

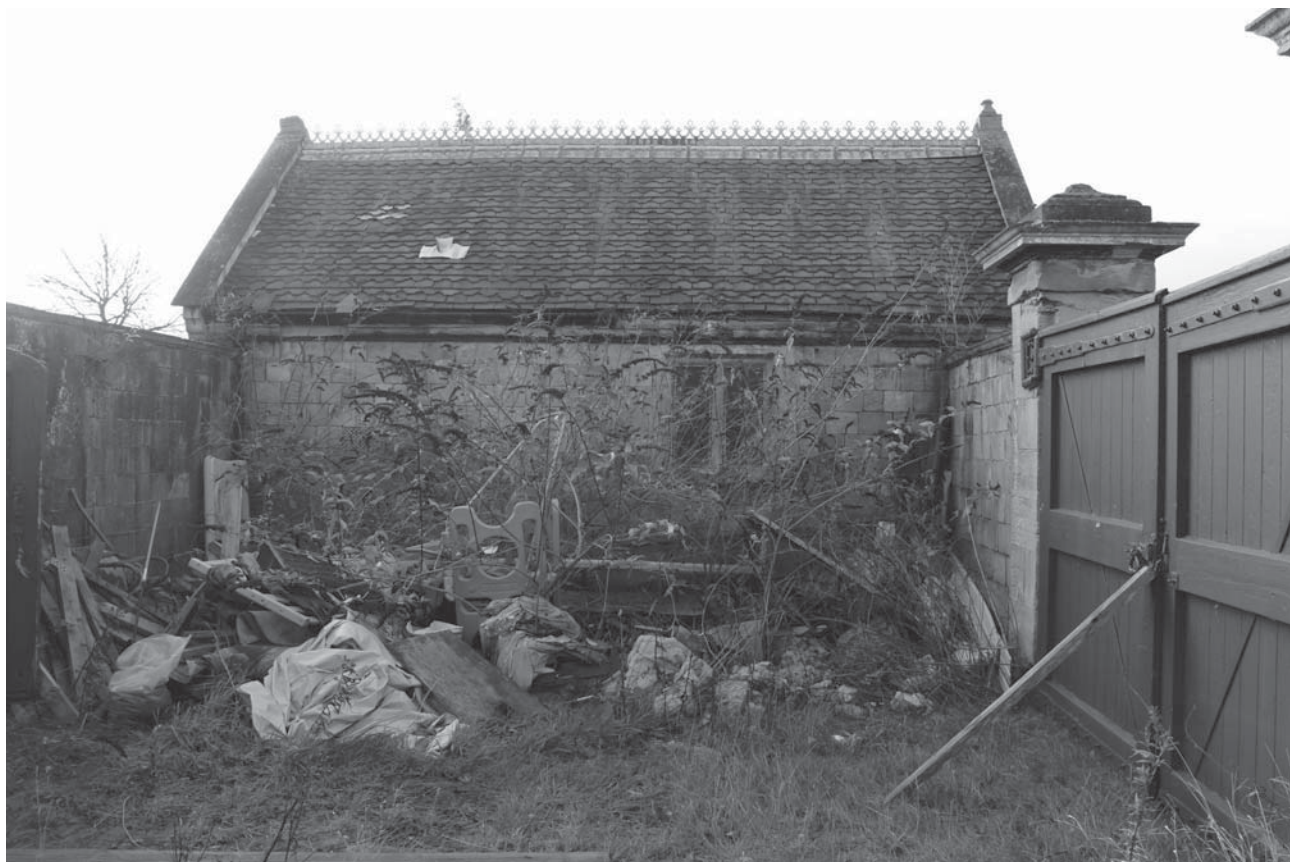
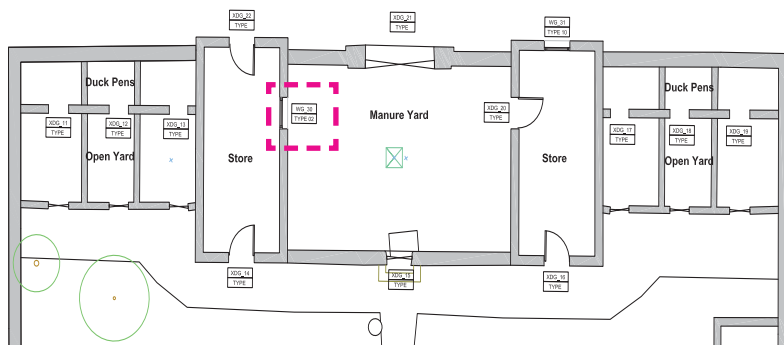
EXISTING EXTERNAL WINDOW SCHEDULE										
Window reference No :						WG-30				
Floor level :	Ground		External window type :		Type 02					
HISTORICAL SIGNIFICANCE			Level of significance		1=low, 5=high	1	2	3	4	5
Approximate date :		C 1860							4	
Description :			WORKS PROPOSED							
Two panel window with central stone pier and metal framed window to both LHS and RHS with no opening light			Retained and repaired :		Removed and replaced :					
			YES. SECONDARY GLAZING TO BE PROVIDED

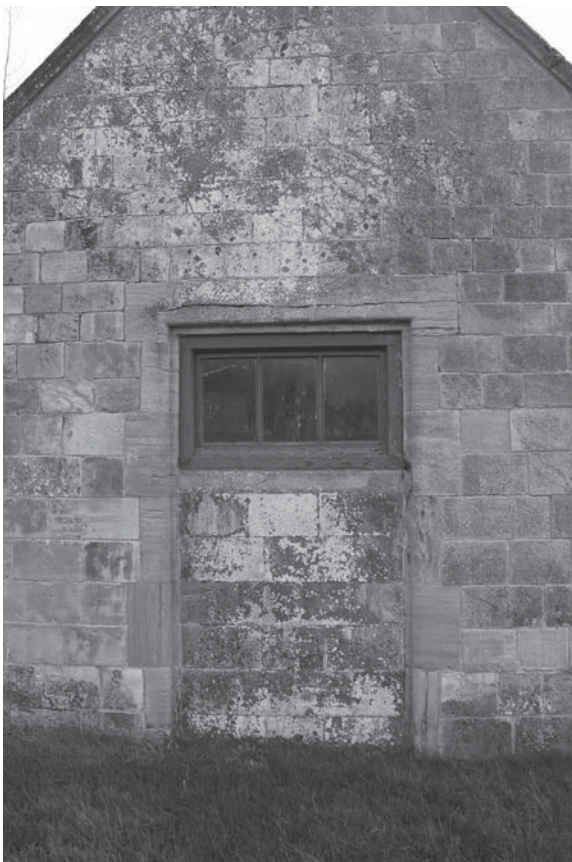
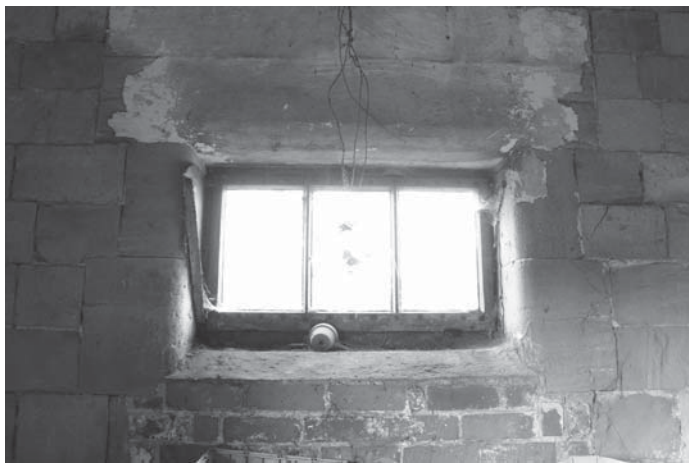
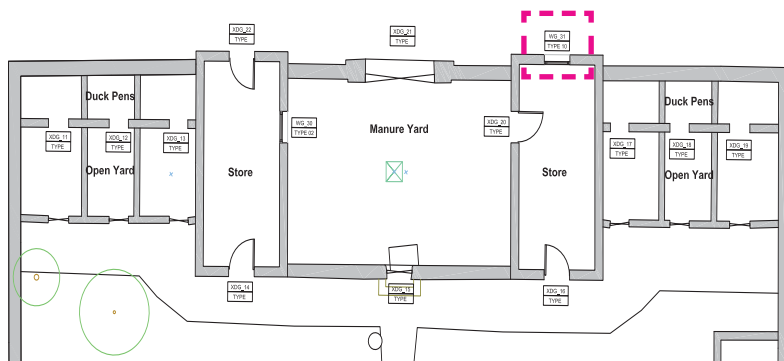
EXISTING EXTERNAL WINDOW SCHEDULE										
Window reference No :						WG-31				
Floor level :	Ground		External window type :		Type 10					
HISTORICAL SIGNIFICANCE			Level of significance		1=low, 5=high	1	2	3	4	5
Approximate date :		C 1860							4	
Description :			WORKS PROPOSED							
Three panel timber window, fully opening pivot hinge with metal restrictor internally.			Retained and repaired :		Removed and replaced :					
			YES. SECONDARY GLAZING TO BE PROVIDED

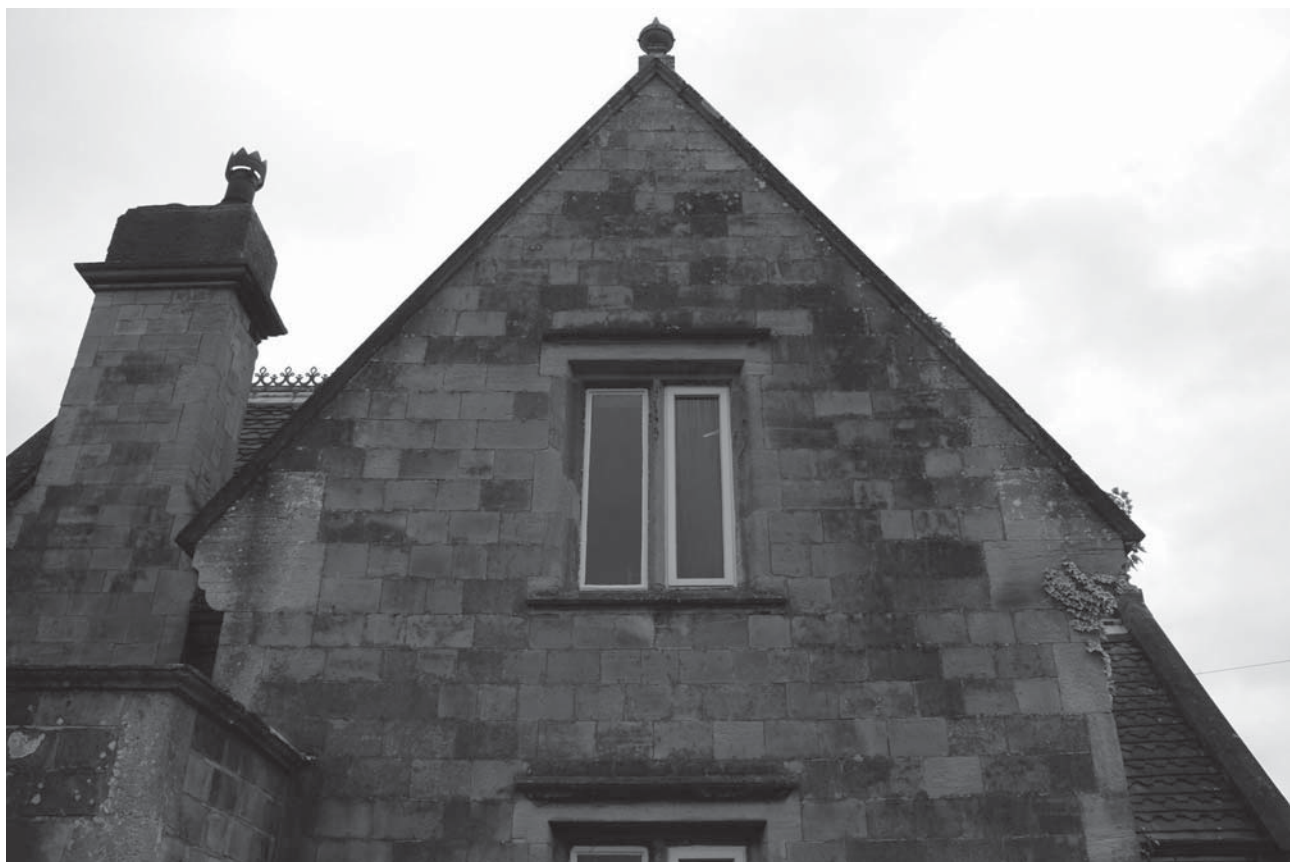
EXISTING EXTERNAL WINDOW SCHEDULE										
Window reference No :						WF-01				
Floor level :	First		External window type :		Type 01					
HISTORICAL SIGNIFICANCE			Level of significance		1=low, 5=high	1	2	3	4	5
Approximate date :		C 1860							4	
Description :			WORKS PROPOSED							
Two panel window with central stone pier and metal framed windows with opening light to RHS			Retained and repaired :		Removed and replaced :					
			YES. SECONDARY GLAZING TO BE PROVIDED

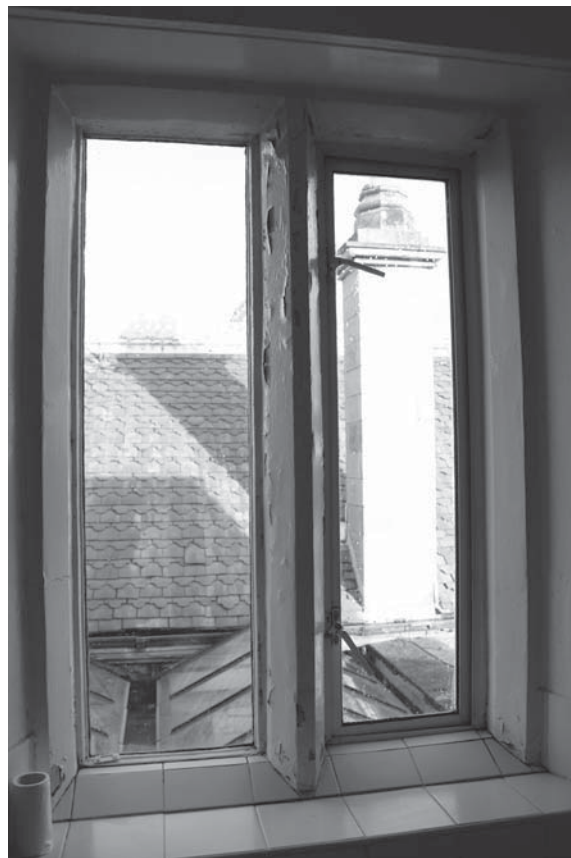
EXISTING EXTERNAL WINDOW SCHEDULE											
Window reference No :						WF-02					
Floor level :		First		External window type :		Type 01					
HISTORICAL SIGNIFICANCE				Level of significance		1=low, 5=high	1	2	3	4	5
Approximate date :		C 1860 & 1900's								4	
Description :				WORKS PROPOSED							
Two panel window with central stone pier and metal framed windows with opening light to LHS				Retained and repaired :		Removed and replaced :					
				YES. SECONDARY GLAZING TO BE PROVIDED
