EXISTING EXTERNAL WINDOW SCHEDULE											
Window reference No :						WF-03					
Floor level :		First		External window type :		Type 06					
HISTORICAL SIGNIFICANCE				Level of significance		1=low, 5=high	1	2	3	4	5
Approximate date :		C 1900's						2			
Description :				WORKS PROPOSED							
Four panel later addition timber framed windows with high level opening lights to LHS and RHS windows				Retained and repaired :		Removed and replaced :					
				YES. SECONDARY GLAZING TO BE PROVIDED

Schedule of existing Doors

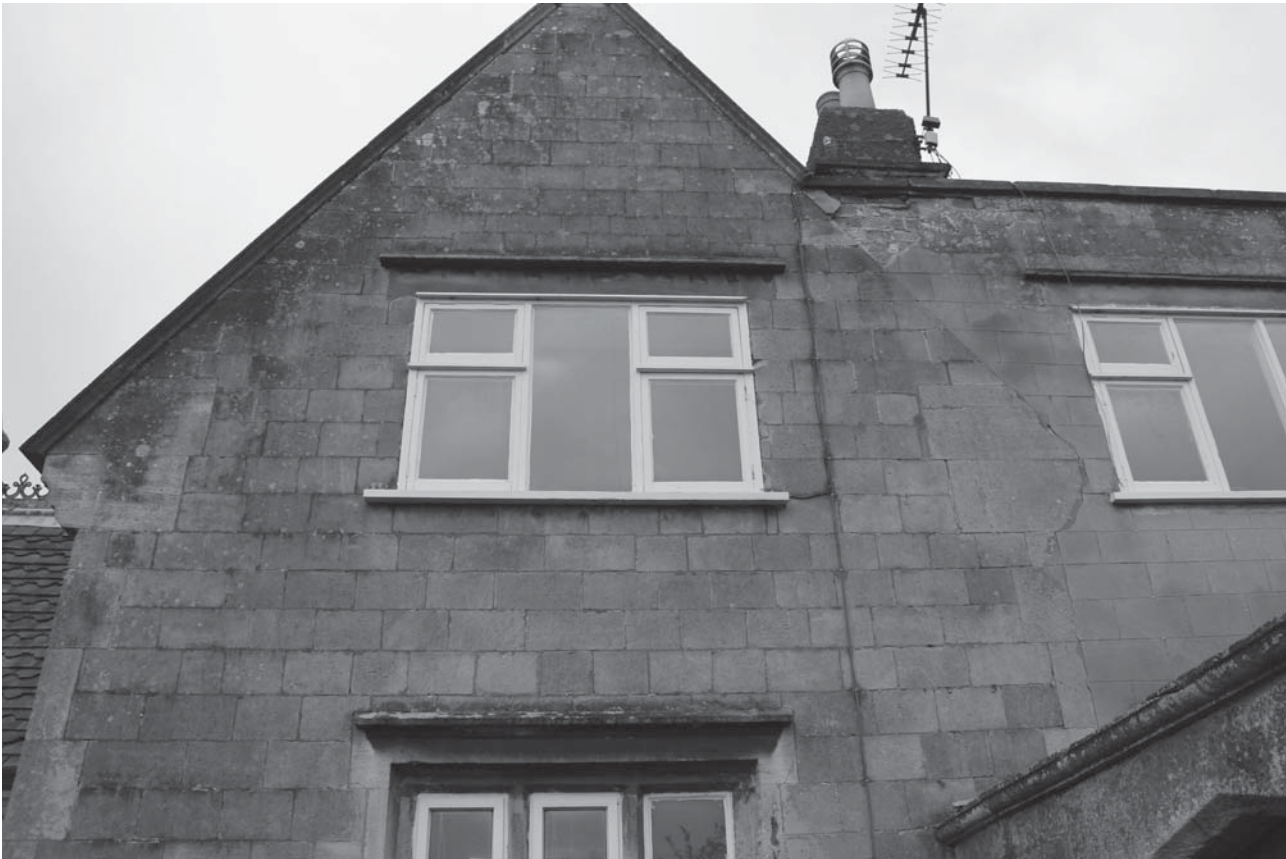
EXISTING EXTERNAL WINDOW SCHEDULE											
Window reference No :						WF-04					
Floor level :		GFirst		External window type :		Type 07					
HISTORICAL SIGNIFICANCE				Level of significance		1=low, 5=high	1	2	3	4	5
Approximate date :		C 1900's						2			
Description :				WORKS PROPOSED							
Three panel later addition timber framed windows with high level opening lights to LHS and RHS windows				Retained and repaired :		Removed and replaced :					
				YES. SECONDARY GLAZING TO BE PROVIDED

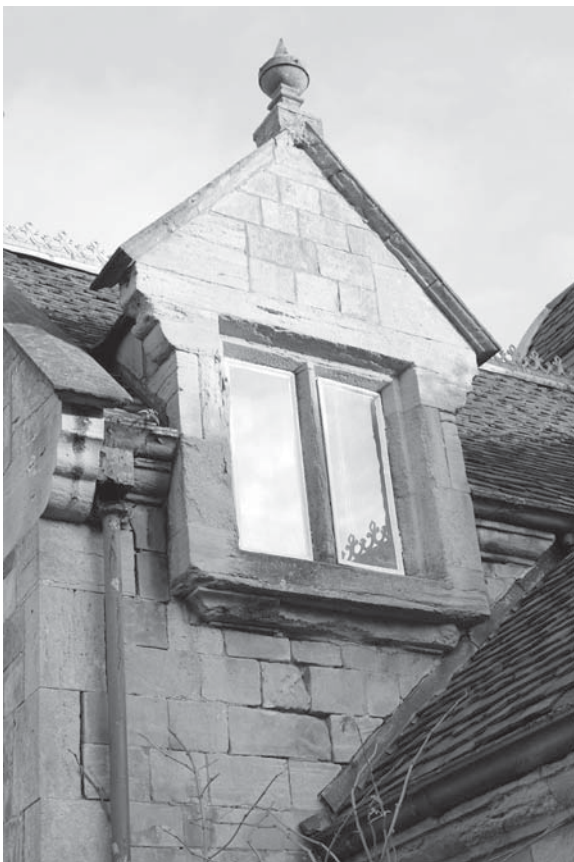
EXISTING EXTERNAL WINDOW SCHEDULE								
Window reference No :				WF-05				
Floor level :	First	External window type :	Type 02					
HISTORICAL SIGNIFICANCE		Level of significance	1=low, 5=high	1	2	3	4	5
Approximate date :	C 1860						4	
Description :		WORKS PROPOSED						
Two panel metal framed windows with central stone pier and with no opening lights		Retained and repaired :	Removed and replaced :					
		YES. SECONDARY GLAZING TO BE PROVIDED

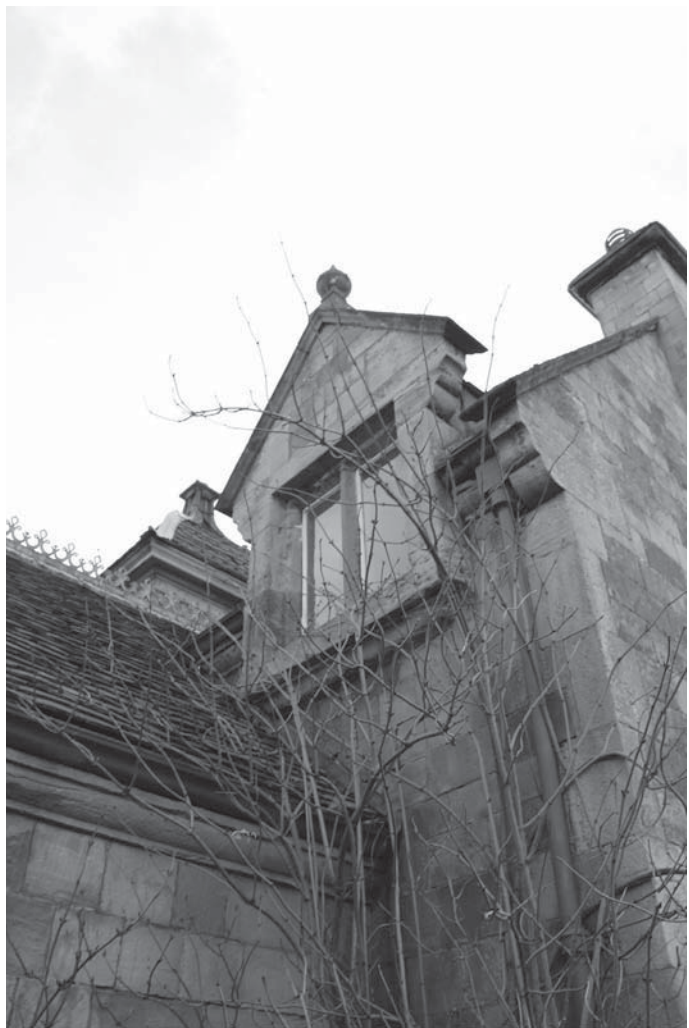
EXISTING EXTERNAL WINDOW SCHEDULE								
Window reference No :				WF-06				
Floor level :	First	External window type :	Type 02					
HISTORICAL SIGNIFICANCE		Level of significance	1=low, 5=high	1	2	3	4	5
Approximate date :	C 1860							
Description :		WORKS PROPOSED						
Two panel metal framed windows with central stone pier and with no opening lights		Retained and repaired :		Removed and replaced :				
		YES. SECONDARY GLAZING TO BE PROVIDED

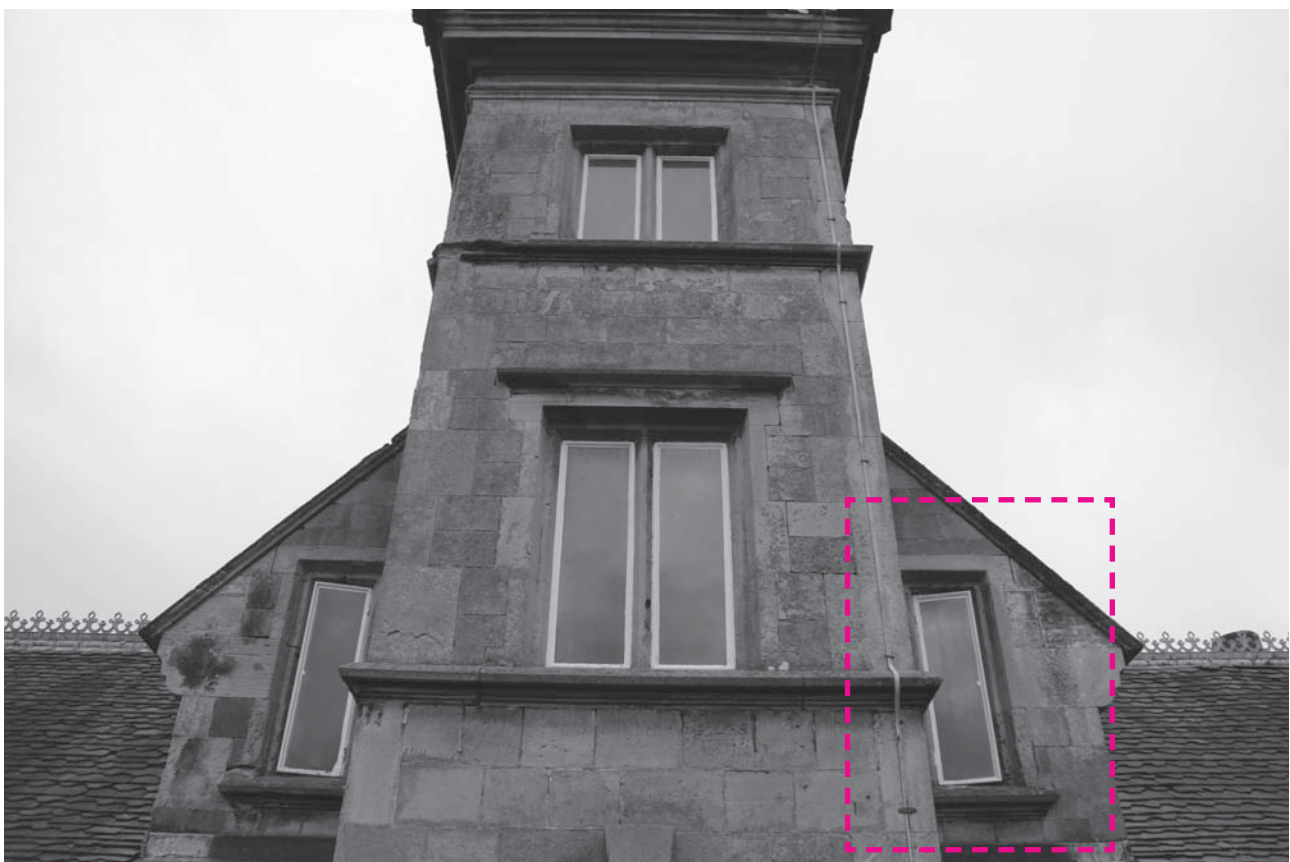
EXISTING EXTERNAL WINDOW SCHEDULE								
Window reference No :				WF-07				
Floor level :	First	External window type :	Type 03					
HISTORICAL SIGNIFICANCE		Level of significance	1=low, 5=high	1	2	3	4	5
Approximate date :	C 1860						4	
Description :		WORKS PROPOSED						
Single panel metal framed window with no opening light		Retained and repaired :	Removed and replaced :					
		YES. SECONDARY GLAZING TO BE PROVIDED

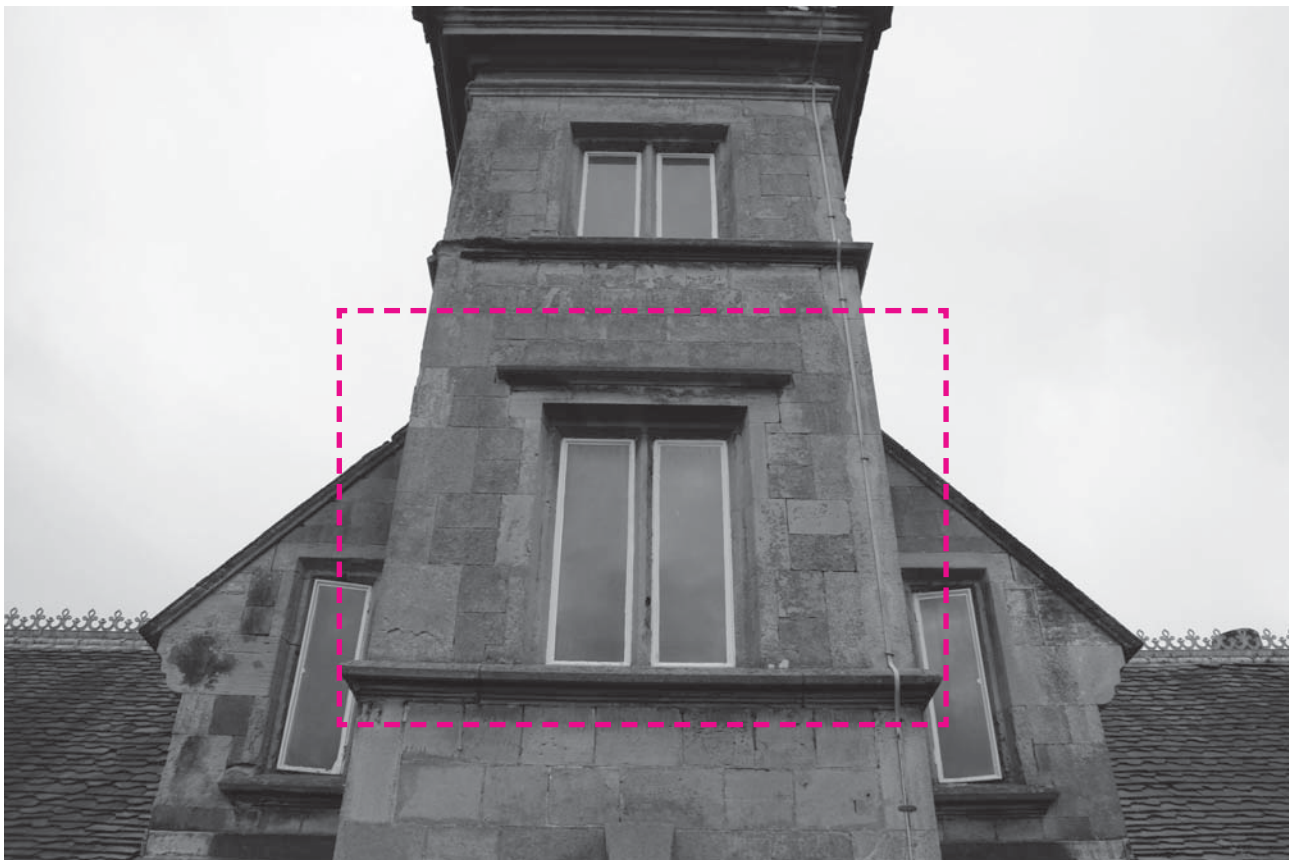
EXISTING EXTERNAL WINDOW SCHEDULE												
Window reference No :						WF-08						
Floor level :	First	External window type :				Type 02						
HISTORICAL SIGNIFICANCE						Level of significance	1=low, 5=high	1	2	3	4	5
Approximate date :	C 1860										4	
Description :						WORKS PROPOSED						
Two panel metal framed windows with central stone pier and with no opening lights						Retained and repaired :		Removed and replaced :				
						YES. SECONDARY GLAZING TO BE PROVIDED

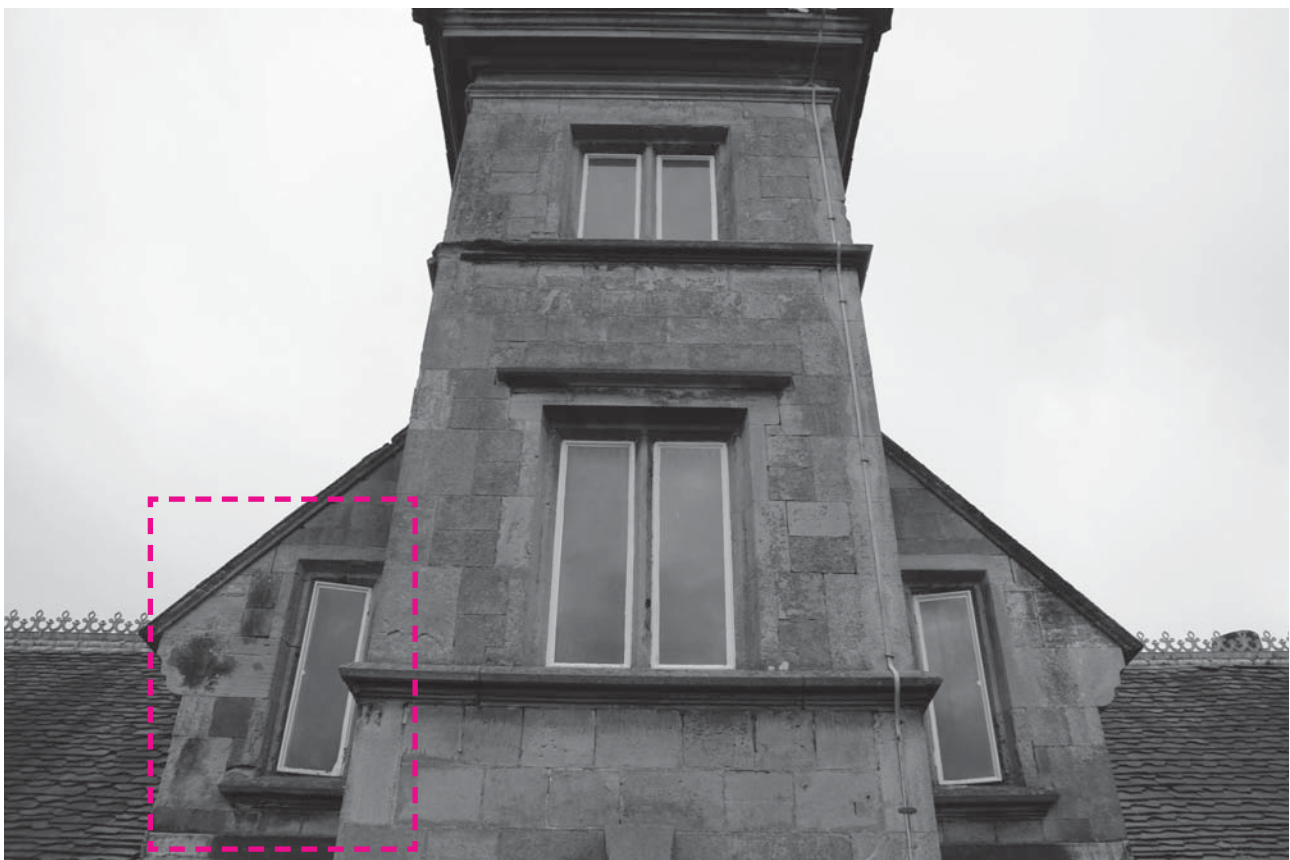
EXISTING EXTERNAL WINDOW SCHEDULE												
Window reference No :						WF-09						
Floor level :	First	External window type :				Type 03						
HISTORICAL SIGNIFICANCE						Level of significance	1=low, 5=high	1	2	3	4	5
Approximate date :	C 1860									4		
Description :						WORKS PROPOSED						
Single panel metal framed window with central vertical pivot opening light.						Retained and repaired :		Removed and replaced :				
						YES. SECONDARY GLAZING TO BE PROVIDED

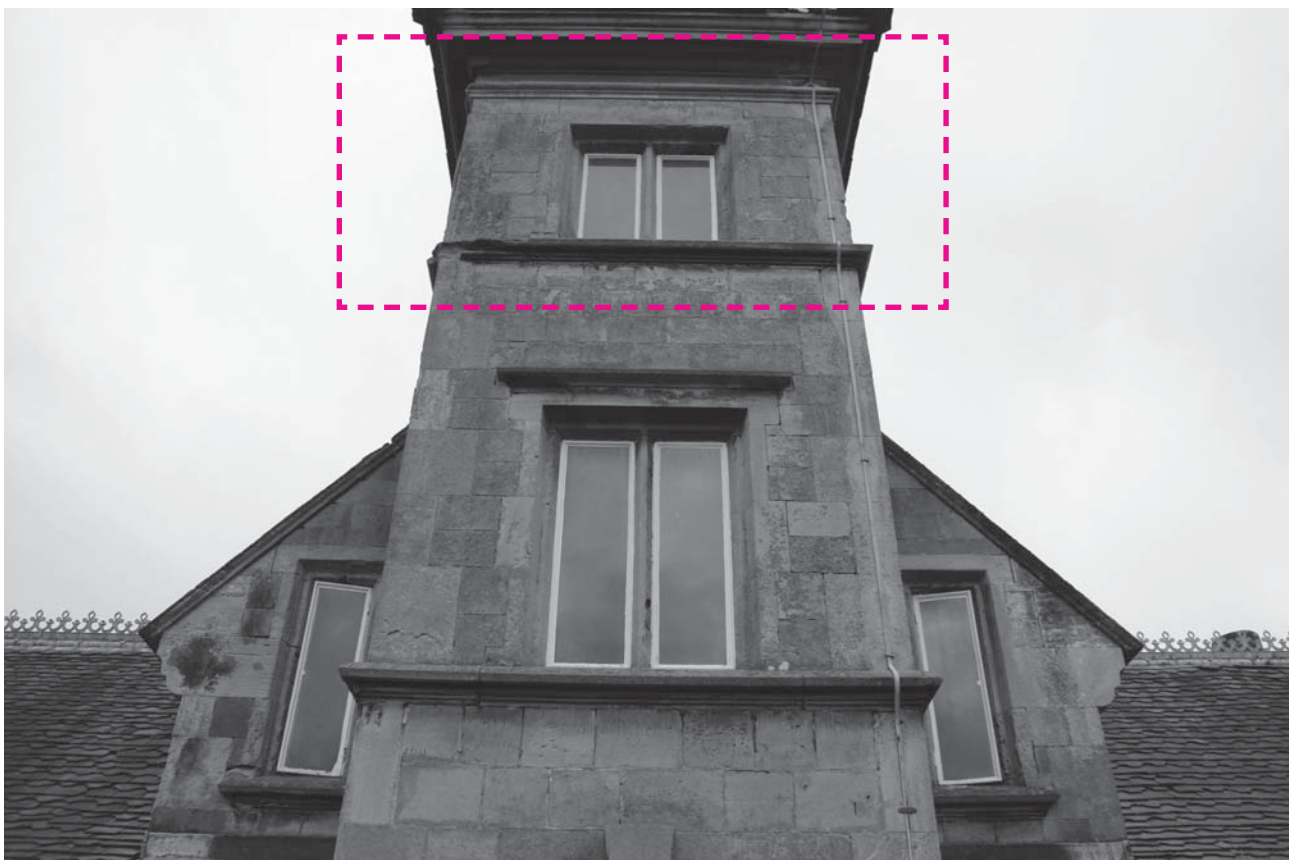
EXISTING EXTERNAL WINDOW SCHEDULE										
Window reference No :						WFS-01				
Floor level :	Second		External window type :		Type 02					
HISTORICAL SIGNIFICANCE			Level of significance		1=low, 5=high	1	2	3	4	5
Approximate date :		C 1860							4	
Description :			WORKS PROPOSED							
Two panel metal framed windows with central stone pier and with no opening lights			Retained and repaired :		Removed and replaced :					
			YES. SECONDARY GLAZING TO BE PROVIDED

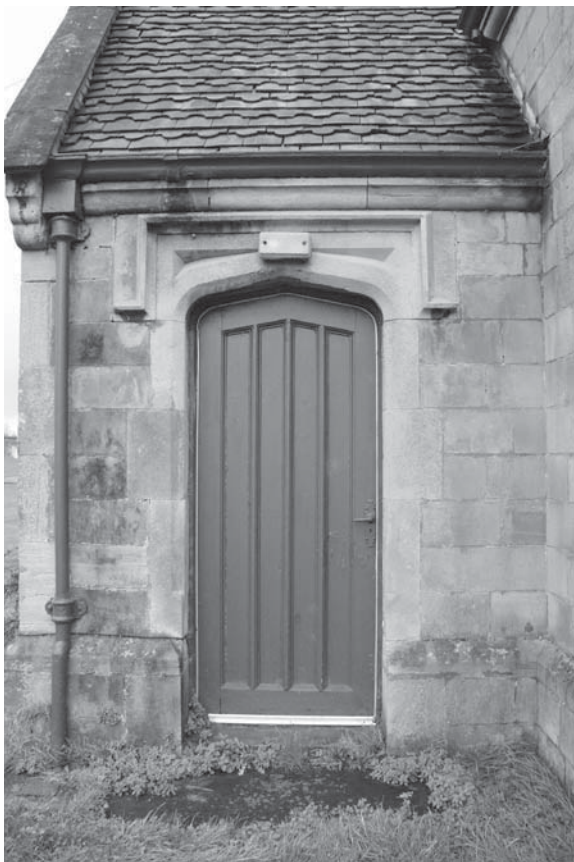
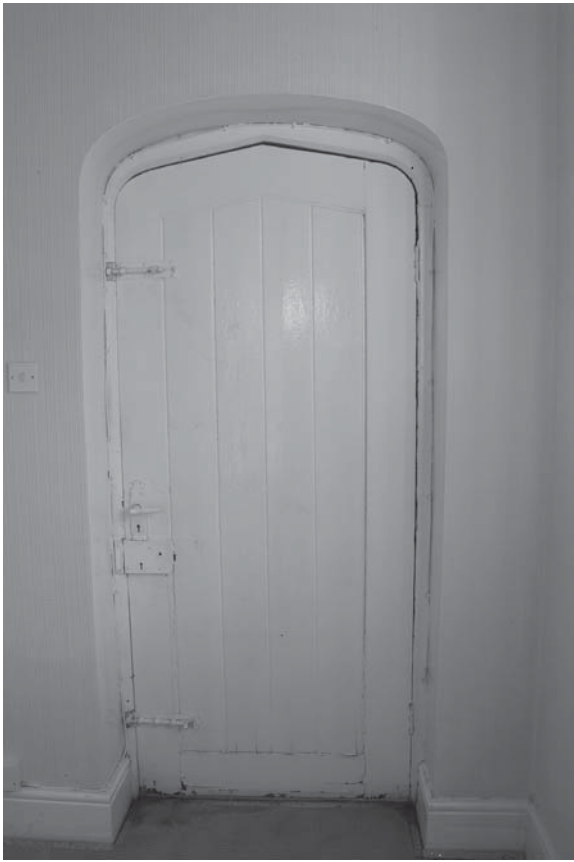
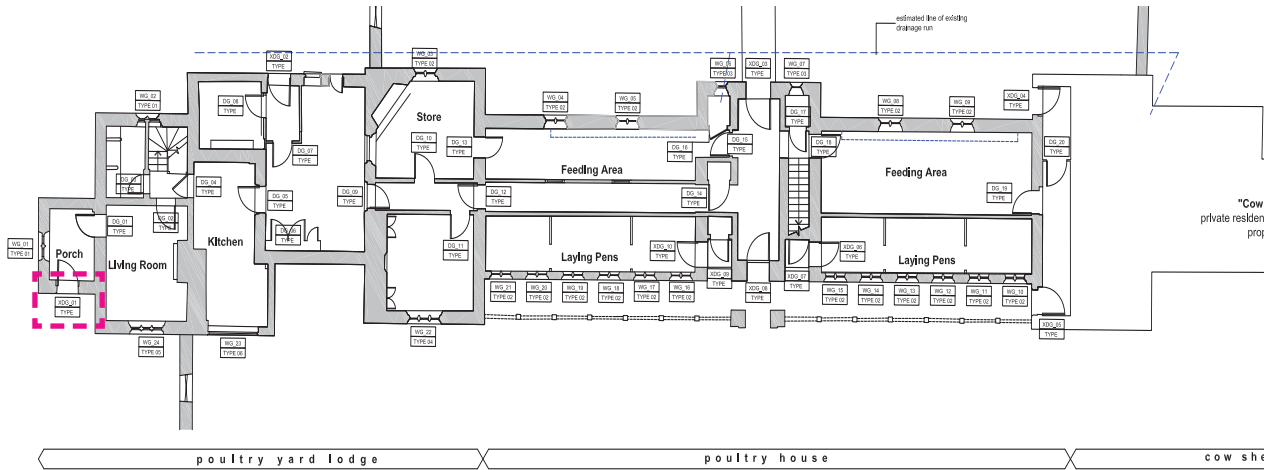
EXISTING EXTERNAL DOOR SCHEDULE						
Door reference No :			XDG-01			
Floor level :	Ground	External door type :		Type 01		
HISTORICAL SIGNIFICANCE		Level of significance	1=low, 5=high	1	2	3
Approximate date :	C 1860's					4
Description :		WORKS PROPOSED				
Tudor arched painted timber panelled door with 4 profiled vertical panel sections.		Retained and repaired :		Removed and replaced :		
		YES.

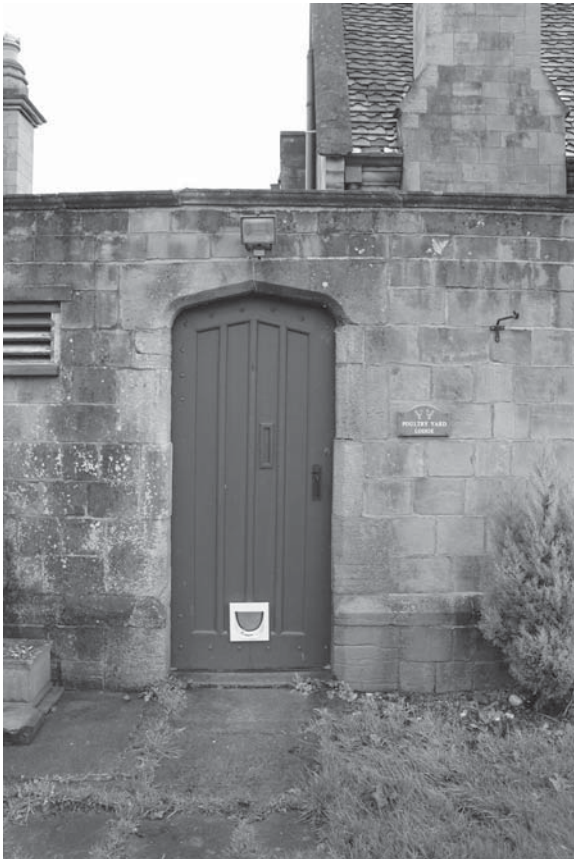
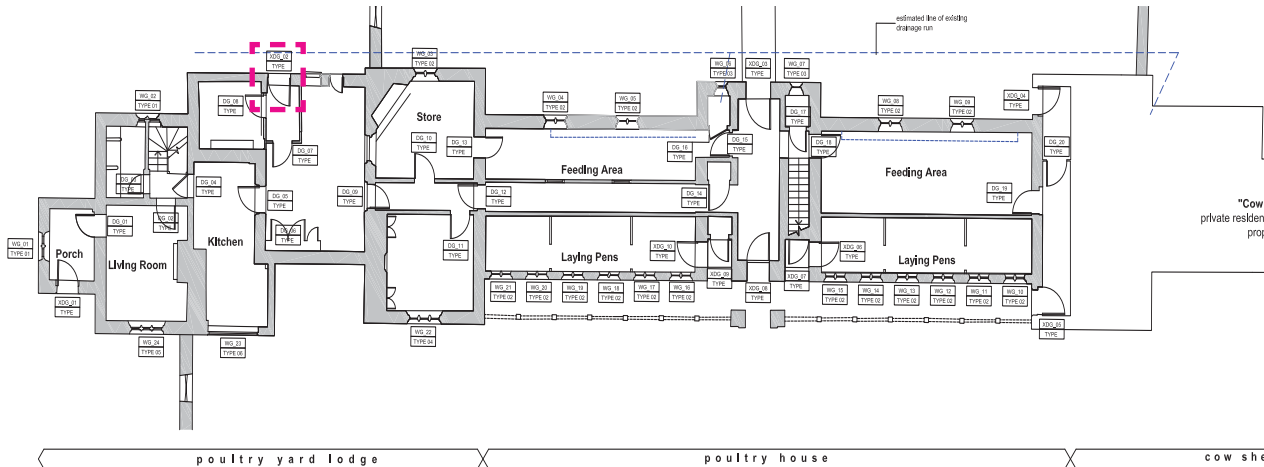
EXISTING EXTERNAL DOOR SCHEDULE										
Door reference No :							XDG-02			
Floor level :		Ground		External door type :		Type 01				
HISTORICAL SIGNIFICANCE				Level of significance	1=low, 5=high	1	2	3	4	5
Approximate date :		C 1860's							4	
Description :				WORKS PROPOSED						
Tudor arched painted timber panelled door with 4 profiled vertical panel sections.				Retained and repaired :		Removed and replaced :				
				YES.

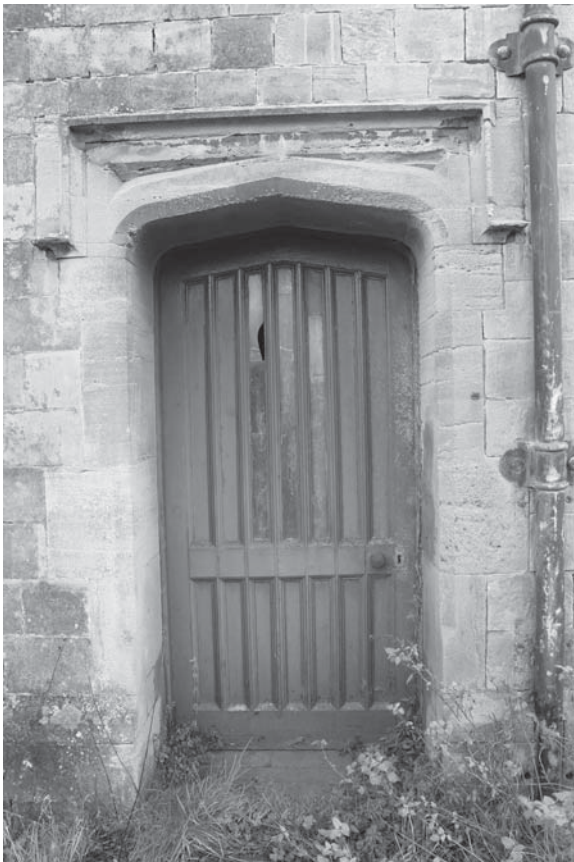
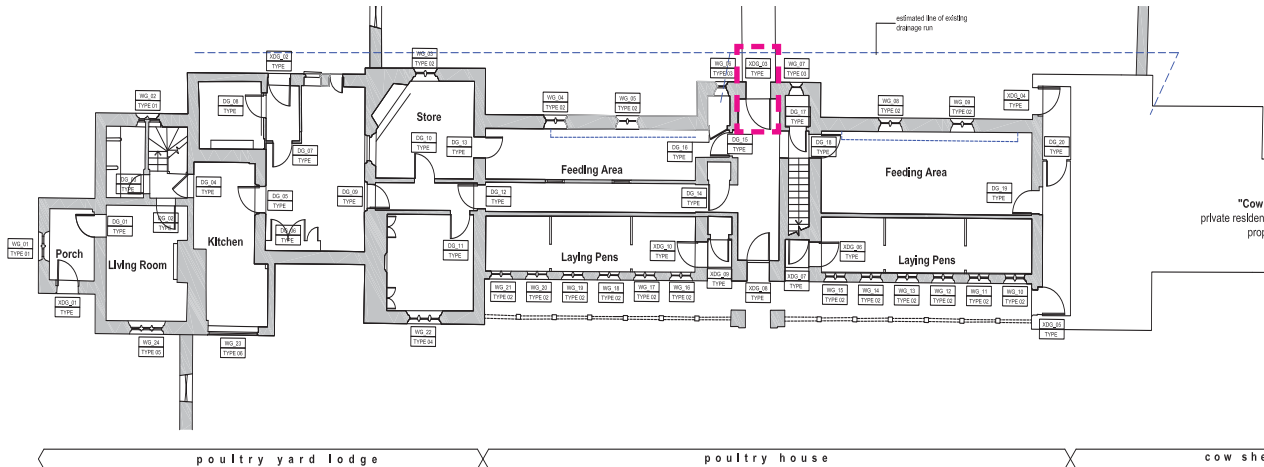
EXISTING EXTERNAL DOOR SCHEDULE						
Door reference No :			XDG-03			
Floor level :	Ground	External door type :		Type 02		
HISTORICAL SIGNIFICANCE		Level of significance	1=low, 5=high	1	2	3
Approximate date :	C 1860's					4
Description :		WORKS PROPOSED				
Tudor arched painted timber panelled door with 7 profiled vertical panel sections and mid rail with 3 central glazed upper panels.		Retained and repaired :		Removed and replaced :		
		YES.

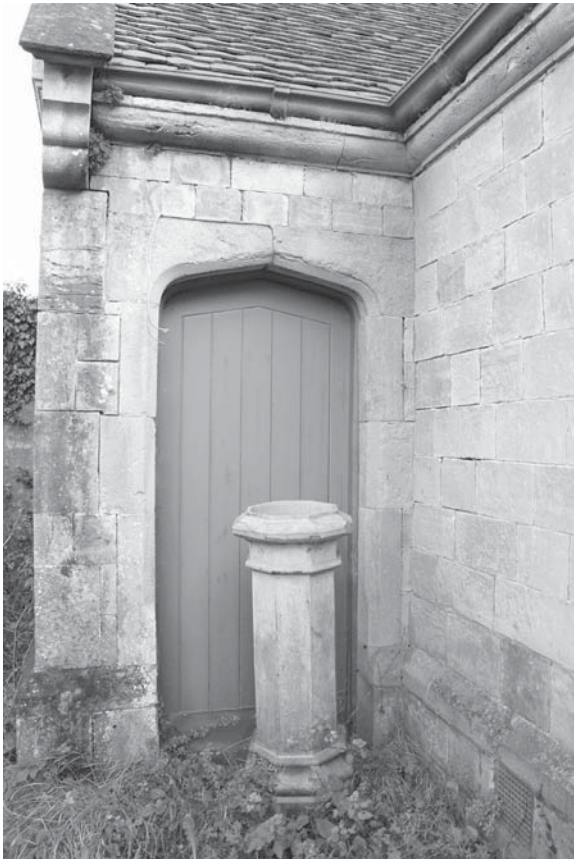
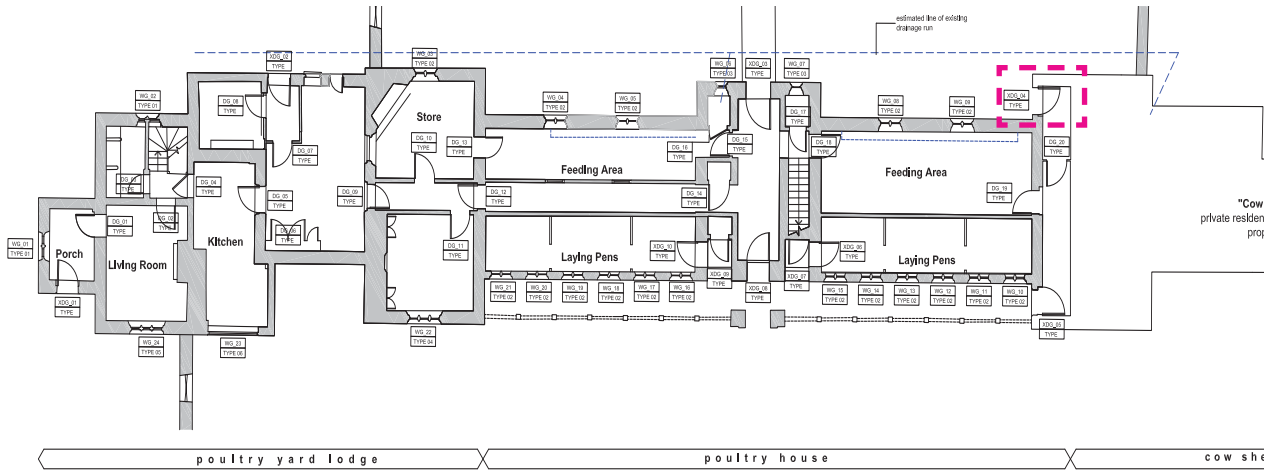
EXISTING EXTERNAL DOOR SCHEDULE									
Door reference No :				XDG-04					
Floor level :	Ground		External door type :		Type 03				
HISTORICAL SIGNIFICANCE			Level of significance	1=low, 5=high	1	2	3	4	5
Approximate date :	C 1860's								4
Description :			WORKS PROPOSED						
Tudor arched painted timber panelled door with 5 flat vertical panel sections.			Retained and repaired :		Removed and replaced :				
			YES.

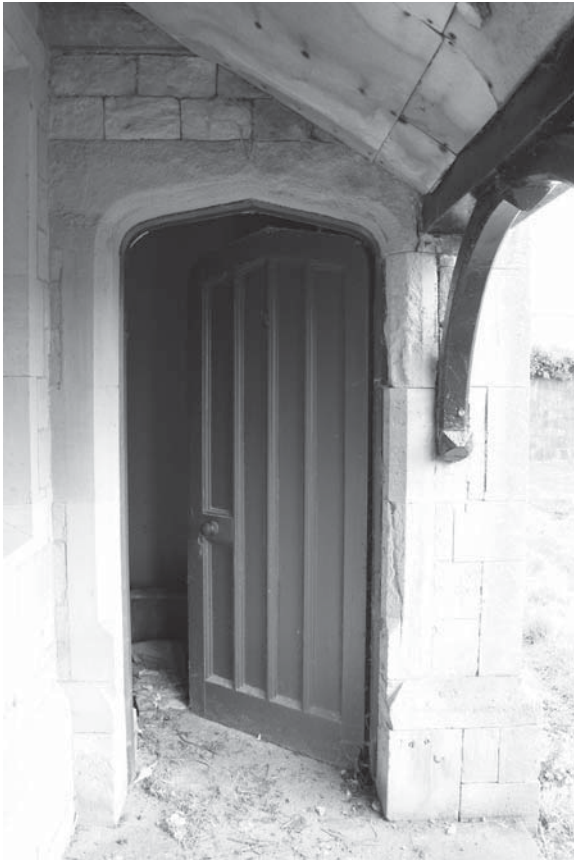
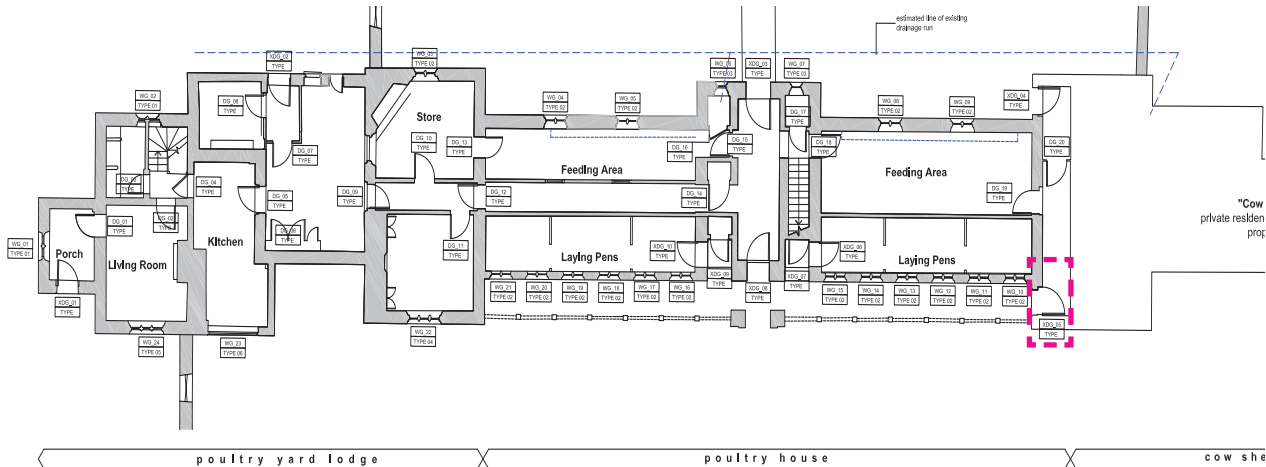
EXISTING EXTERNAL DOOR SCHEDULE									
Door reference No :						XDG-05			
Floor level :	Ground		External door type :		Type 01				
HISTORICAL SIGNIFICANCE			Level of significance	1=low, 5=high	1	2	3	4	5
Approximate date :	C 1860's								4
Description :			WORKS PROPOSED						
Tudor arched painted timber panelled door with 4 profiled vertical panel sections.			Retained and repaired :		Removed and replaced :				
			YES.

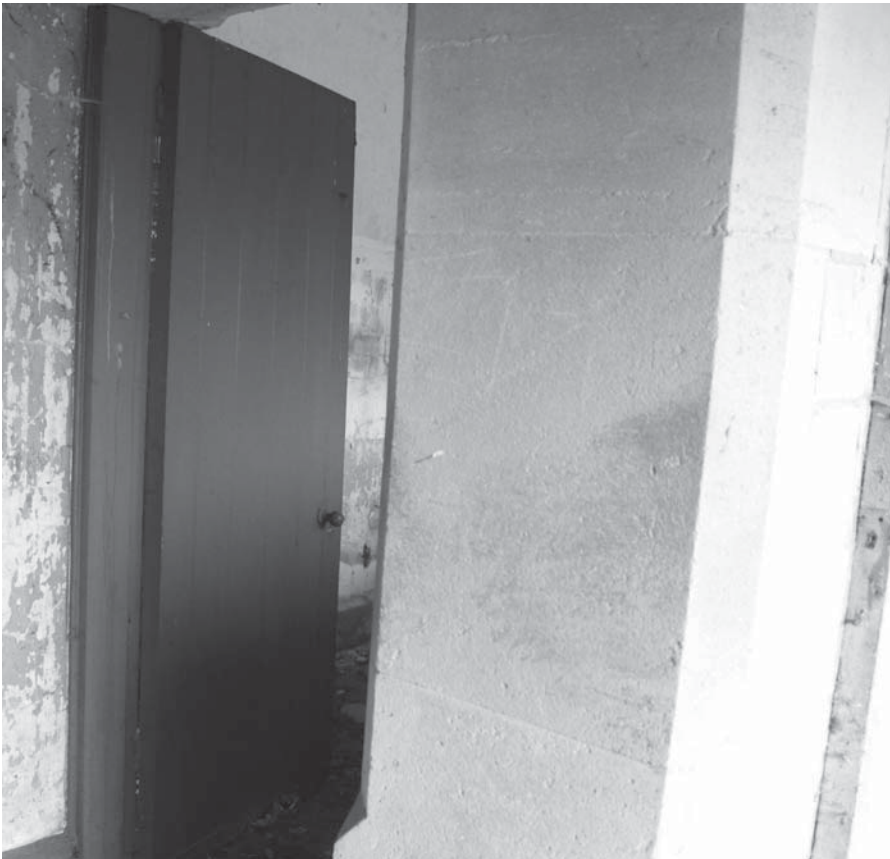
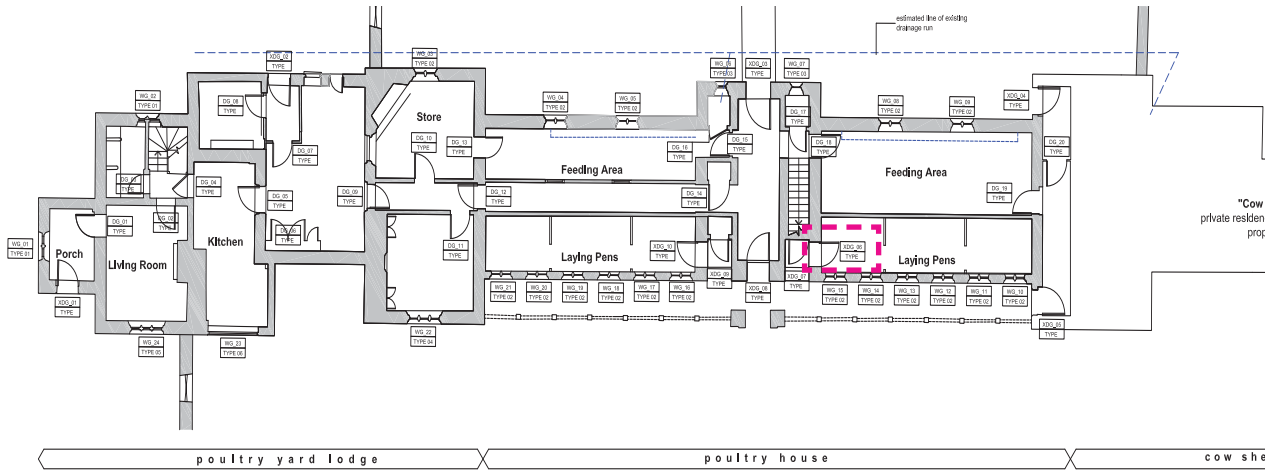
EXISTING EXTERNAL DOOR SCHEDULE						
Door reference No :			XDG-06			
Floor level :	Ground	External window type :	Type 04			
HISTORICAL SIGNIFICANCE		Level of significance	1=low, 5=high	1	2	3
Approximate date :	C 1860's					3
Description :		WORKS PROPOSED				
Flat panelled stable door, 6 panel.		Retained and repaired :		Removed and replaced :		
		YES.

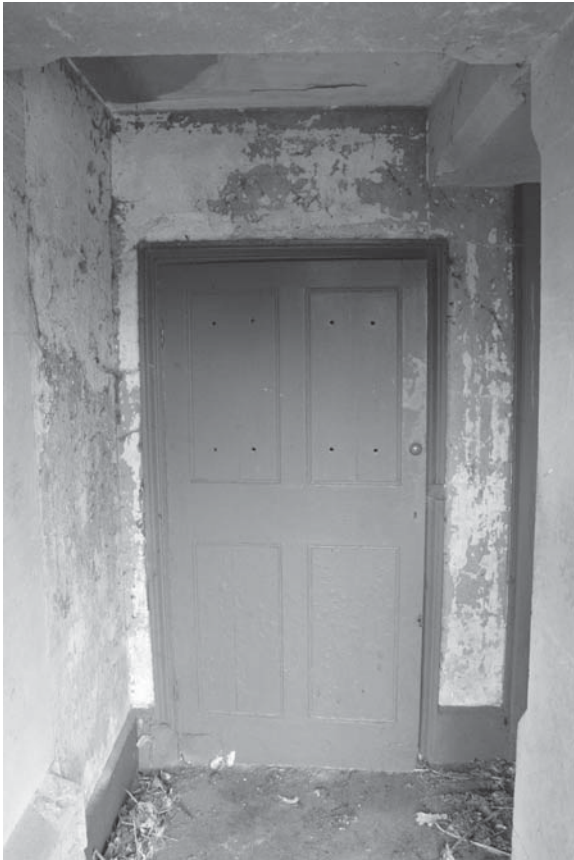
EXISTING EXTERNAL DOOR SCHEDULE						
Door reference No :			XDG-07			
Floor level :	Ground	External door type :	Type 05			
HISTORICAL SIGNIFICANCE		Level of significance	1=low, 5=high	1	2	3
Approximate date :	C 1860's					3
Description :		WORKS PROPOSED				
Timber 4 panel door door with central rail and ventilation holes within panels		Retained and repaired :		Removed and replaced :		
		YES.

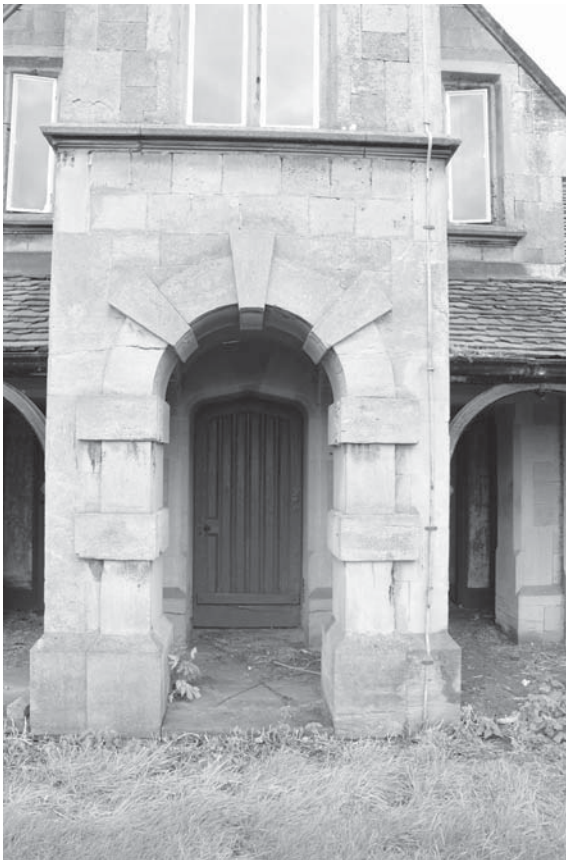
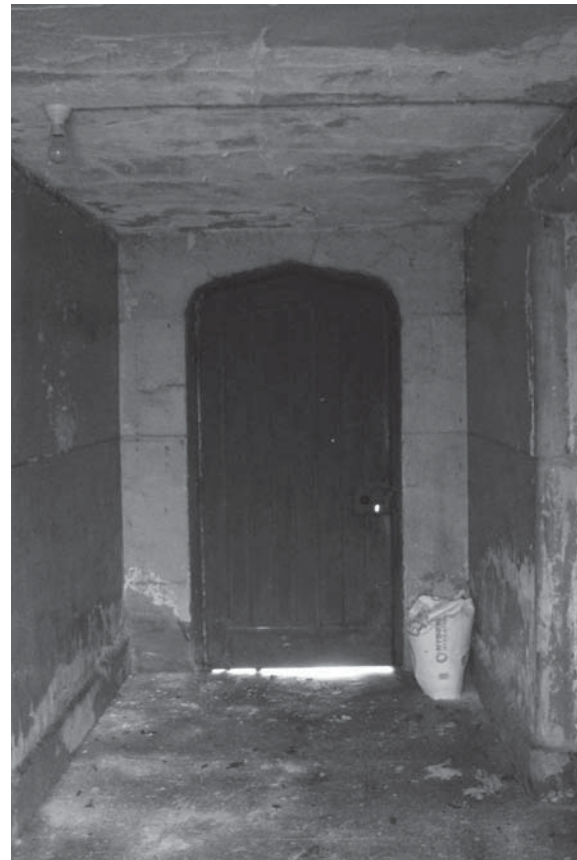
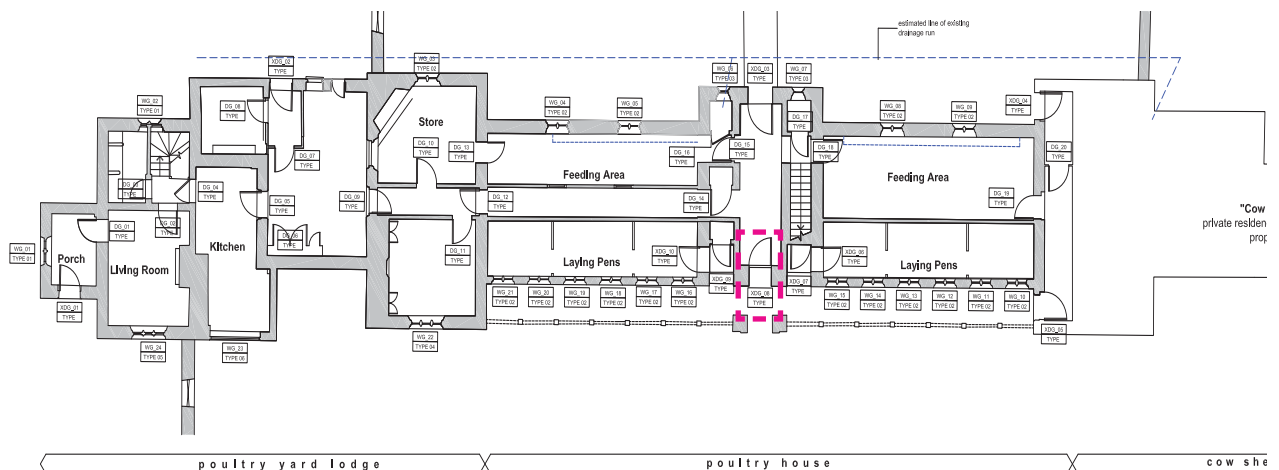
EXISTING EXTERNAL DOOR SCHEDULE											
Door reference No :							XDG-08				
Floor level :		Ground		External door type :		Type 02					
HISTORICAL SIGNIFICANCE				Level of significance		1=low, 5=high	1	2	3	4	5
Approximate date :		C 1860's									5
Description :				WORKS PROPOSED							
Tudor arched painted timber panelled door with 6 recessed vertical panel sections.				Retained and repaired :		Removed and replaced :					
				YES.

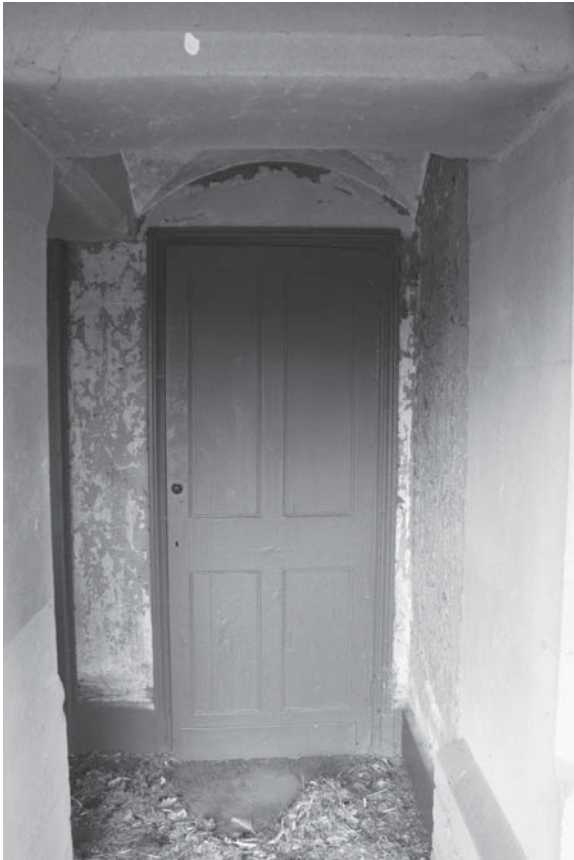
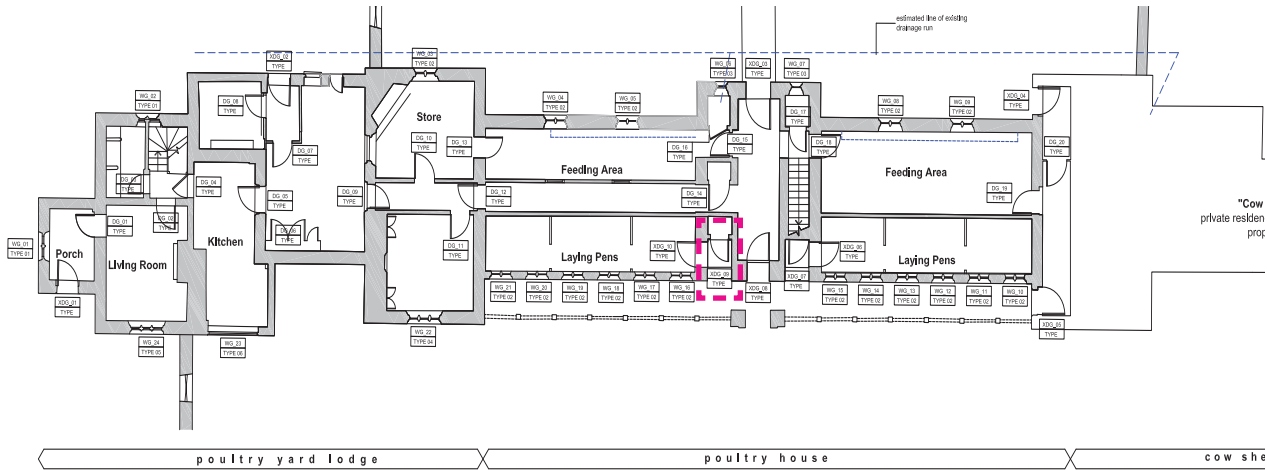
EXISTING EXTERNAL DOOR SCHEDULE						
Door reference No :			XDG-09			
Floor level :	Ground	External door type :	Type 05			
HISTORICAL SIGNIFICANCE		Level of significance	1=low, 5=high	1	2	3
Approximate date :	C 1860's					3
Description :		WORKS PROPOSED				
Timber 4 panel door door with central rail and ventilation holes within panels		Retained and repaired :	Removed and replaced :			
		YES.

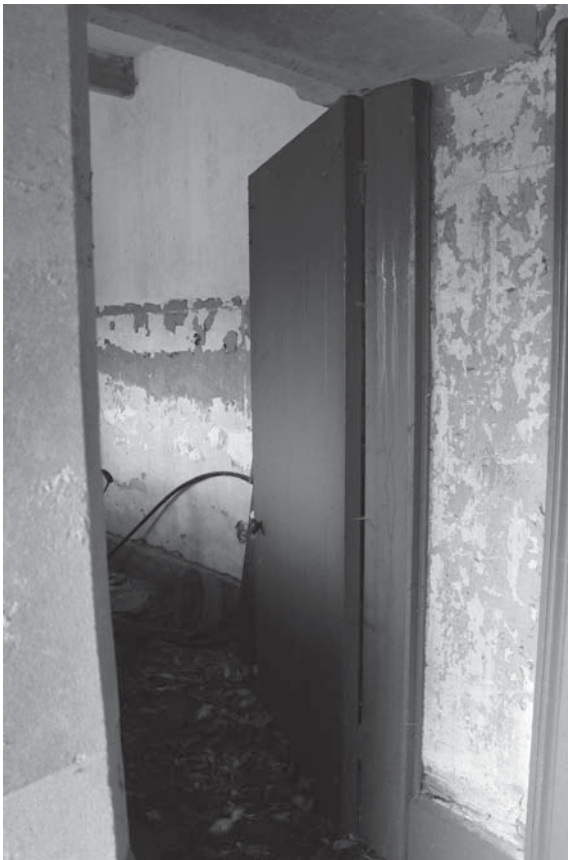
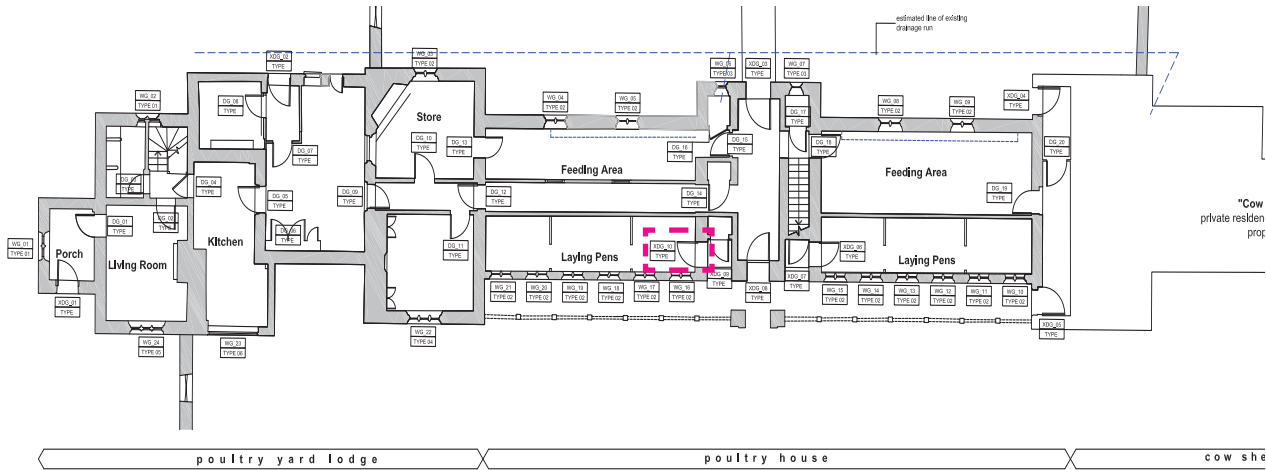
EXISTING EXTERNAL DOOR SCHEDULE						
Door reference No :			XDG-10			
Floor level :	Ground	External window type :		Type 04		
HISTORICAL SIGNIFICANCE		Level of significance	1=low, 5=high	1	2	3
Approximate date :	C 1860's					3
Description :		WORKS PROPOSED				
Flat panelled stable door, 6 panel.		Retained and repaired :		Removed and replaced :		
		YES.

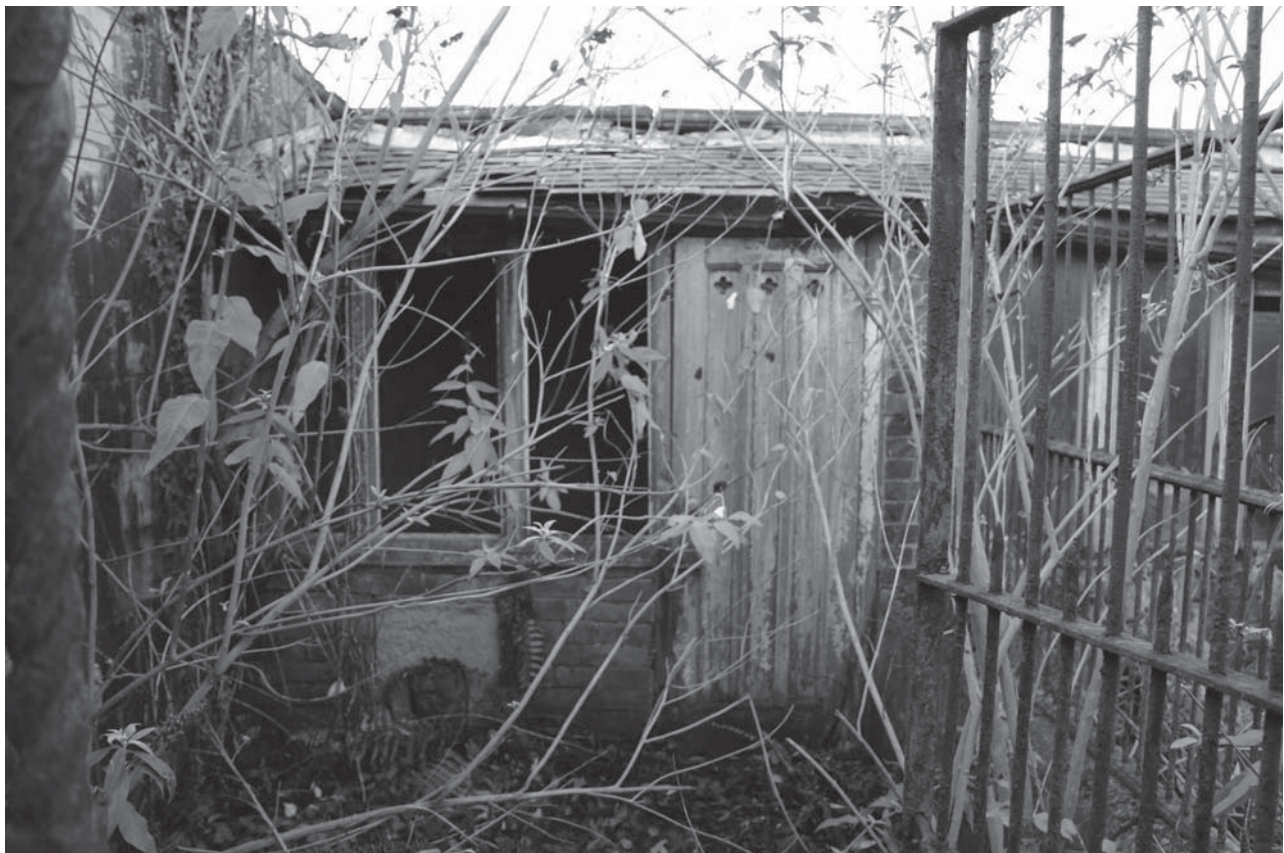
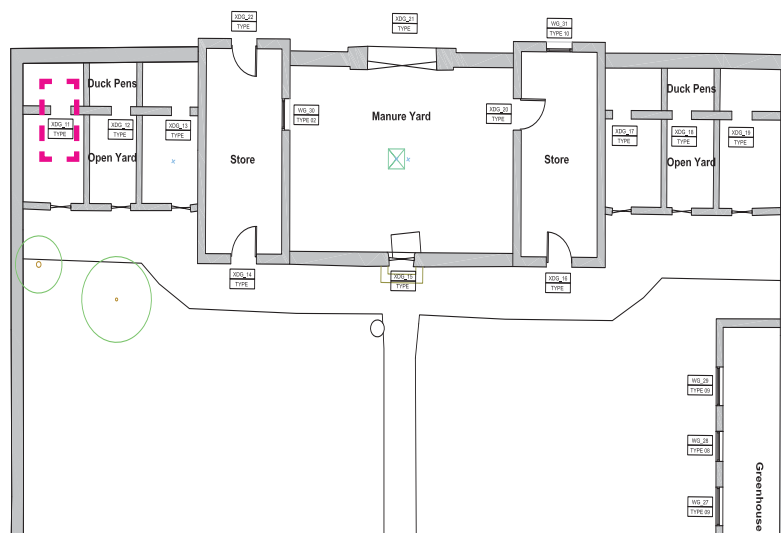
EXISTING EXTERNAL DOOR SCHEDULE										
Door reference No :						XDG-11				
Floor level :	Ground		External door type :		Type 06					
HISTORICAL SIGNIFICANCE			Level of significance		1=low, 5=high	1	2	3	4	5
Approximate date :		C 1860's						3		
Description :			WORKS PROPOSED							
Timber 3 panel door door with central rail and high level cross detail ventilation holes within panels.			Retained and repaired :		Removed and replaced :					
			YES.
