EXISTING EXTERNAL WINDOW SCHEDULE											
Window reference No :						WF-03					
Floor level :		First		External window type :		Type 06					
HISTORICAL SIGNIFICANCE				Level of significance		1=low, 5=high	1	2	3	4	5
Approximate date :		C 1900's						2			
Description :				WORKS PROPOSED							
Four panel later addition timber framed windows with high level opening lights to LHS and RHS windows				Retained and repaired :		Removed and replaced :					
				YES. SECONDARY GLAZING TO BE PROVIDED

Schedule of existing Doors

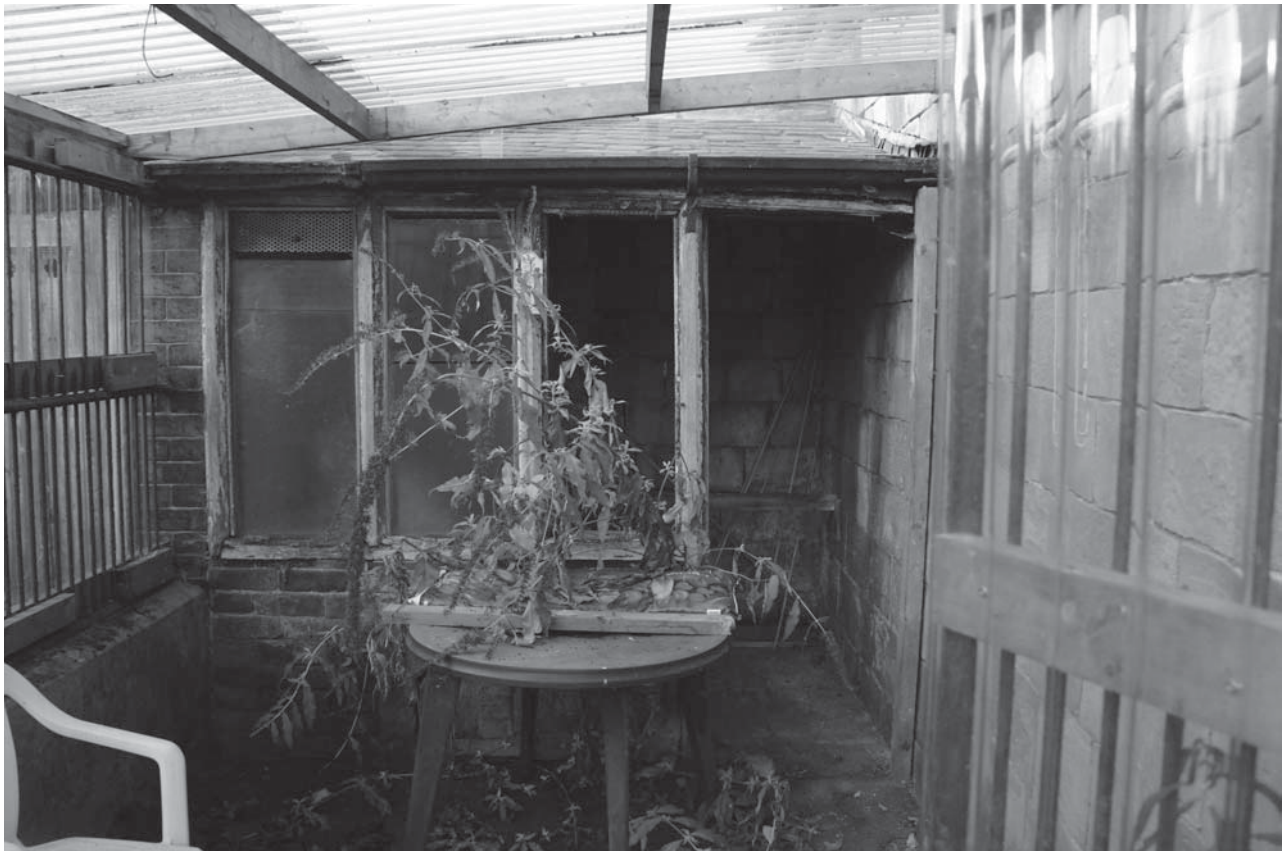
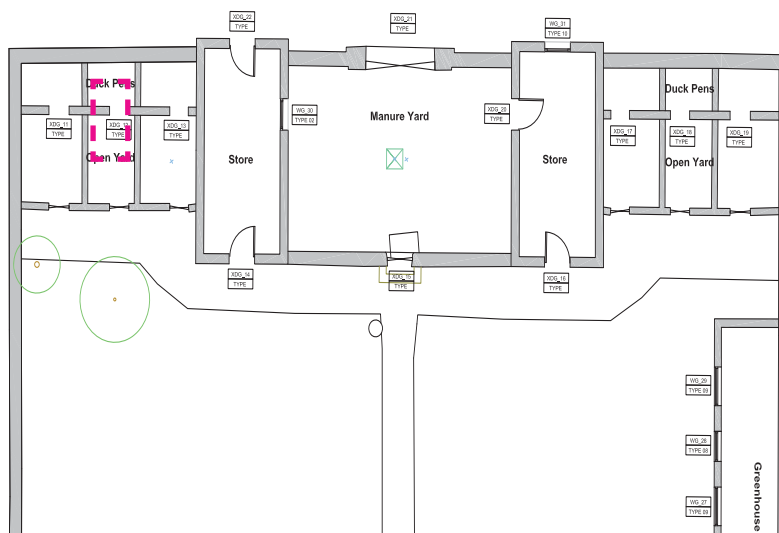
EXISTING EXTERNAL DOOR SCHEDULE								
Door reference No :				XDG-12				
Floor level :	Ground	External window type :						
HISTORICAL SIGNIFICANCE		Level of significance	1=low, 5=high	1	2	3	4	5
Approximate date :	C 1860's							
Description :		WORKS PROPOSED						
No existing door.		Retained and repaired :	Removed and replaced :					
			New door to be provided to match XDG-11

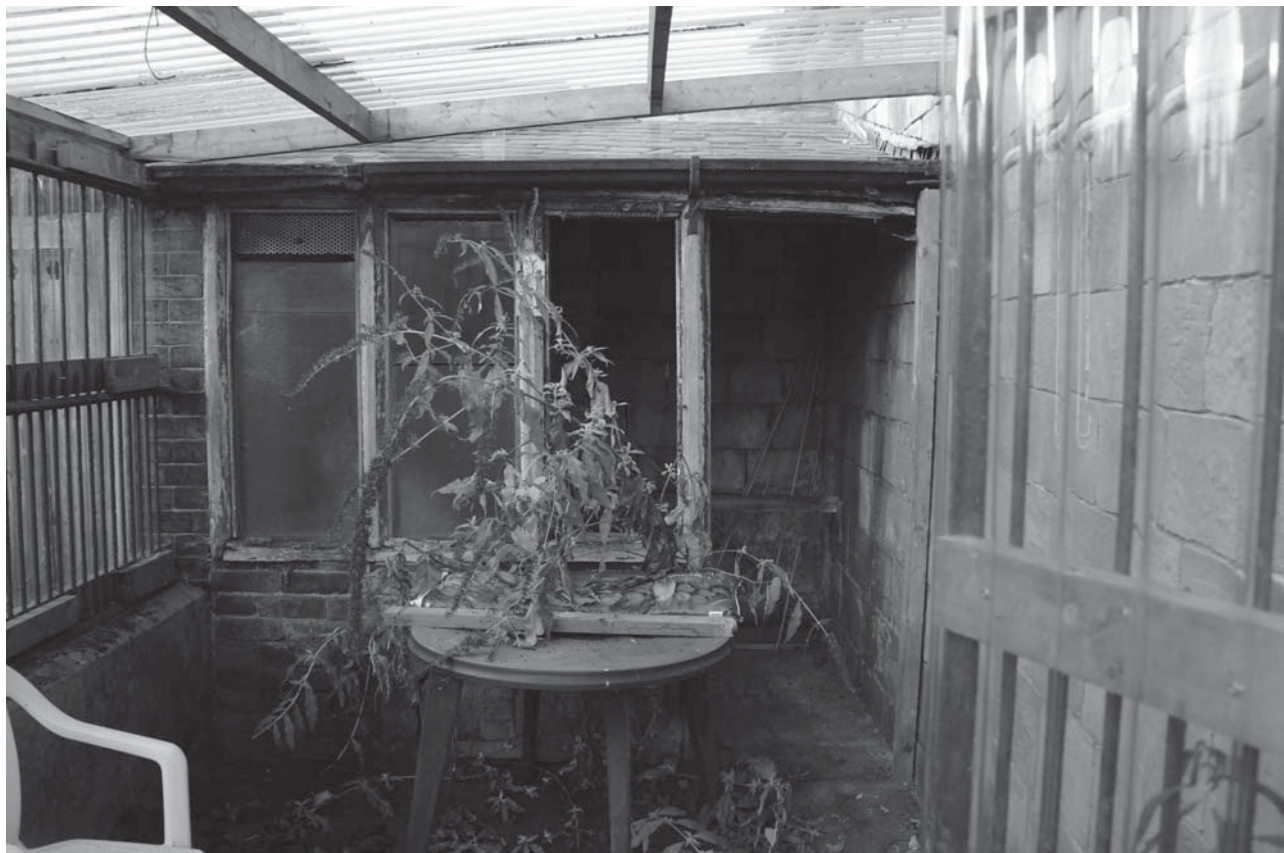
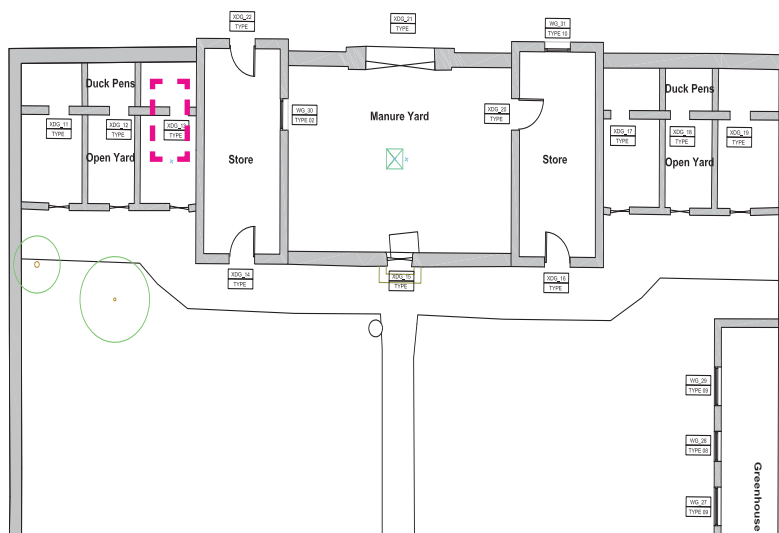
EXISTING EXTERNAL DOOR SCHEDULE												
Door reference No :						XDG-13						
Floor level :	Ground		External window type :									
HISTORICAL SIGNIFICANCE						Level of significance	1=low, 5=high	1	2	3	4	5
Approximate date :	C 1860's											
Description :						WORKS PROPOSED						
No existing door.						Retained and repaired :		Removed and replaced :				
								New door to be provided to match XDG-11

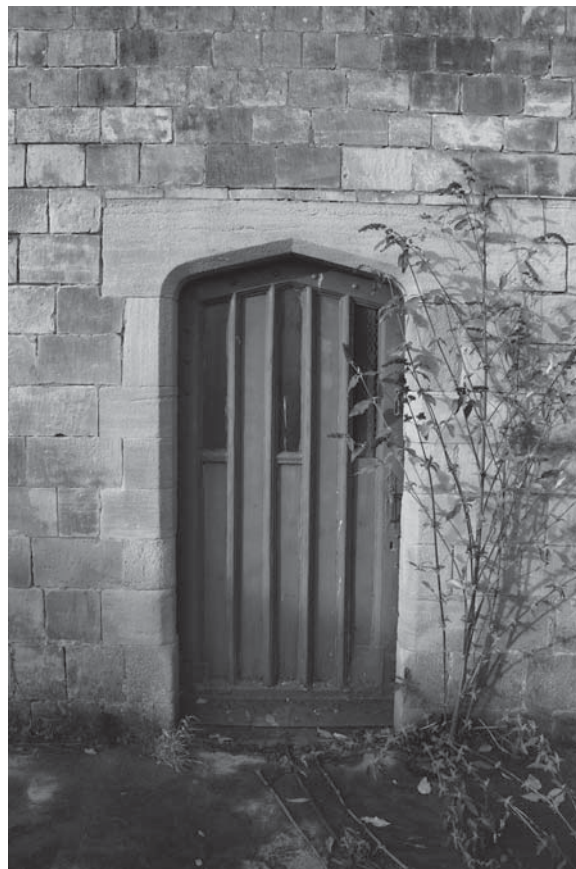
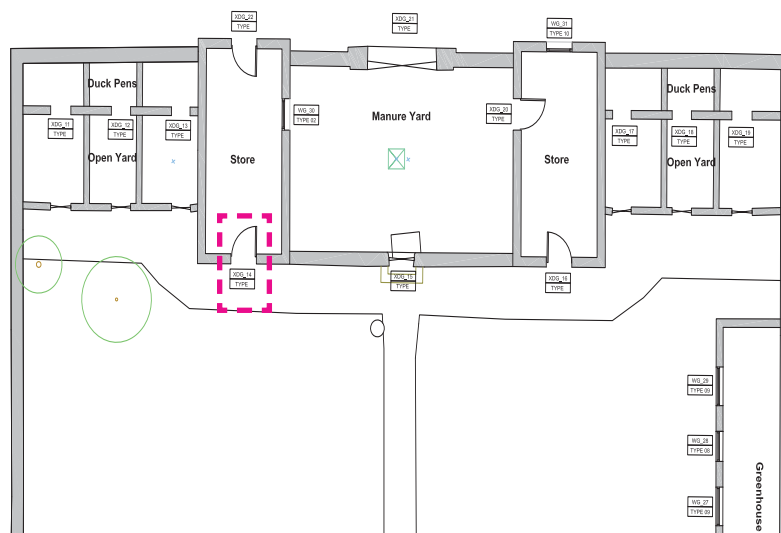
EXISTING EXTERNAL DOOR SCHEDULE										
Door reference No :						XDG-14				
Floor level :	Ground		External door type :		Type 07					
HISTORICAL SIGNIFICANCE			Level of significance		1=low, 5=high	1	2	3	4	5
Approximate date :	C 1860's								4	
Description :			WORKS PROPOSED							
Tudor arched painted timber panelled door with 6 profiled vertical panel sections with 3 glazed upper panels.			Retained and repaired :		Removed and replaced :					
			YES.

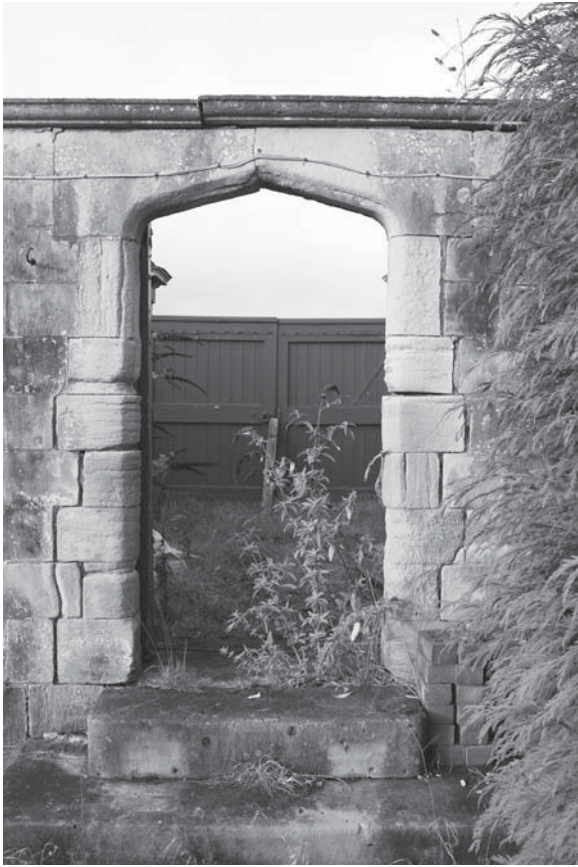
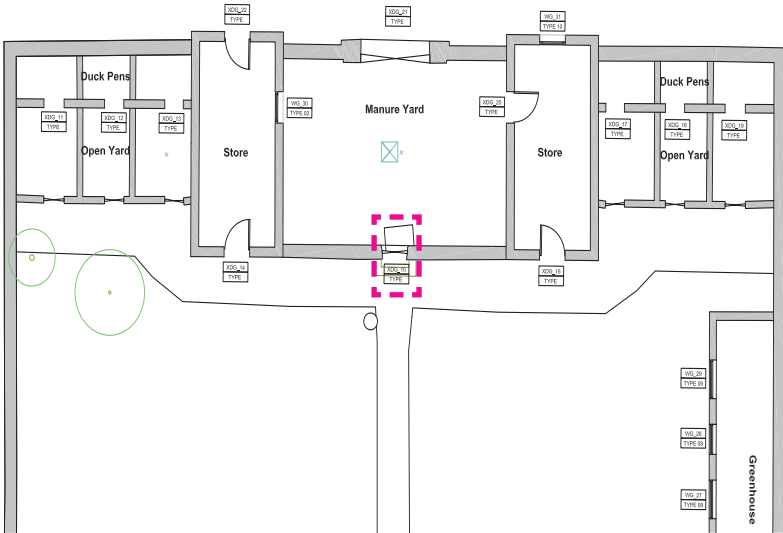
EXISTING EXTERNAL DOOR SCHEDULE								
Door reference No :				XDG-15				
Floor level :	Ground	External window type :						
HISTORICAL SIGNIFICANCE		Level of significance	1=low, 5=high	1	2	3	4	5
Approximate date :	C 1860's							
Description :		WORKS PROPOSED						
No existing door.		Retained and repaired :	Removed and replaced :

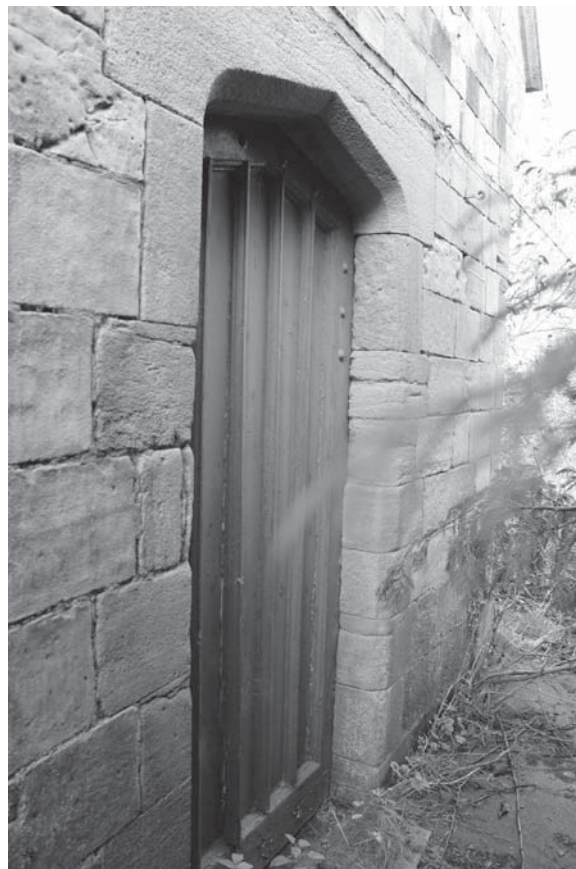
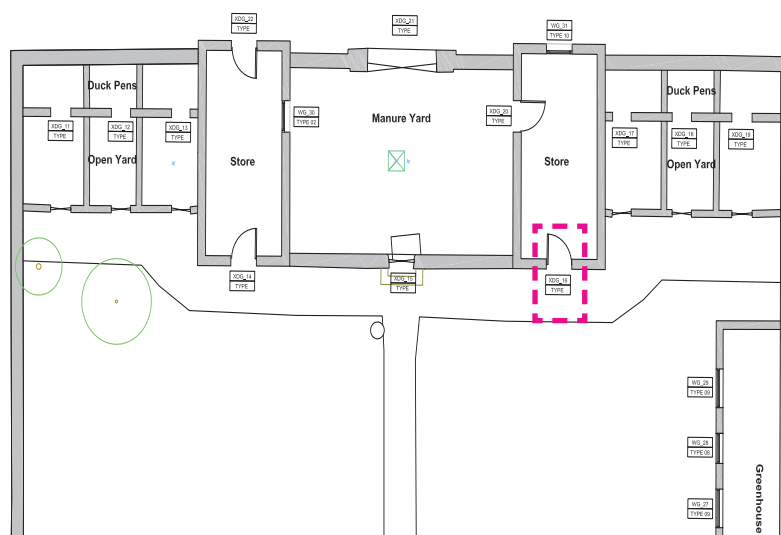
EXISTING EXTERNAL DOOR SCHEDULE											
Door reference No :							XDG-16				
Floor level :		Ground		External door type :		Type 01					
HISTORICAL SIGNIFICANCE				Level of significance		1=low, 5=high	1	2	3	4	5
Approximate date :		C 1860's								4	
Description :				WORKS PROPOSED							
Tudor arched painted timber panelled door with 4 profiled vertical panel sections.				Retained and repaired :		Removed and replaced :					
				YES.

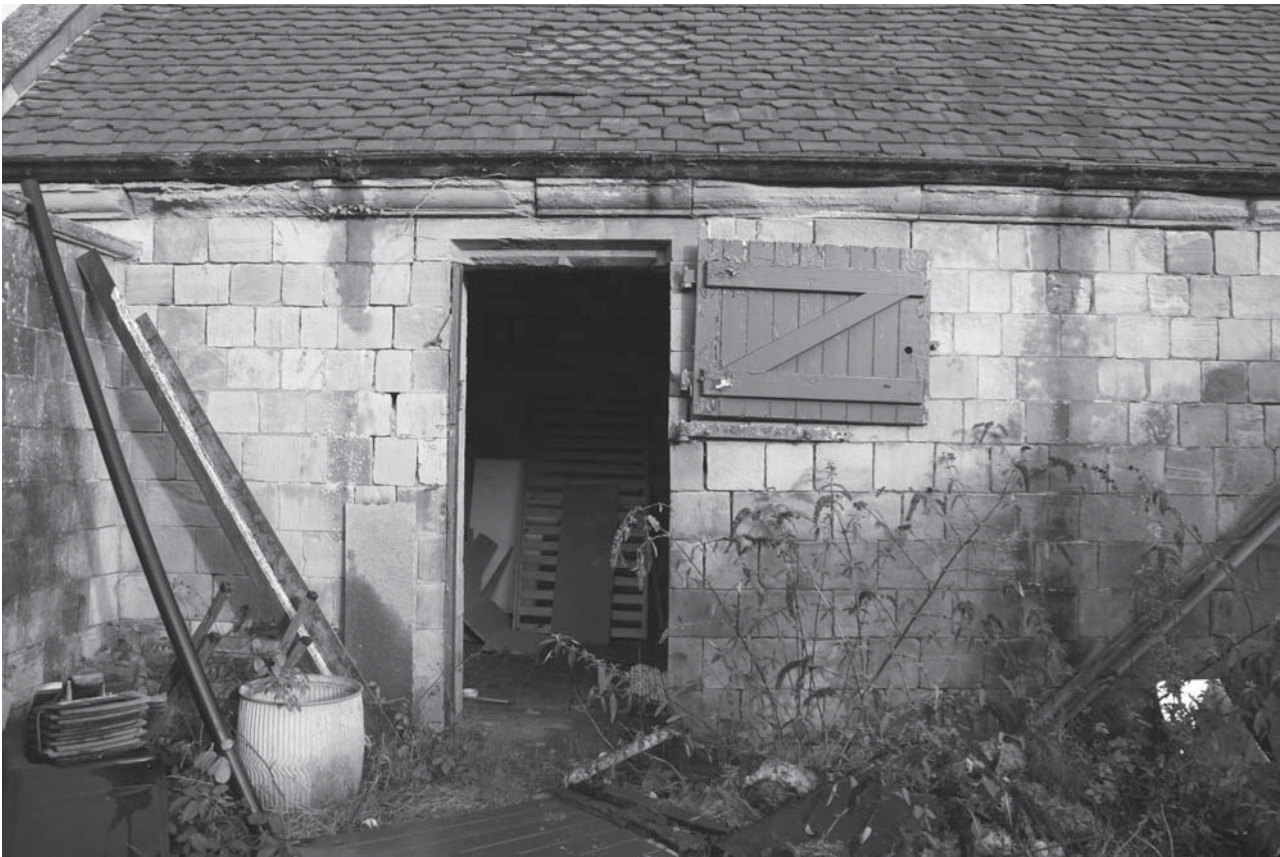
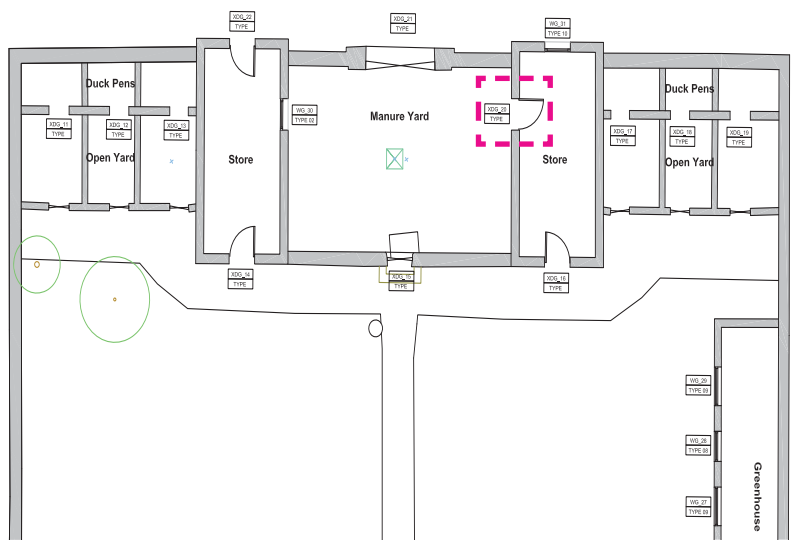
EXISTING EXTERNAL DOOR SCHEDULE						
Door reference No :			XDG-20			
Floor level :	Ground	External window type :	Type 08			
HISTORICAL SIGNIFICANCE		Level of significance	1=low, 5=high	1	2	3
Approximate date :	C 1860's				2	
Description :		WORKS PROPOSED				
Part removed 2 part timber stable door with timber bracing.		Retained and repaired :		Removed and replaced :		
				New door to be provided to match historic timber door style.

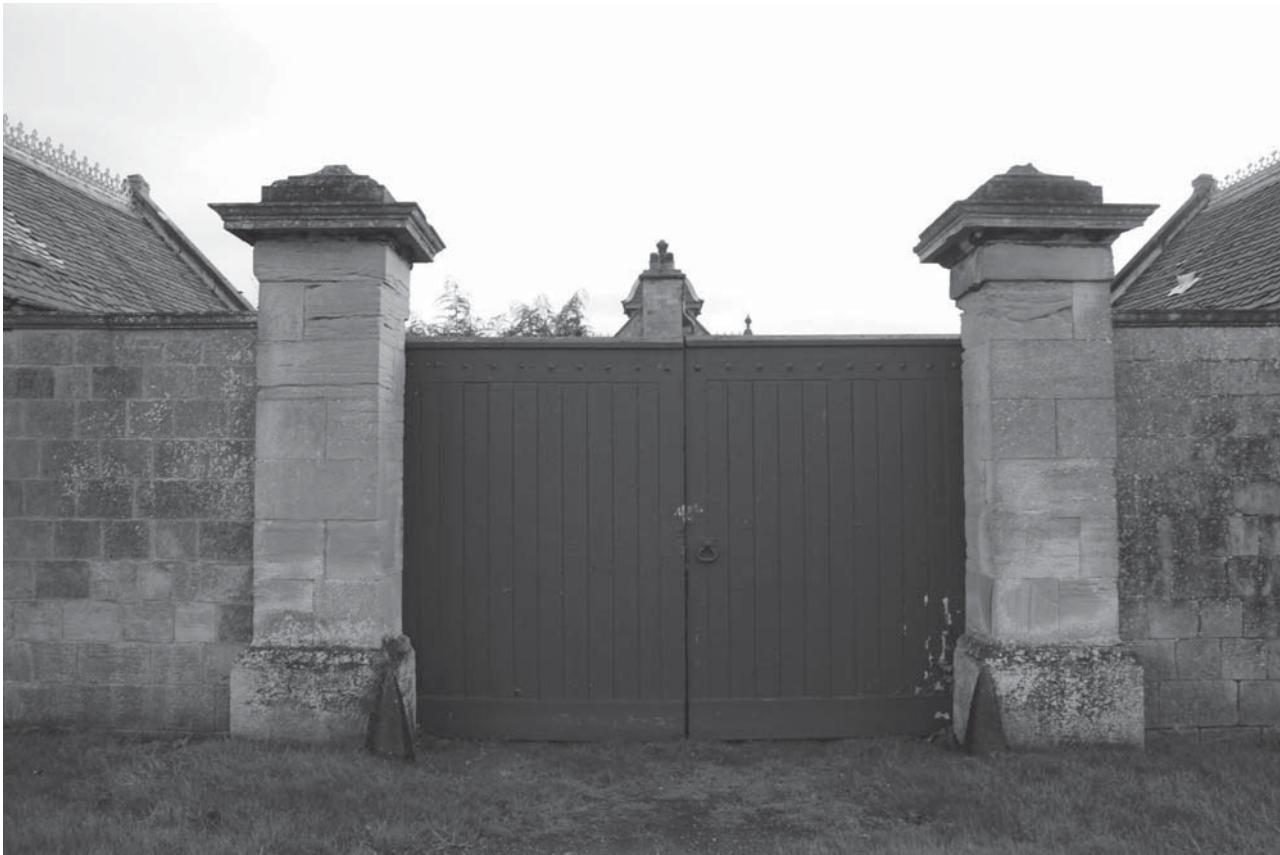
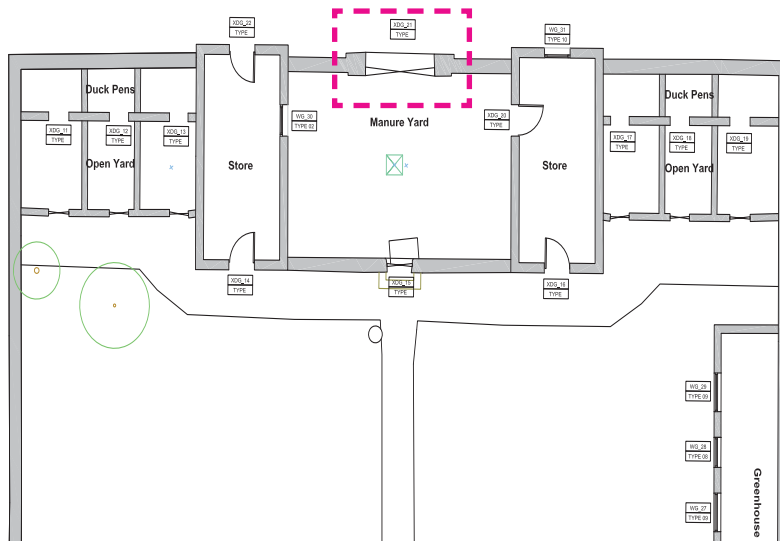
EXISTING EXTERNAL DOOR SCHEDULE										
Door reference No :						XDG-21				
Floor level :	Ground		External door type :		Type 09					
HISTORICAL SIGNIFICANCE			Level of significance		1=low, 5=high	1	2	3	4	5
Approximate date :		C 1860's							4	
Description :			WORKS PROPOSED							
Timber gates with iron fixing details / bolts to top rail and cast iron handle.			Retained and repaired :		Removed and replaced :					
			YES.

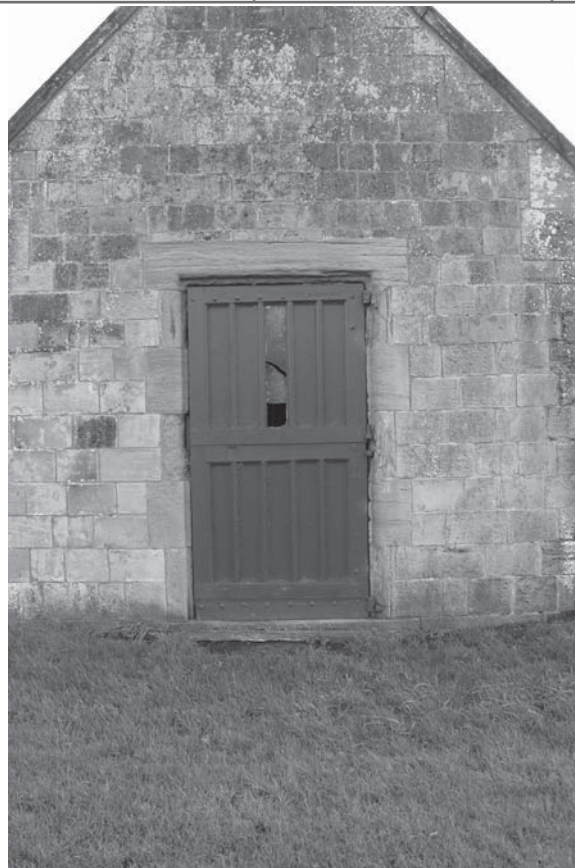
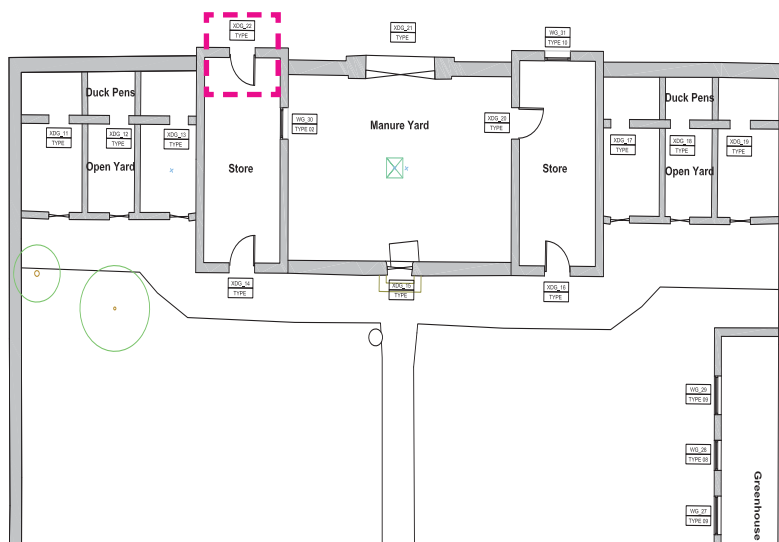
EXISTING EXTERNAL DOOR SCHEDULE										
Door reference No :						XDG-22				
Floor level :	Ground		External window type :		Type 10					
HISTORICAL SIGNIFICANCE			Level of significance		1=low, 5=high	1	2	3	4	5
Approximate date :		C 1860's							4	
Description :			WORKS PROPOSED							
Square headed painted timber stable door with with 5 profiled vertical panel sections to top and bottom door. Iron bolt detail to top and bottom rail.			Retained and repaired :		Removed and replaced :					
			YES

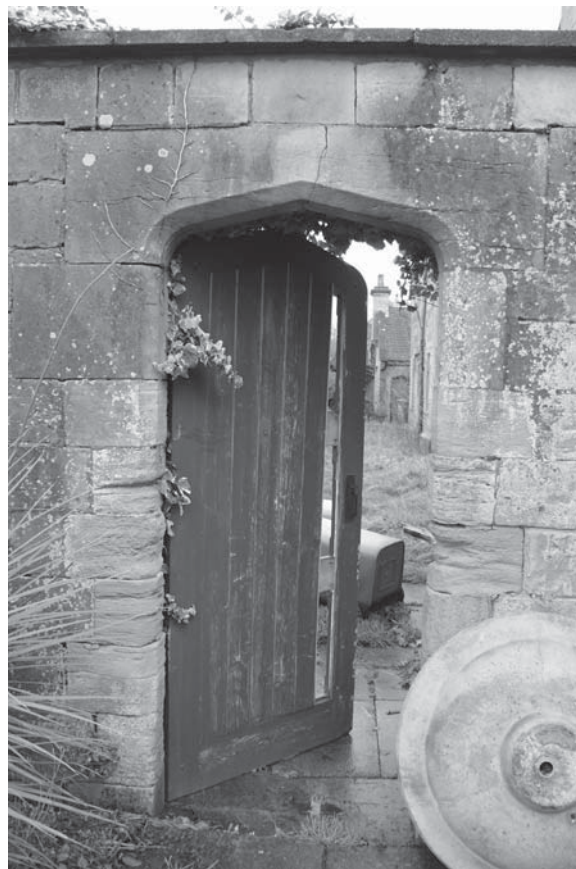
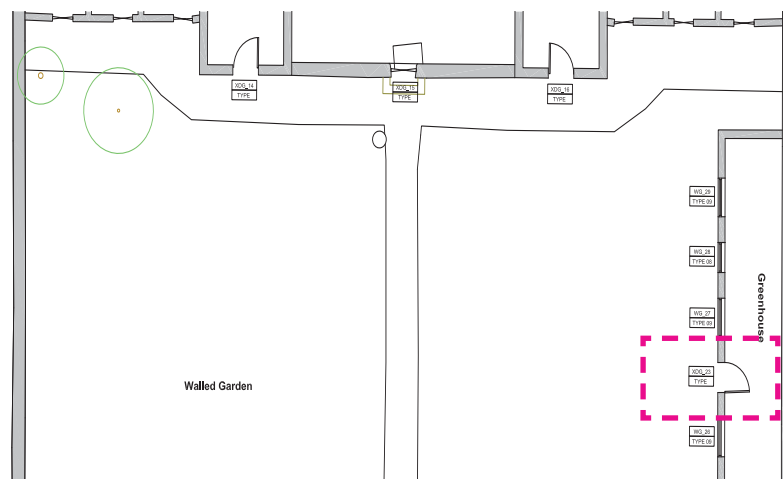
EXISTING EXTERNAL DOOR SCHEDULE										
Door reference No :						XDG-23				
Floor level :	Ground		External door type :		Type 11					
HISTORICAL SIGNIFICANCE			Level of significance		1=low, 5=high	1	2	3	4	5
Approximate date :	C 1860's							3		
Description :			WORKS PROPOSED							
Tudor arched painted timber panelled door with 6 flat vertical panel sections.			Retained and repaired :		Removed and replaced :					
			YES.
